CC5™ Batched Rolls

Iquique, Chile

CC5™ used to repair a
ditch broken by a 8.2
magnitude earthquake

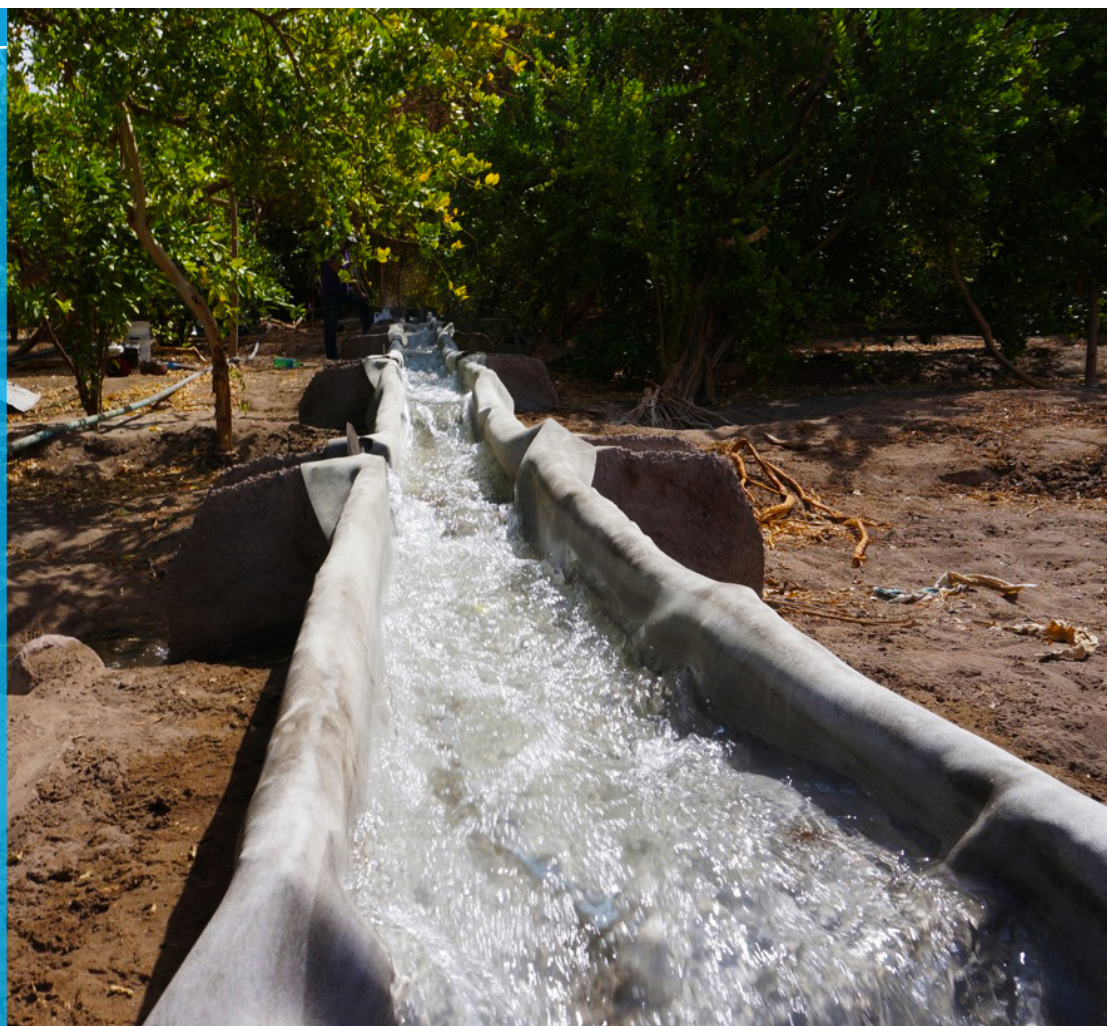
Repaired ditch

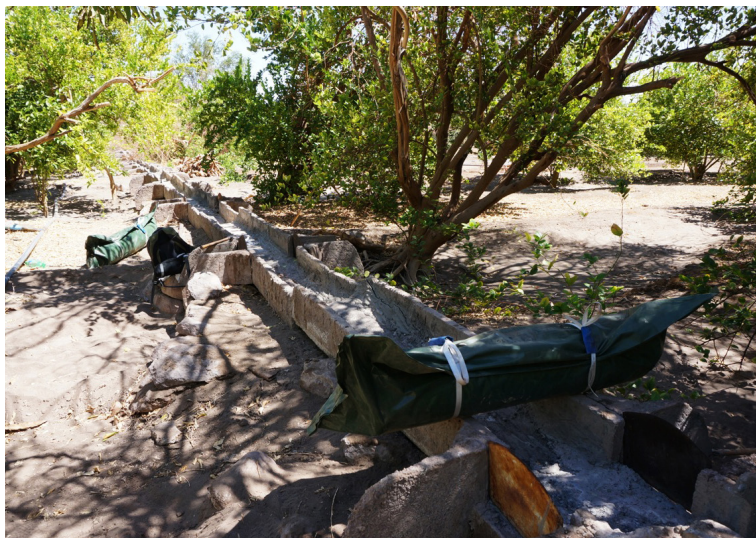
On the 1st of April 2014, an 8.2 magnitude earthquake struck off the coast of Chile, 95km northwest of Iquique. The force of the earthquake broke apart the farm's existing poured concrete irrigation ditch, cracking it in several places and making it unusable. This posed an immediate threat to the lemon trees and therefore the livelihood of the farmers. The INDAP (a government agency dedicated to help small farmers) and Pacifictek funded the project as a joint venture, both parties donating time, money and materials.

A batched roll of CC5™ and the broken ditch

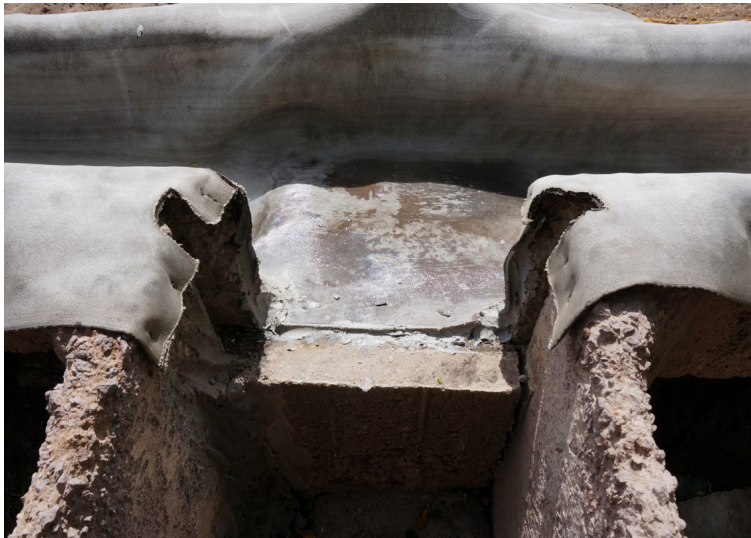
An epoxy grout joint to allow for the steel doors

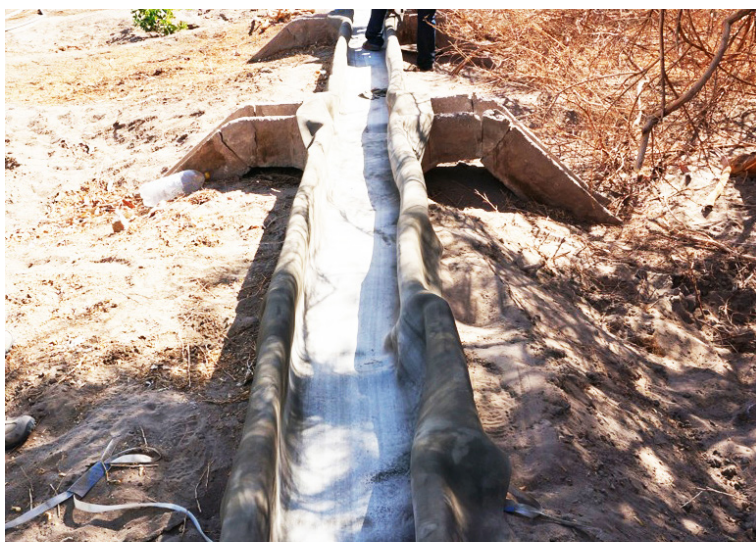
Overlapped and screwed joint

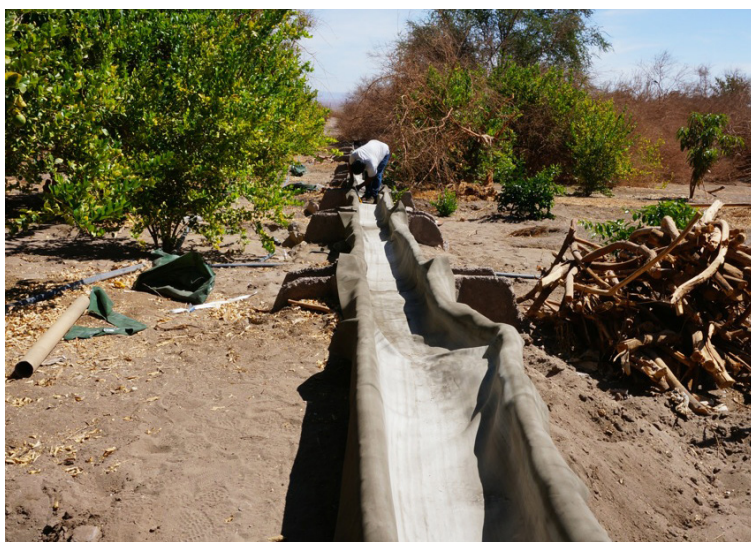
Example of CC conforming to profile

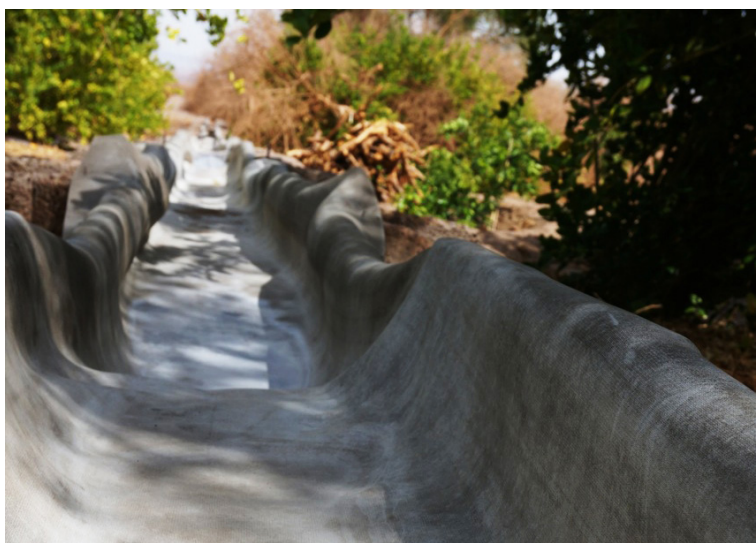
After hydration

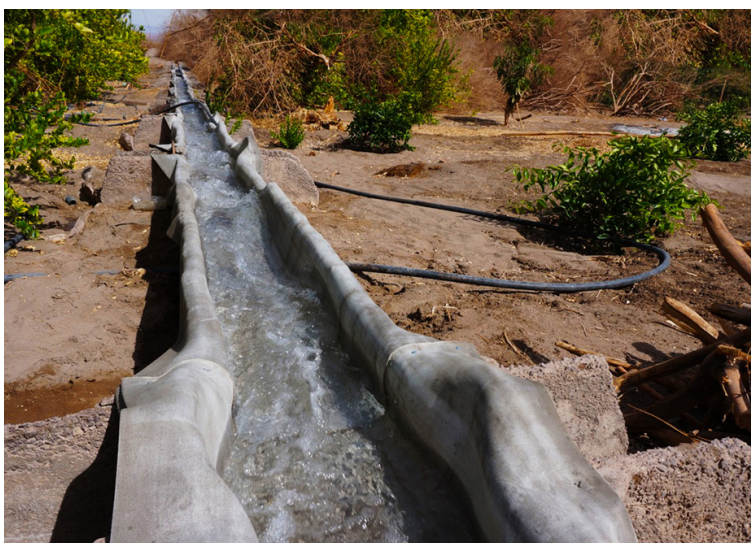
The finished ditch
