CC8™ Bulk Rolls

Tongwynlais, Wales

CC used to remediate an existing channel to prevent water damage to adjacent properties

Completed CC remediation installation in Tongwynlais, Wales

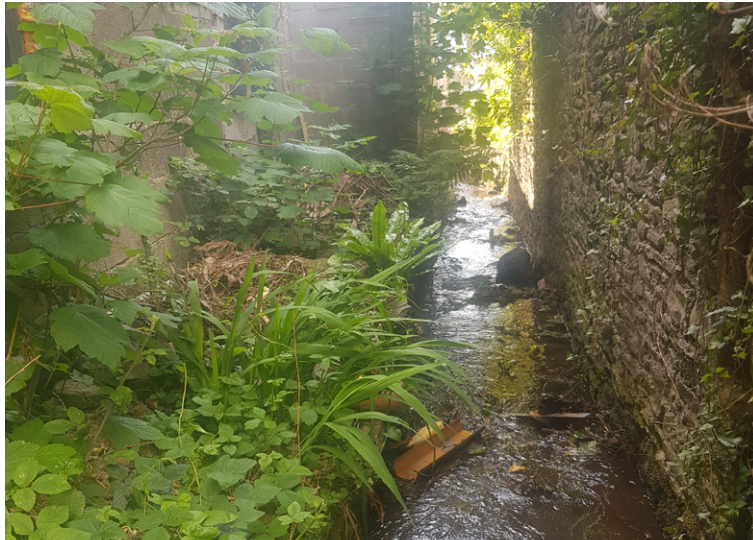
The channel in question was a masonry walled structure with a loose gravel invert. Over time the mortar between the rock in the channel walls had eroded. During a period when the water level was high in the channel, the water pressure caused rising damp and localised flooding in the area, which also affected the local properties. Cardiff Council's water specialist, Alun Holvey, sought a solution that would provide continued erosion protection as well as a barrier which could reduce permeability in the channel.

Channel prior to works

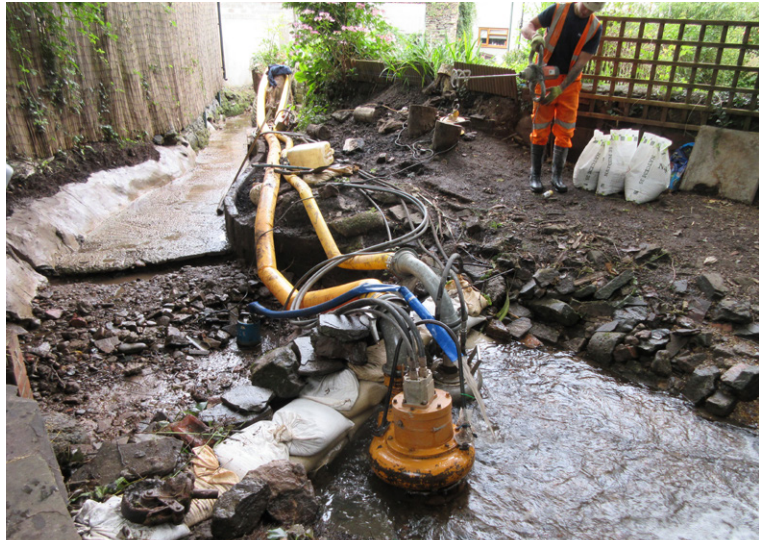
Water was overpumped to allow works to be carried out

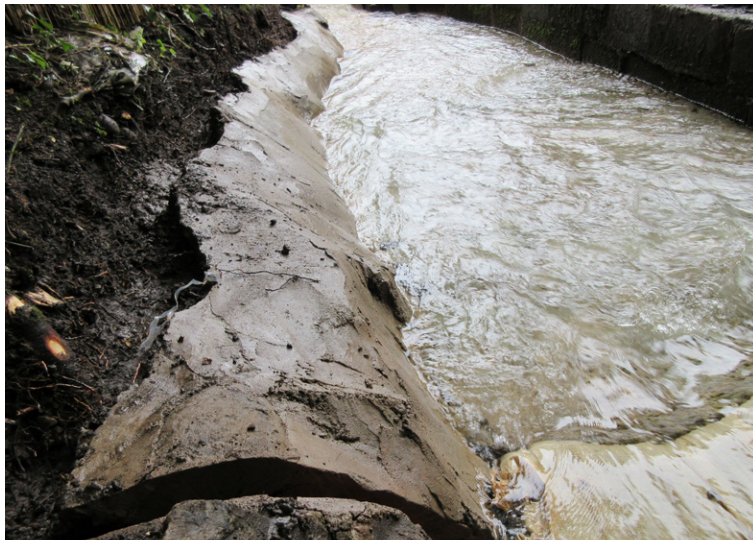
Channel side slopes coated with marine cement for a smooth surface

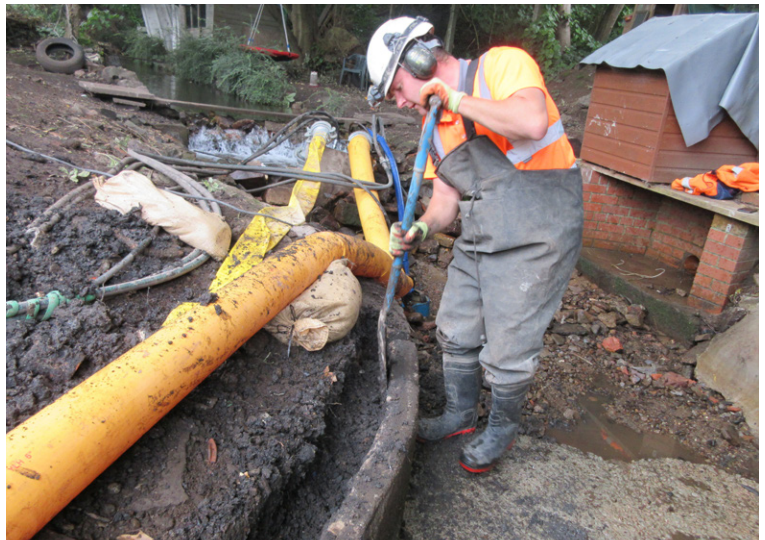
Anchor trenches were prepared by hand

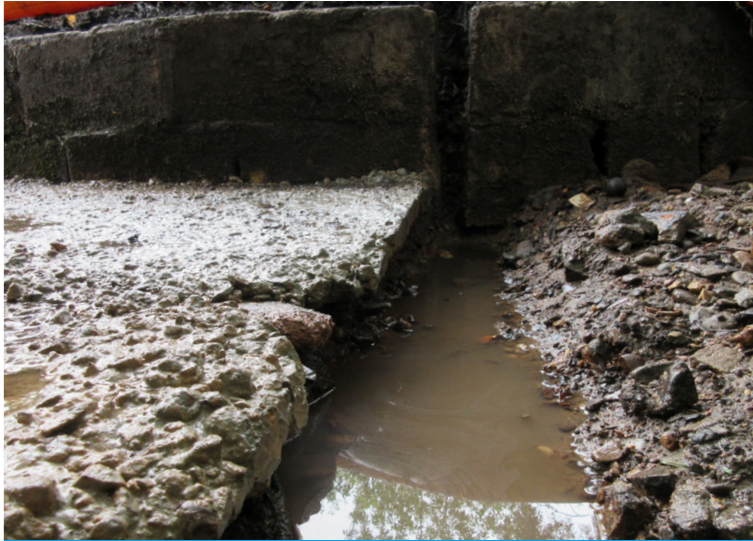
Anchor trench created for CC termination downstream

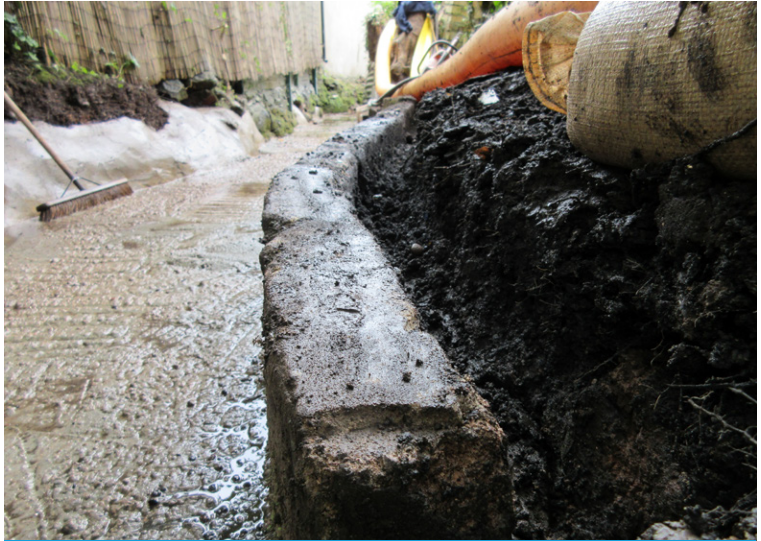
Anchor trench and brushed poured concrete finish for invert

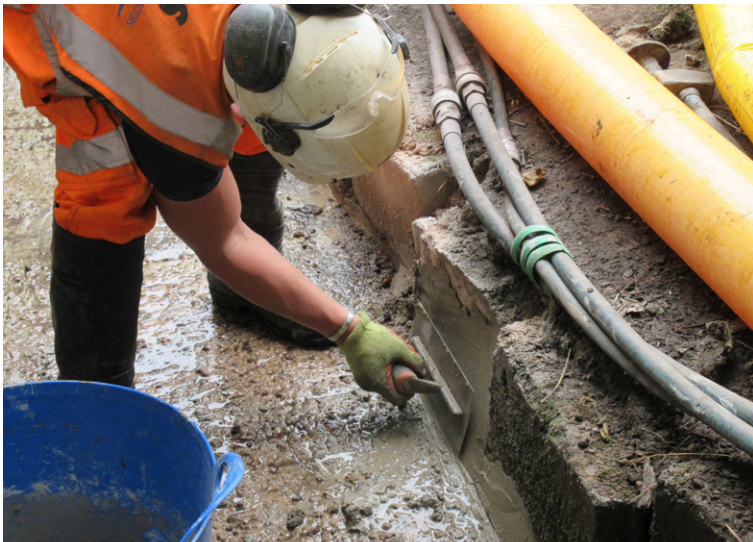
Marine cement used to fill voids in uneven blockwork

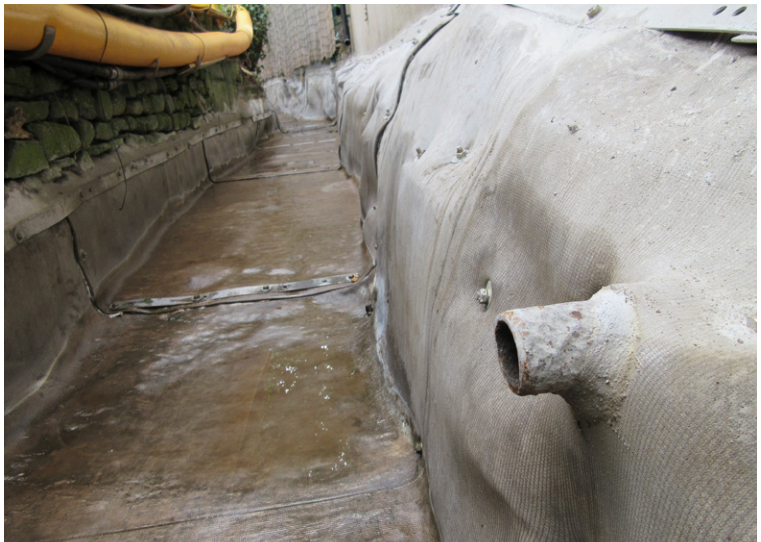
CC was cut to accommodate new and existing protruding pipework

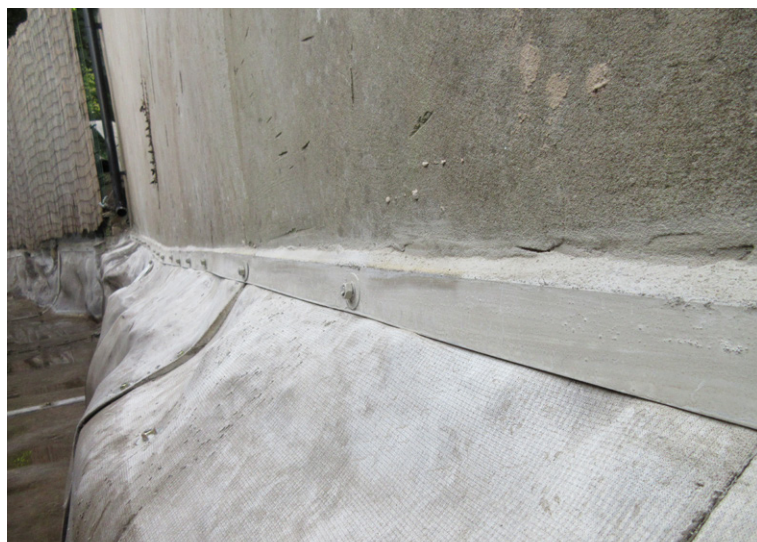
Termination of CC against outer wall of houses

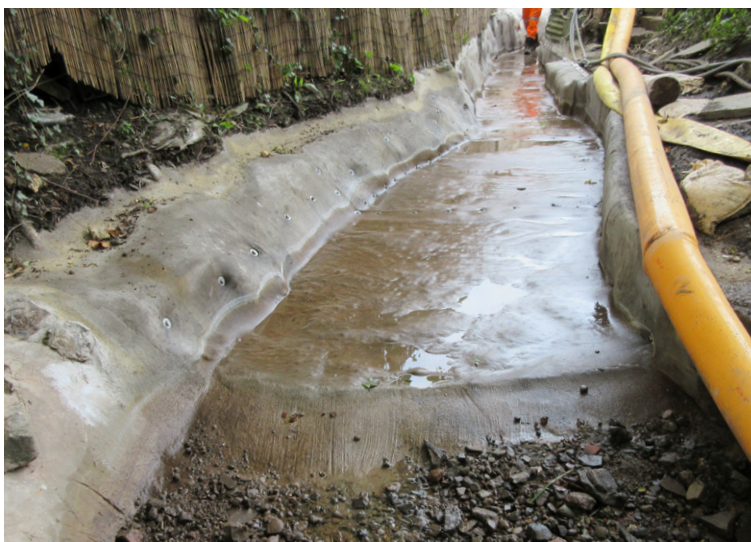
Termination of CC into anchor trench downstream

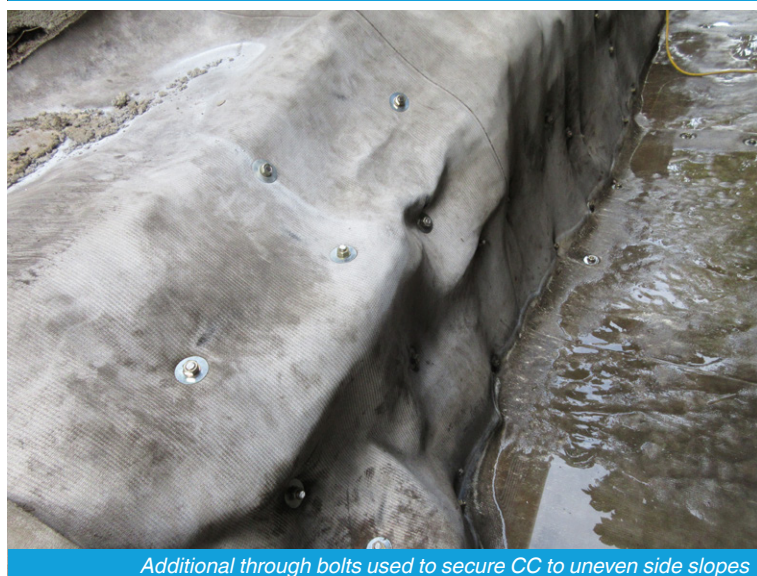
Additional through bolts used to secure CC to uneven side slopes

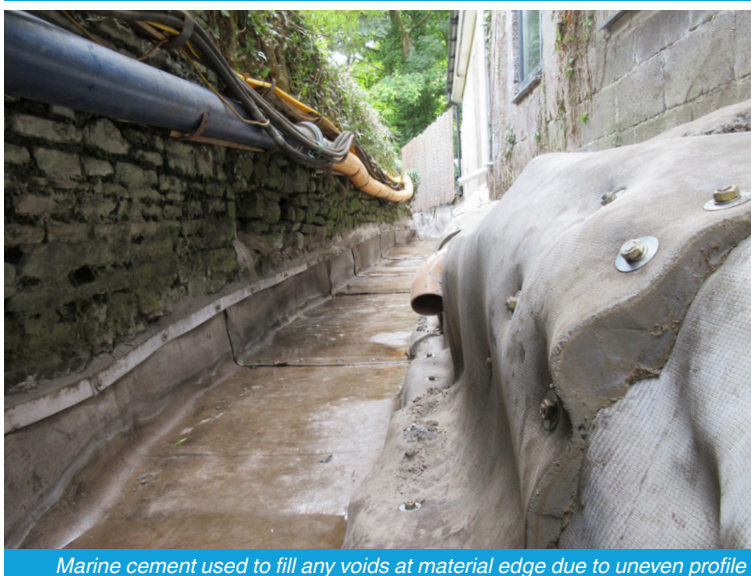
Marine cement used to fill any voids at material edge due to uneven profile
