CC5™ Bulk Rolls

Sohar, Oman

CC used to prevent slippage of a channel's side wall which sits around 1.5m Diam pipes

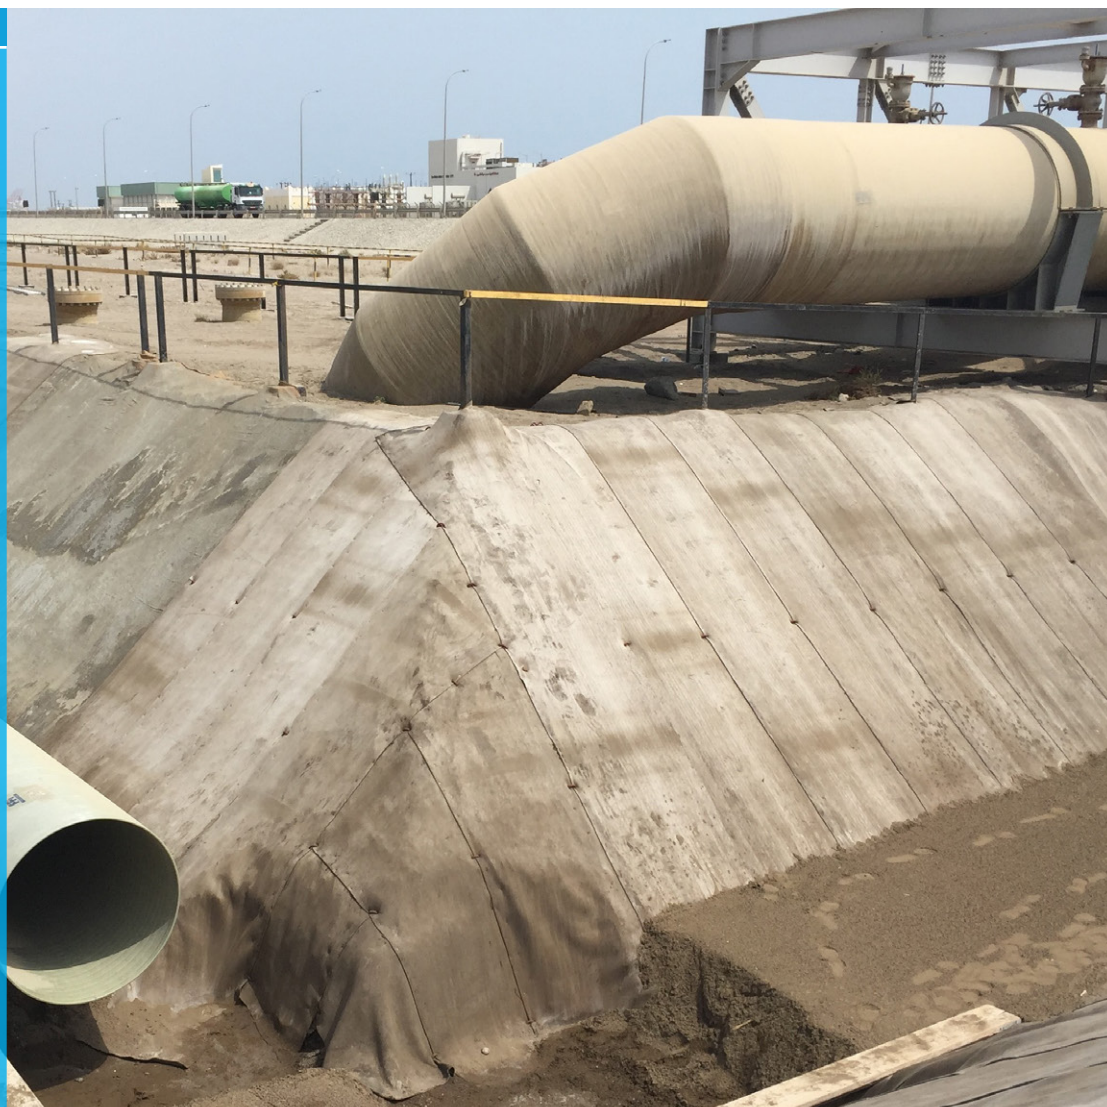
Completed section of CC lined channel wall

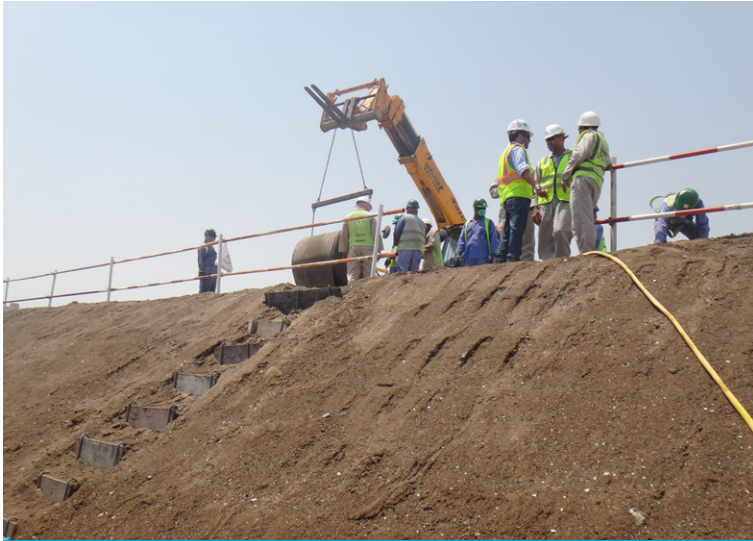
The large channel walls measure 4m in depth by 7m in length and had suffered slippage as a result of weathering and erosion over time. The substrate is also sand-based and very fine, making it more prone to slippage. Due to the nature of the site, and the proximity of the sensitive piping infrastructure to the channel walls, piling and concrete in traditional forms (e.g. poured, pre-cast and sprayed) were not suitable. Time constraints were also an issue as the client wanted to act quickly, get the channel back into use and also due to the 50°C temperatures reached during the day would prevent the use of other solutions as they would crack. As a result, CC was the only viable option.

Channel wall prior to lining

In preparation for the installation, the slope was re-graded and the corners banked. The base of the channel was also excavated to ensure it lay below the level of the pipes and pipe support columns. The slope was then watered prior to deploying the CC to add compaction to the slopes when the material was laid.

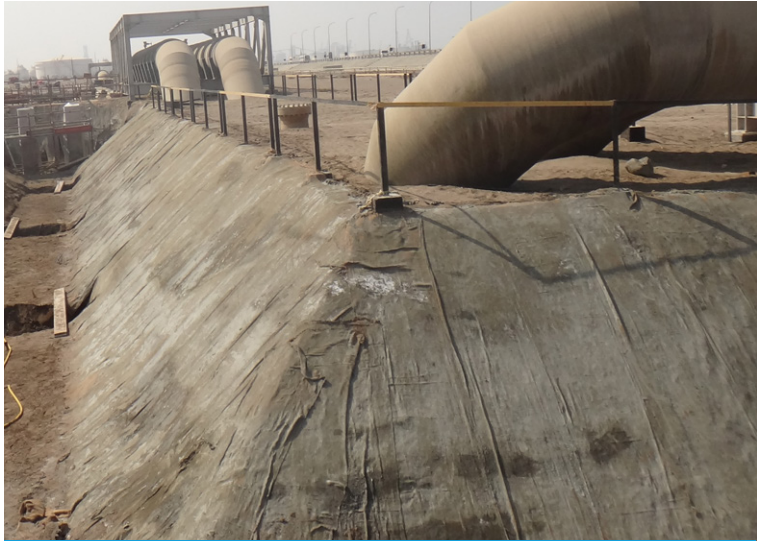
Channel wall covered prior to installation

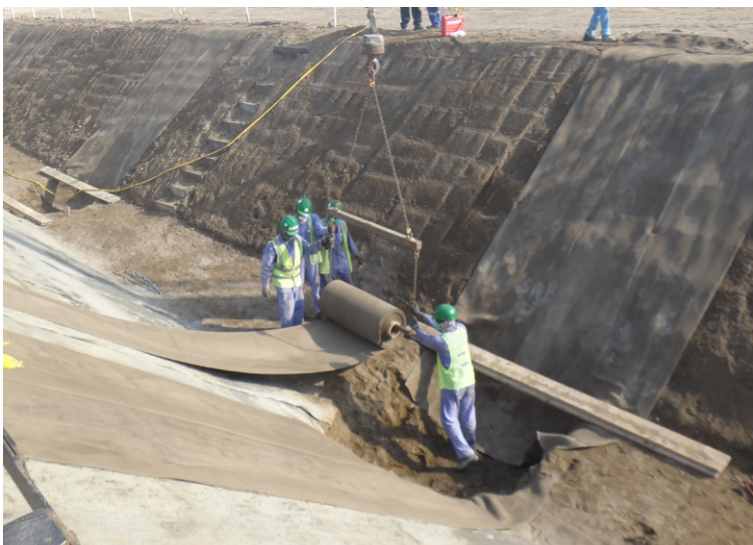
CC depoyed from spreader beam

On the first day, the arrival of the crane was delayed. In order to prevent delaying the progress of the project, the CC was deployed from a spreader beam on a fork lift, and rolled down the slope from the crest before being pegged at the crest and cut to length.

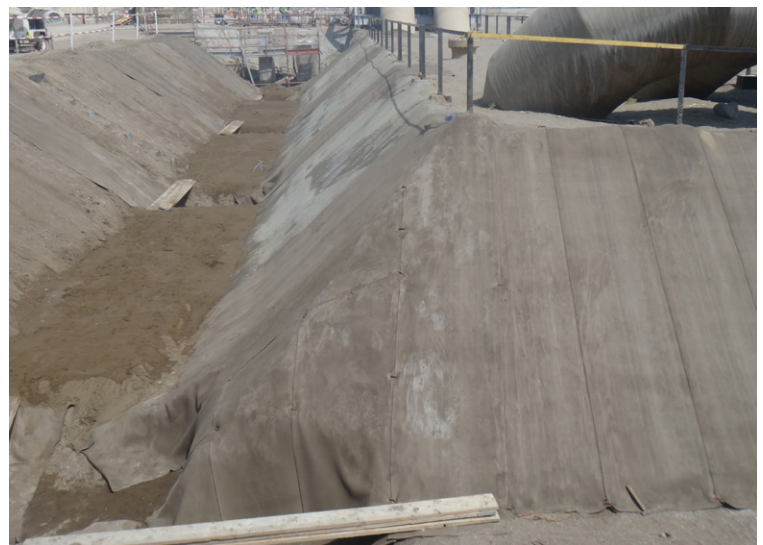
Corner detail

Once sealed and jointed, ground pegs were inserted at every 1m along the material edges, while pegs were inserted where required on the corners to ensure the CC held position as the pipes on the left of the slope, which were operational, caused some vibration. In some areas, the distance between the works site and the active pipe was less than 1m.

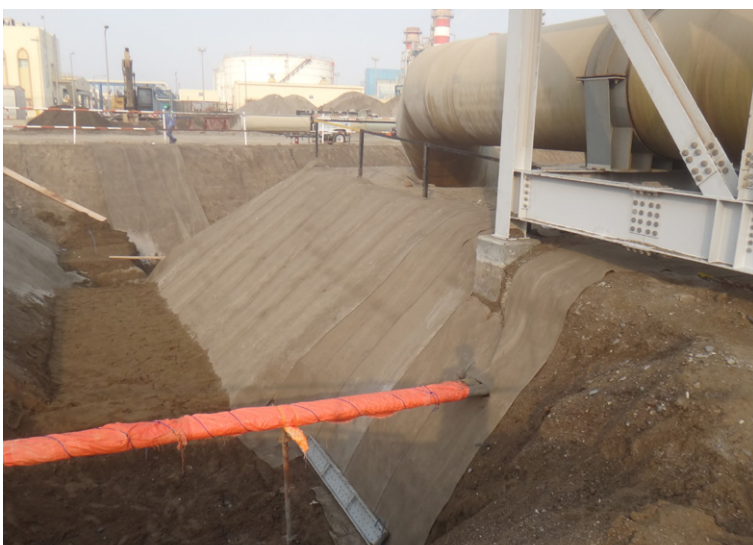
CC easily accomodates existing infrastructure

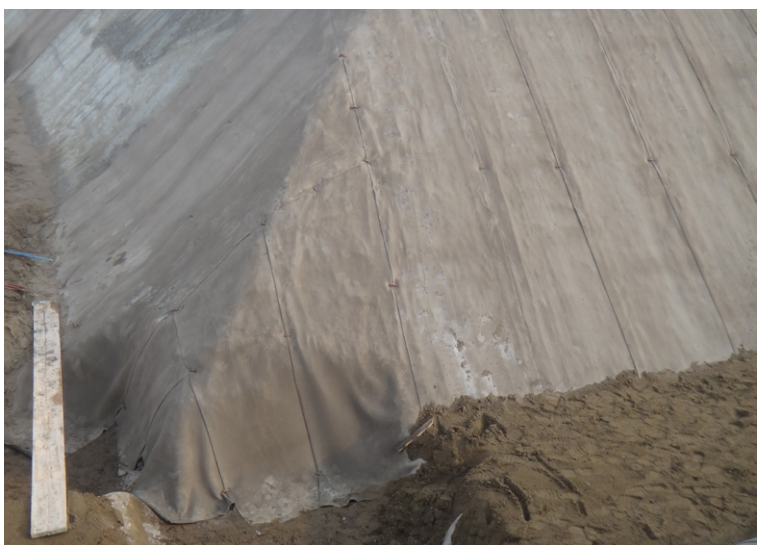
CC edges buried at the toe

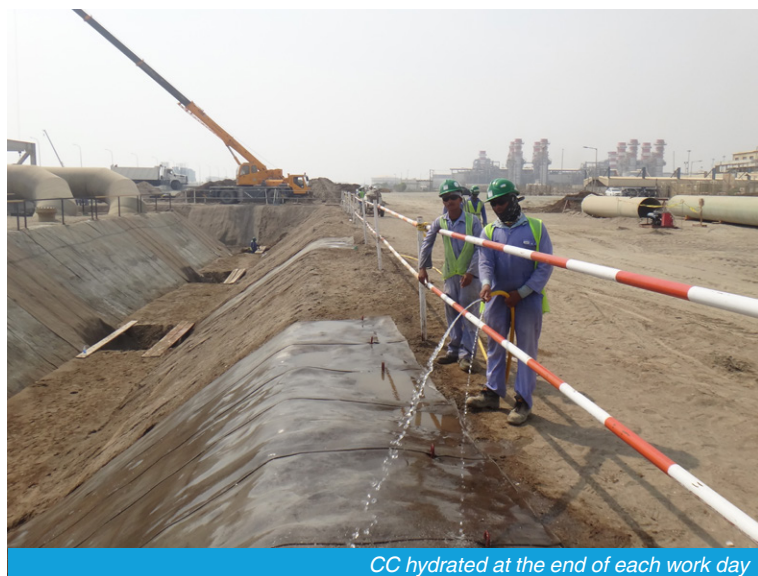
CC hydrated at the end of each work day

Once the installation had been completed, a 5000-gallon tank was used with a pressure pump on a 20mm nominal hose. The CC was hydrated again an hour later and again the following morning due to an increase in wind and temperatures overnight.

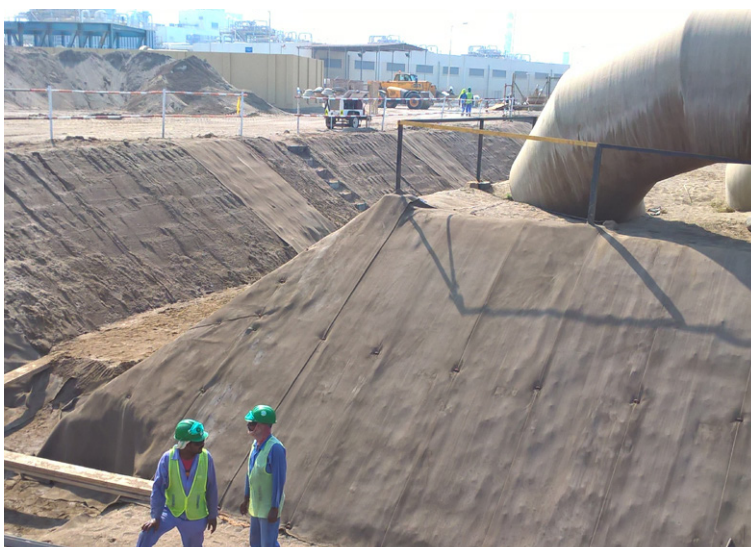
Proximity of channel wall to pipes
