CC13 & CC8
batch rolls

Aysen, XV region
Chile

CC used for time critical remedial work of a fish farm, lining a cracked and dilapidated concrete reservoir.

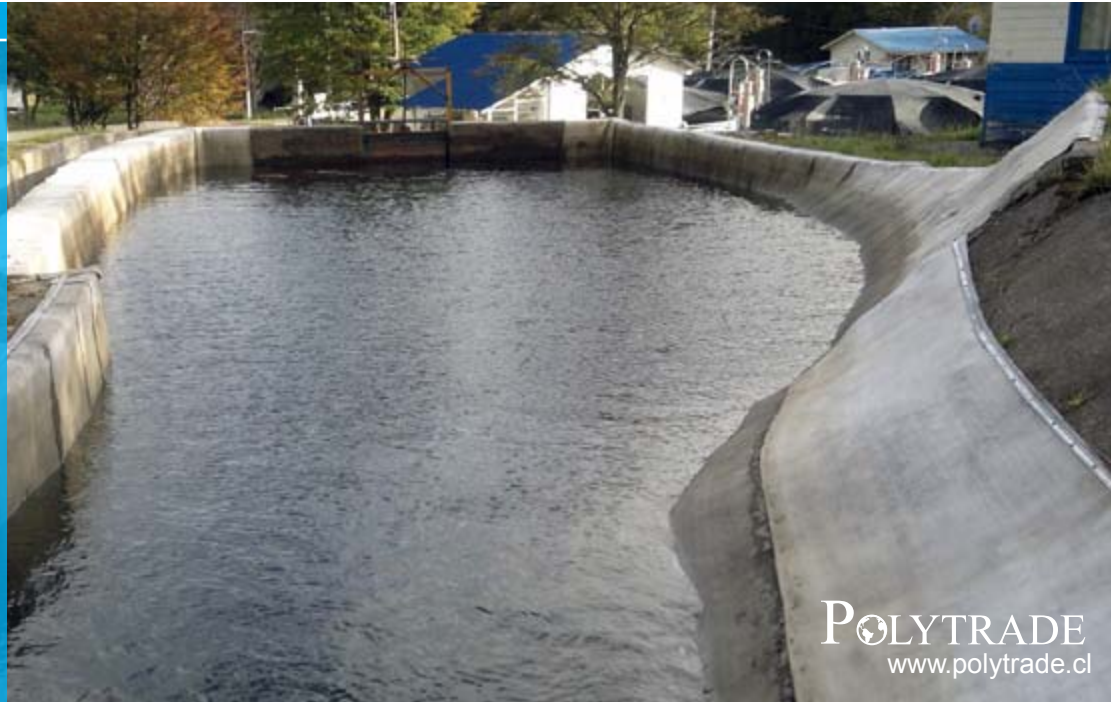
Reconditioned fish farm reservoir which was restocked 1 day after CC installation

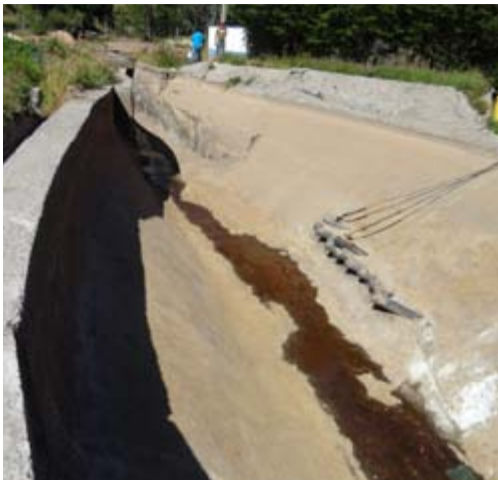
Dilapidated concrete reservoir

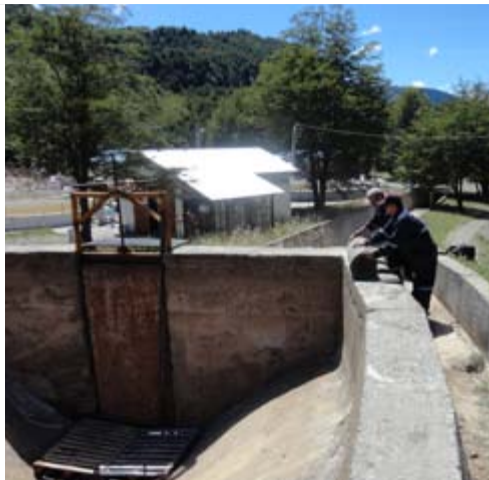
Unrolling CC8 batched rolls into position

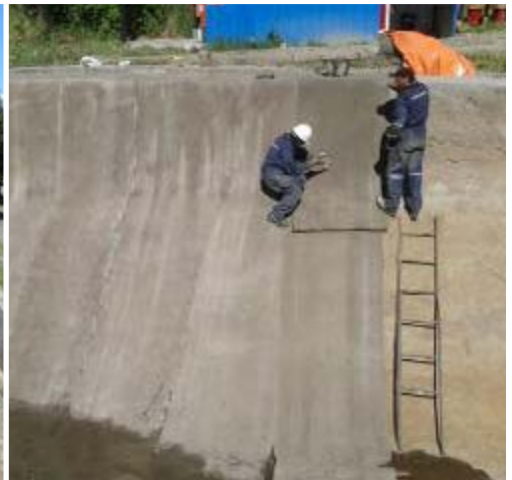
Fixing CC to the existing concrete substructure

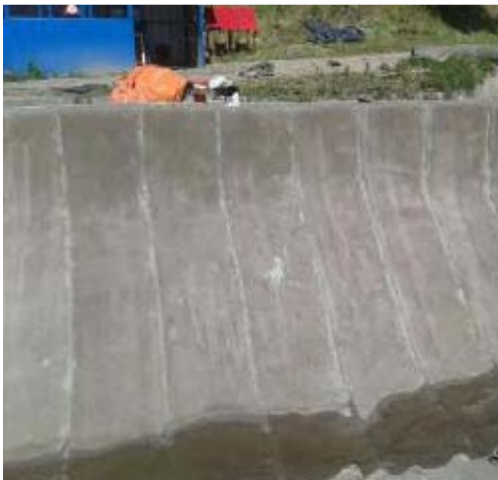
Lined concrete reservoir with sealed joints

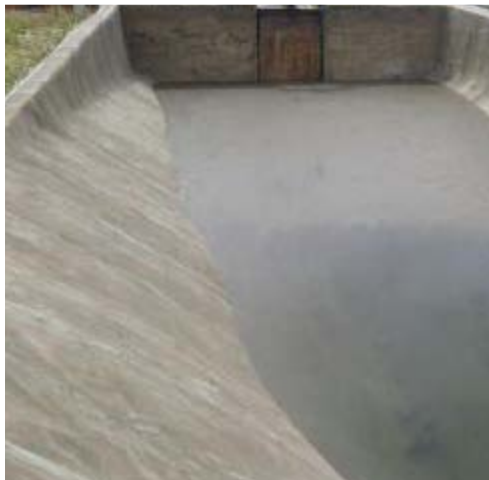
Refilling the basin to hydrate the CC

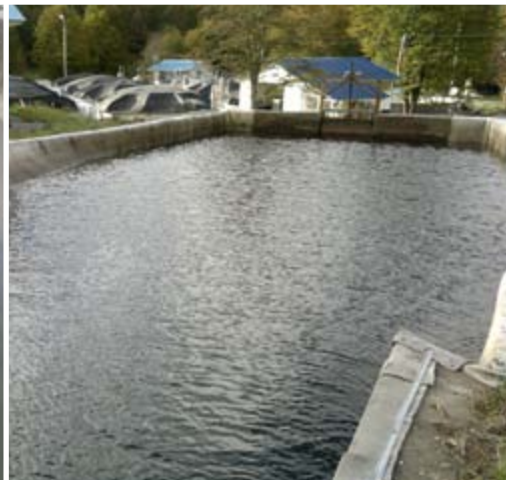
Completed reconditioned fish reservoir
