CC8 bulk rolls

Alcobendas Station, Madrid, Spain

- Slope stabilisation of railway embankments on a high speed rail line.

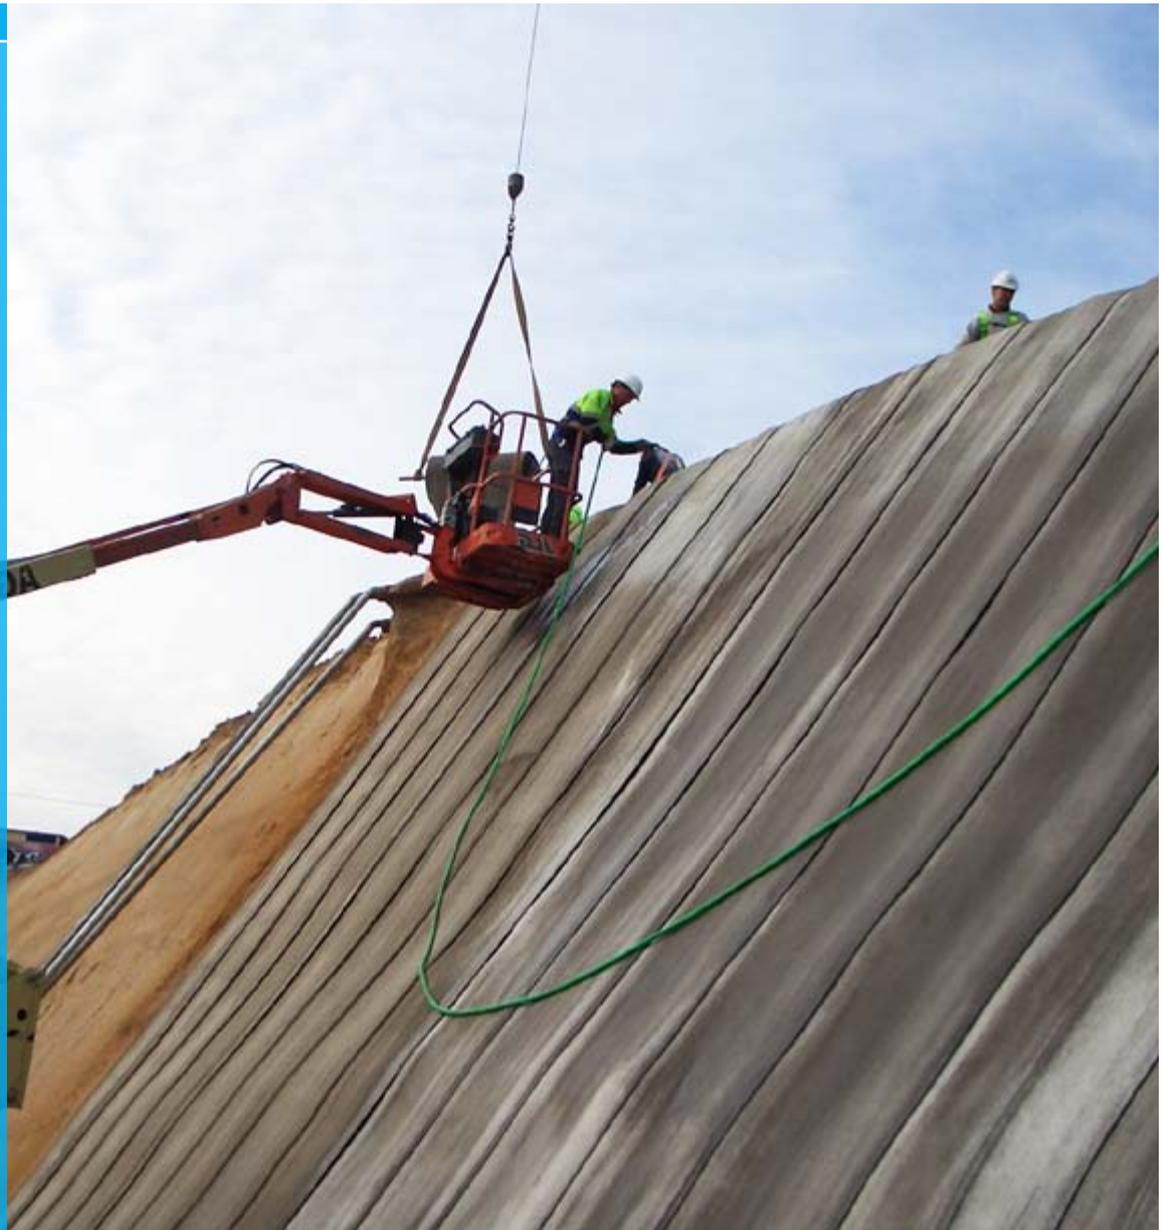
Dispensing CC8 bulk rolls from spreader beam equipment

2500sqm of CC8 was specified and delivered on site in bulk rolls, which were dispensed from spreader beam equipment and plant. The CC was fixed at the top of the 12m slope using galvanised steel pegs whilst adjacent CC layers were screwed together. A shallow surface runoff ditch was formed at the toe of the slope. Train traffic was not affected during the works: the station was able to remain open during the installation as there was no risk of discharge from material onto the tracks, often a problem with sprayed concrete techniques.

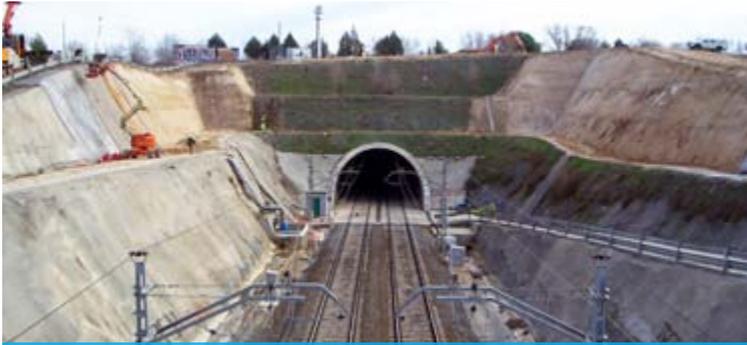
Alcobendas tunnel station. Train traffic able to continue during works

- Installation of CC allowed train traffic to continue without disruption of service.

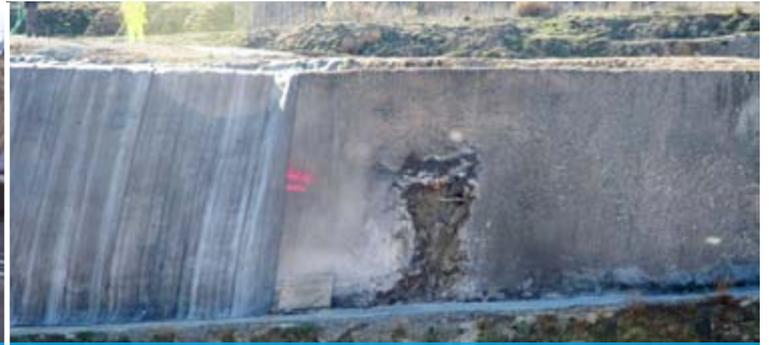
Damaged guniting section from previous remediation work

In December 2010, ADIF, the Spanish authority responsible for railway infrastructure management, specified Concrete Canvas (CC) to be used as slope protection for a railway station in Madrid. CC was chosen to address years of erosion and instability issues affecting the entrance of Alcobendas tunnel station. Erosion of the steep railway slope embankments had caused silting at the drainage pumps in the tunnel entrance. Shotcrete had been used twice previously but presented several problems with installation and durability.

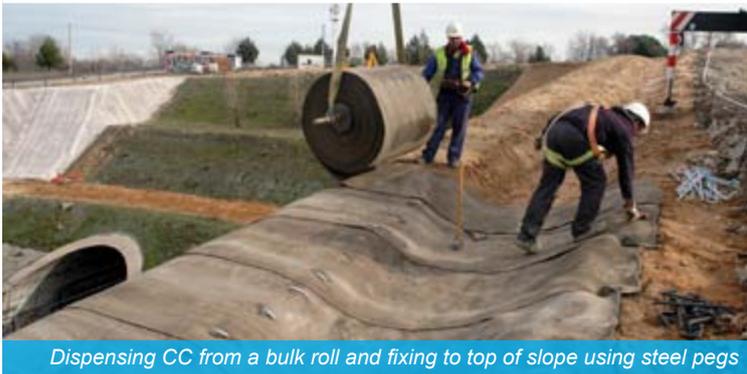
Dispensing CC from a bulk roll and fixing to top of slope using steel pegs

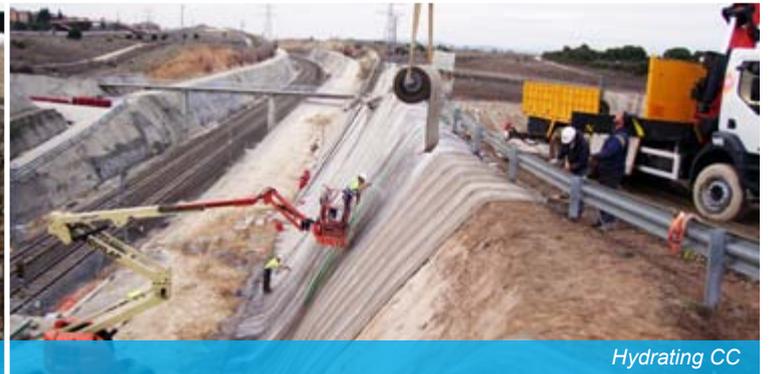
Hydrating CC

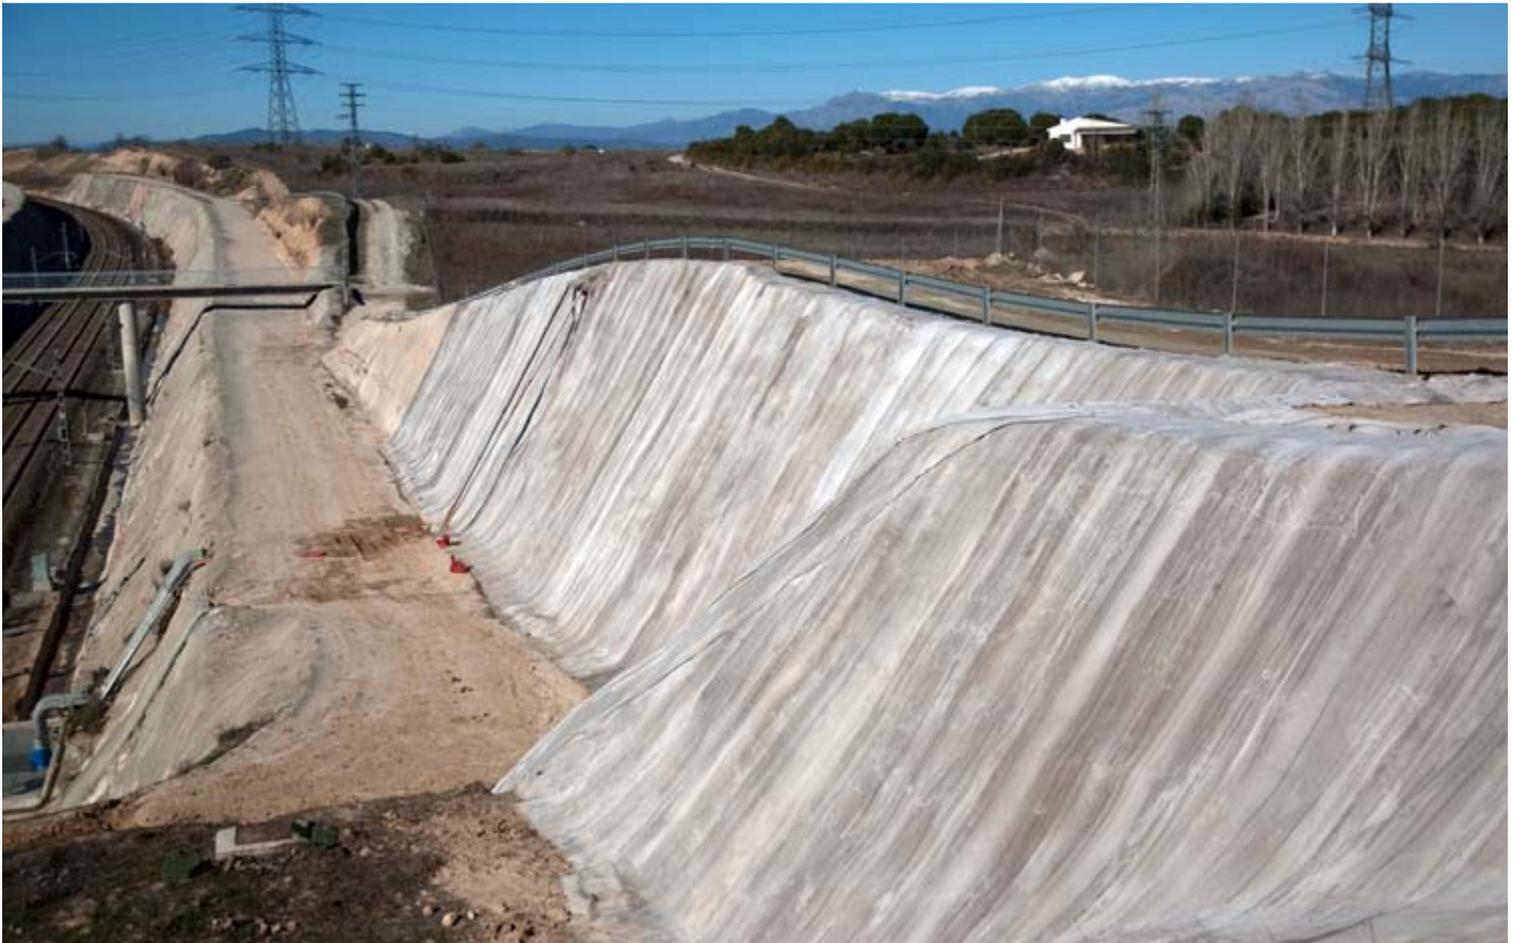
Completed CC lined embankment

Installing at a rate of over 450sqm/day, the project was completed in under a week and was 70% quicker to install than if shotcrete or gunite had been used.
