CC8™ Bulk Roll

Undisclosed Tank Farm, Oman

CC8™ was used to prevent the weathering of a roadside slope which was leading to rockfall onto the road.

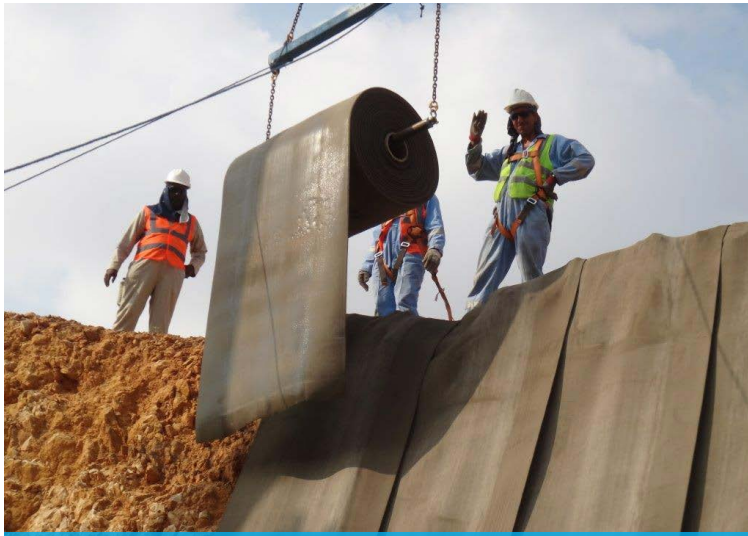
CC being lifted into position

Loose rock was removed from the face of the slope to ensure intimate contact between it and the CC. Bulk rolls of 8mm thick CC (CC8™) were delivered to site and mounted onto a spreader beam which was then hung from a crane. The rolls were lifted to the top of the slope and the leading edge was placed in an anchor trench and pegged with 380mm stainless steel pegs. The rest of the CC was then unrolled down the entire height of the slope and cut to length, avoiding wastage. This process was repeated with each layer overlapping the previous by 100mm. The overlaps were sealed with CT1 sealant and screwed at 100mm centres in 2 offset rows. Pegs were also inserted where needed down the face. These extra precautions were taken due to periodic high flow rates over the face of the slope. At the base, a mortar was used to seal the CC to the concrete substrate and to the pipes installed to allow the egress of water, preventing the build up of hydrostatic pressure behind the CC. Hydration was achieved using a 200 gallon small tanker at the crest of the slope and a bowser at the base. Due to the high temperatures a second hydration was undertaken an hour later.

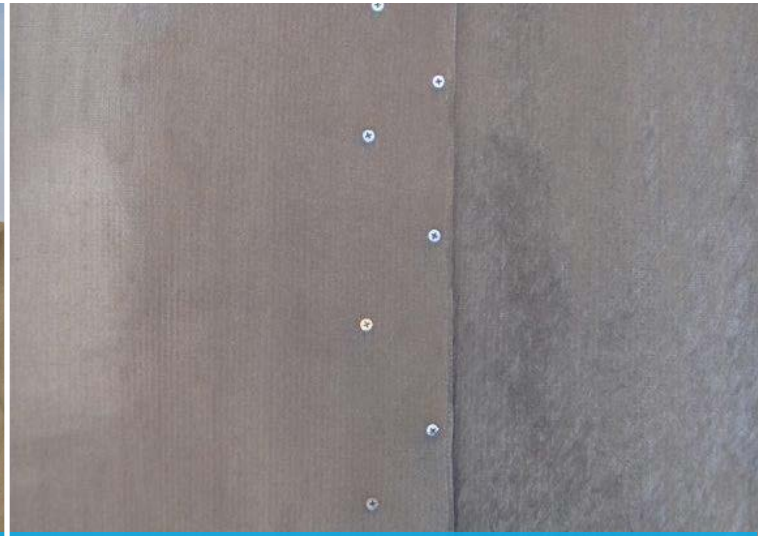
CC jointed with two offset rows of screws
