Secondary containment

Just add water

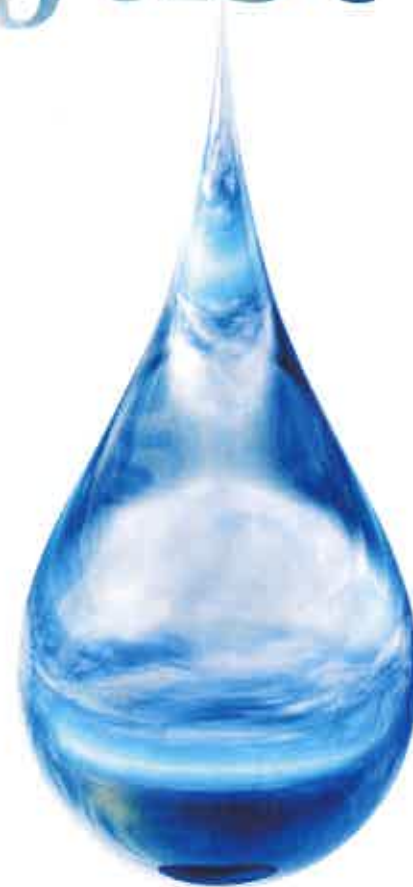
Concrete Canvas was originally incorporated to manufacture its Concrete Canvas Shelters: a 'building in a bag.' By just using water and air, a solid building can be deployed by two people in less than two hours and is ready to use in under 24 hours. This provides a solid, waterproof and fire-proof portable structure ideal for use in remote regions such as disaster areas or war zones.

The material, which is a geosynthetic cementitious composite mat (GCCM) can be used to guard against the costly effects of wind, rain and long term degradation of terminal bunds. It can be installed up to 10 times faster than traditional methods of concrete and is much more environmentally friendly.

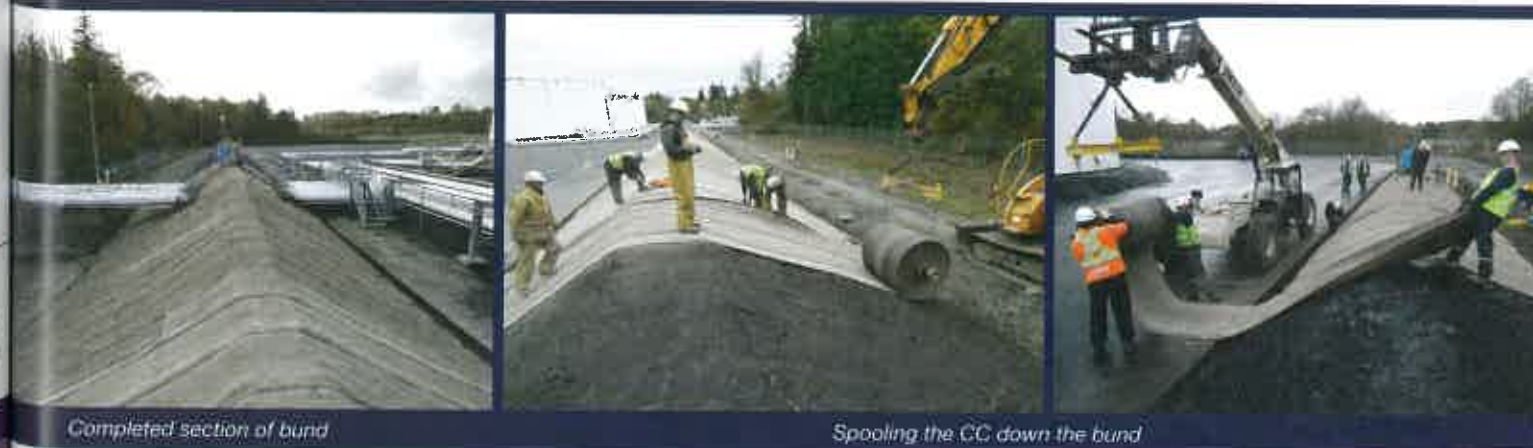
Completed section of bund

Spooling the CC down the bund

Western Refinery Services completed the installation over a period of seven days with a team of eight. Bulk rolls were placed at the crest of the berm and spooled down one side before being unrolled down the other. This process was repeated along the berm, with a 100mm overlap being created between layers. Each overlap was screwed and sealed using 200mm self tapping screws placed at 300mm intervals and Sika 1-A sealant. On the inside of the bund, the cut edges of the CC were placed into an anchor trench before being captured with concrete paving.

On the outer edge of the bund, masonry bolts were used to fix the CC to the existing concrete infrastructure. In areas where the bund had eroded to the extent it no longer met the height requirements, sandbags were used to fill any voids before the CC was deployed.

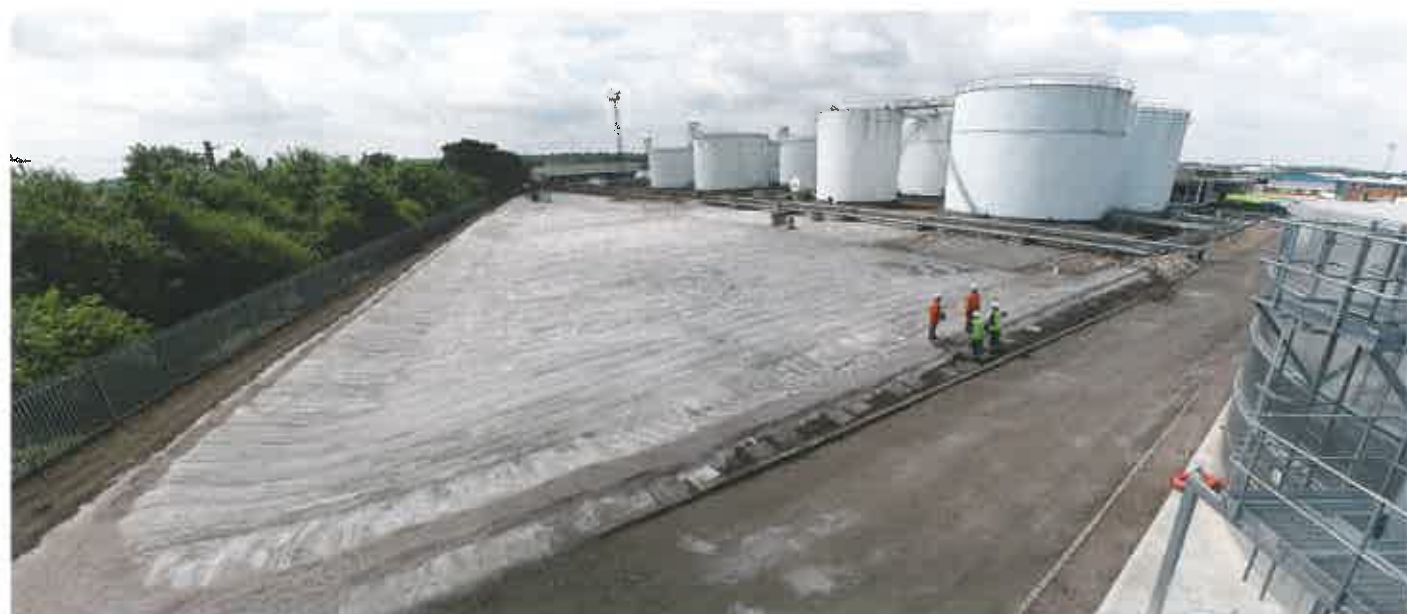
Completed installation of a lagoon lining

to bund linings, however. In April 2014 an oil distribution terminal in the UK required an upgrade for its firewater runoff lagoon. It had reached the end of its serviceable life and had degraded as a result of 15 years of weathering, puncture and UV damage.

CC is available in three thicknesses: CC5, CC8 and CC13 which are 5, 8 and 13mm thick respectively. CC5 is conventionally used for secondary containment applications, but due to the degree of traffic on the lagoon during cleaning and maintenance CC8 was selected in this case.

The project was completed over a nine week period, installed at an average rate of 250-300m² per day using a six man team. The CC lining will greatly increase the operational life span of the lagoon whilst significantly upgrading its permeability and fire protection, improving the overall safety and compliance of the site.

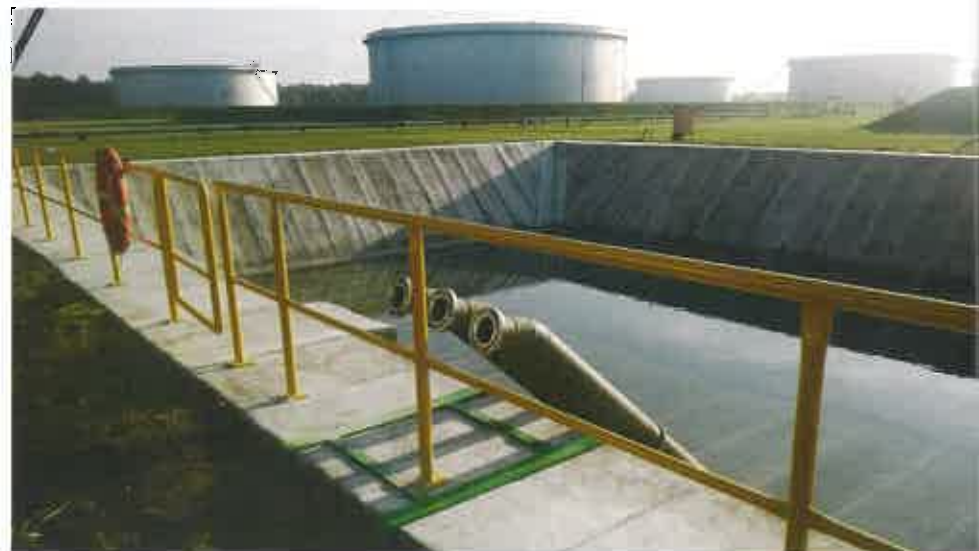
Completed installation
