## REMEDIATION

In August 2014, Concrete Canvas® GCCM\* (CC) was used to line an extinguishing lake to improve impermeability. The original poured concrete structure had cracked and spalled, resulting in excessive water loss. Removing the incumbent basin and re-building it using poured concrete and form work was considered, however this would have been more time consuming and taken the basin out of operation for an extended period of time during construction.

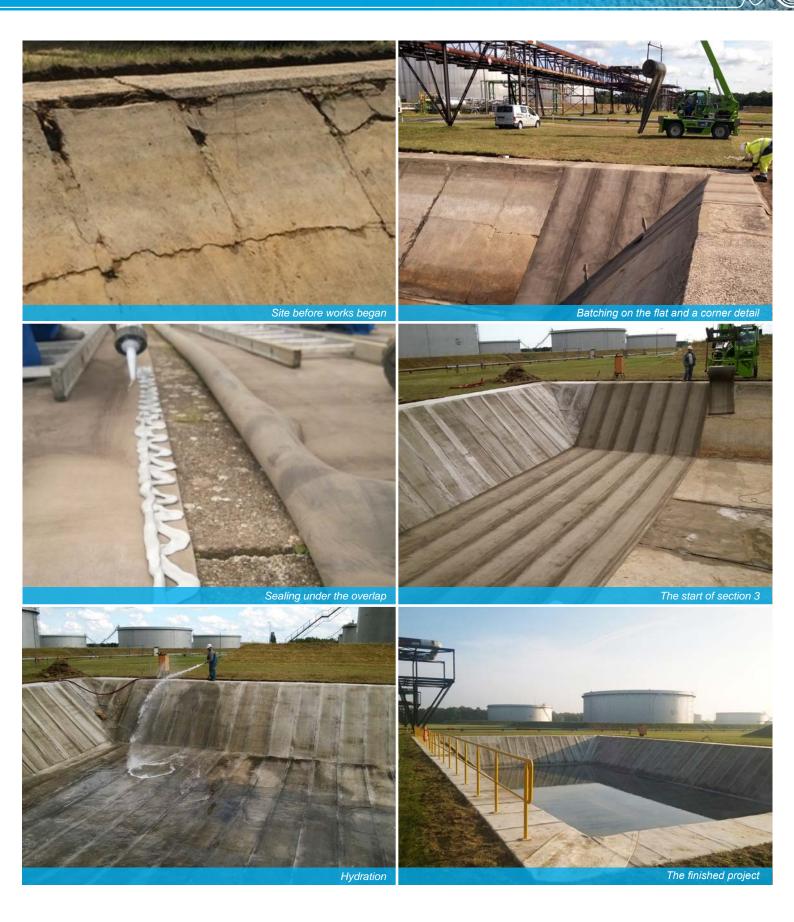
Installation was carried out by an approved contractor (with no prior experience of installing CC) for PCK; a joint venture between BP, Rosneft, Shell, Eni and Total. The failing concrete was cleaned and mortar applied to any larger cracks so as to eliminate voids under the CC. An anchor trench was created on the shoulder of the basin so as to prevent water ingress underneath the CC and provide a neat termination to the cut edges. Bulk rolls of 5mm thick CC (CC5™) were delivered to site before being mounted onto a spreader beam hung from a Zoom Boom. The project was completed in sections with the two shorter sides being completed first. For these sections the CC was unrolled on the flat, batched to specific profile length and positioned into the basin by hand with alternating perpendicular overlaps created at the corners. This allowed for the CC to be unrolled across the width of the basin for the remaining two sections, starting at each end and progressing towards the middle where a drainage sump is located. Each section of CC was jointed and hydrated via the same procedure: the leading edge of the CC was fixed to the concrete substrate using 40mm wedge anchors at 2m intervals, the subsequent layer was positioned to overlap the previous by 100mm, then the construction team hydrated under the overlap and applied certificated sealing material. Hydration was achieved via an extinguishing hose connected to the main ring system on site.

900sqm of CC5™ were installed by 5 people in 4 days with some inclement weather. The client was very impressed with the result and subsequently instigated a bund lining trial as well as planning to line a 6000sqm extinguishing basin with CC. A poured concrete solution would have taken at least one month to complete, meaning a time saving of over 75%. Additionally CC needed far less labour and was more cost effective than a poured concrete solution.
