CC5 Bulk Rolls

Zipaquirá-Bogotá
Highway, Colombia

CC5 used as an erosion control measure in order to protect Zipaquirá-Bogotá highways from a washout of fines and other debris

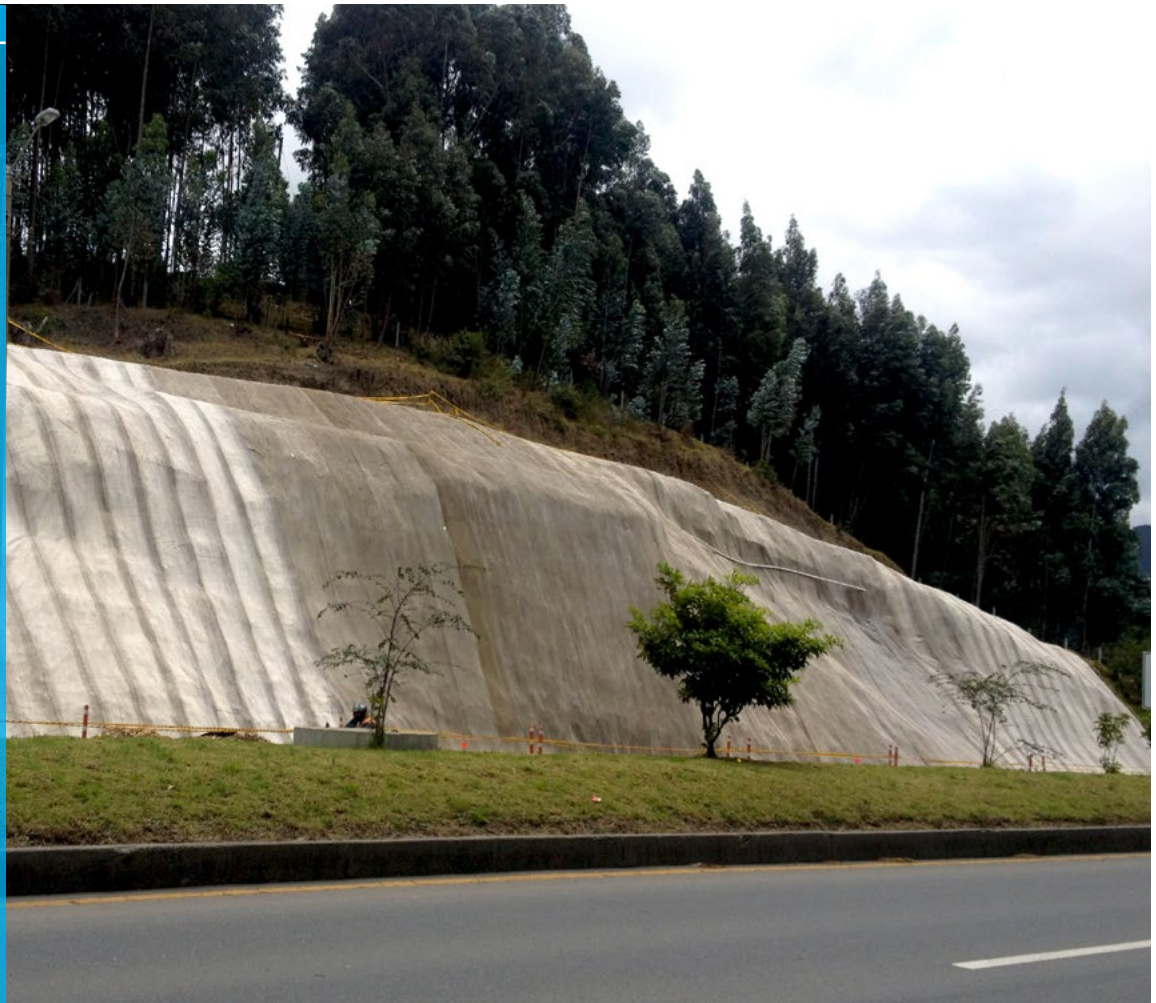
Completed slope

The 1000sqm installation was completed in 13 days in inclement weather by an installation team of 6. The client and installation team were **impressed with the ease and speed at which CC was installed**, as well as the material's "consistency and functionality". Feedback provided by the project's head engineer in November 2013 stated that, after two weeks of very heavy rain, the CC was still stable and the slope had not shown any movement or further loss of fines.

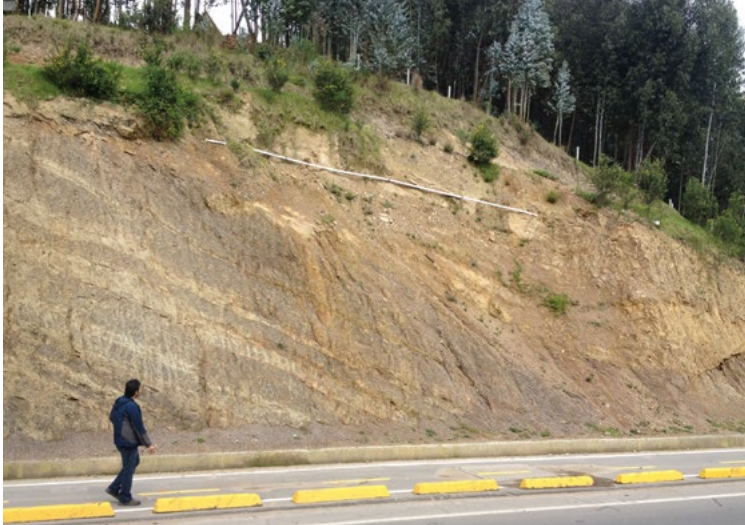
The slope prior to installation of CC, displaying signs of slip and erosion

In July 2013, Concrete Canvas (CC) was used as an erosion control measure on a slope adjacent to a section of the Zipaquirá-Bogotá Highway in Chinchilla, Colombia. The slope had suffered from slip and the erosion of fines due to adverse weather in the region, a situation exacerbated by leakage from a water pipe that had been installed across a significant section of the slope. There was potential for falling debris to cause an accident on the highway, or block the cycle path that ran alongside it. Shotcrete had been considered for the project. However, there was a concern that the associated rebound may cause damage to the highway and surrounding infrastructure.

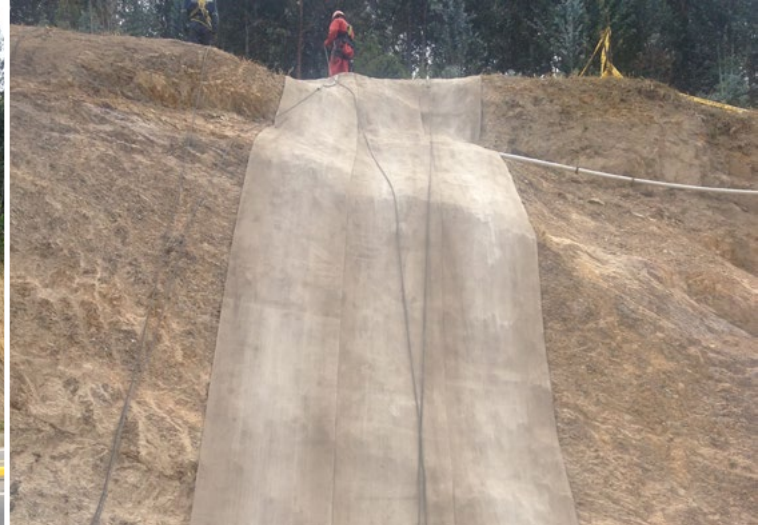
A spreader beam and climbing equipment was used to lay lengths of CC5

Prior to installation the area affected was cleared of vegetation, loose soil and rock and other debris. Bulk rolls of CC5 were then delivered to site and cut to length, ensuring that the CC could cater for the slope's varying profile whilst eliminating material wastage. Each length of CC was fixed to the top of the slope using 400mm steel ground pegs before being unrolled down the slope using a spreader beam and climbing equipment. Adjacent lengths of CC were overlapped by 100mm and screwed together at 200mm. Anchor bolts were used to fix the material to the foot of the slope and to the drainage outlet at one end of the slope. The installed CC was then hydrated.

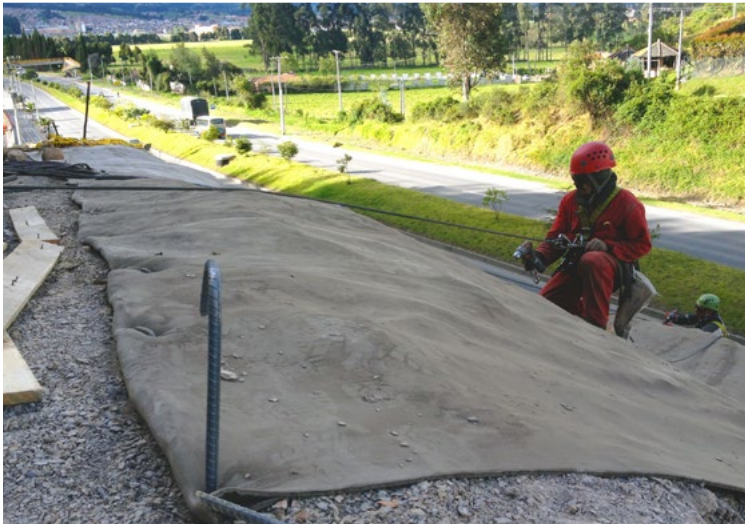
CC was fixed to the top of the slope using steel ground pegs

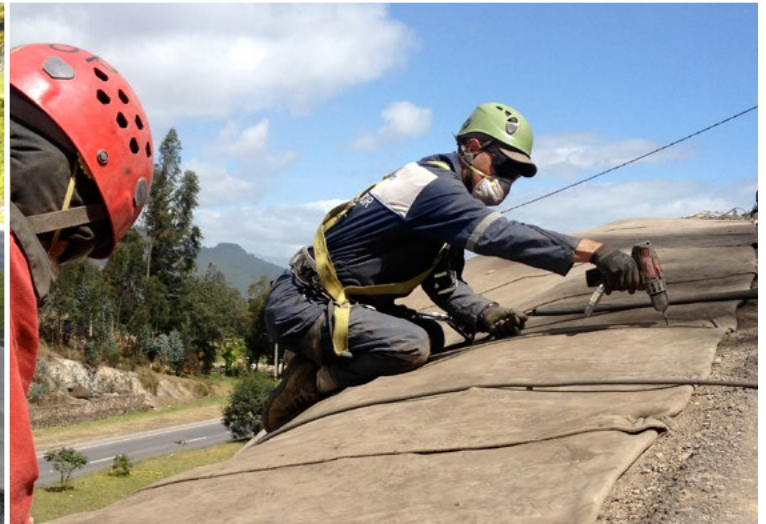
Adjacent layers of CC were overlapped by 100mm and screwed together

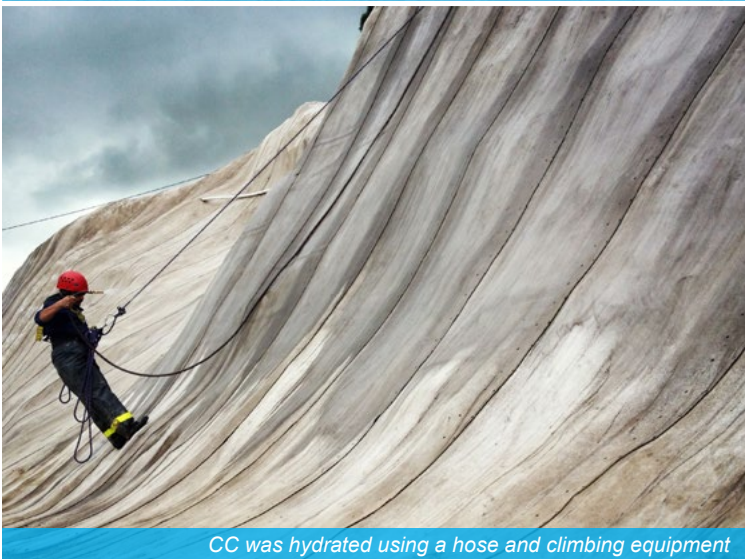
CC was hydrated using a hose and climbing equipment

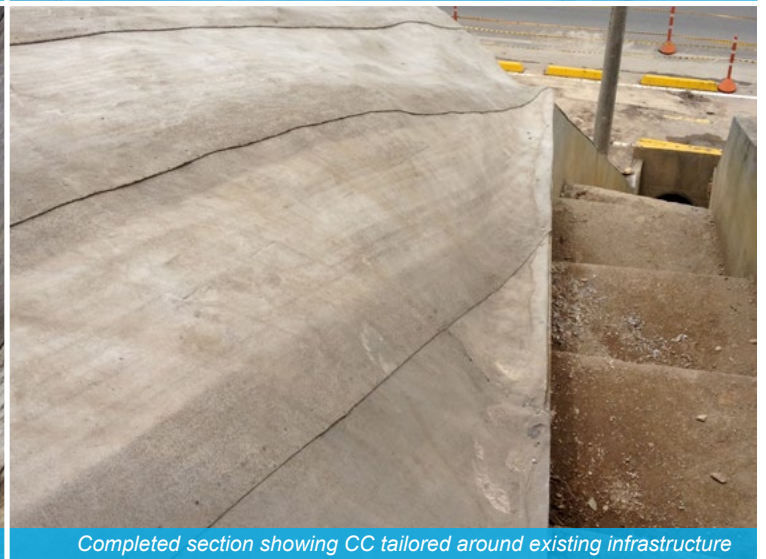
Completed section showing CC tailored around existing infrastructure
