CC8™ Bulk Roll

Undisclosed Tank Farm, Oman

CC8™ was used to prevent the weathering of a roadside slope which was leading to rockfall onto the road.

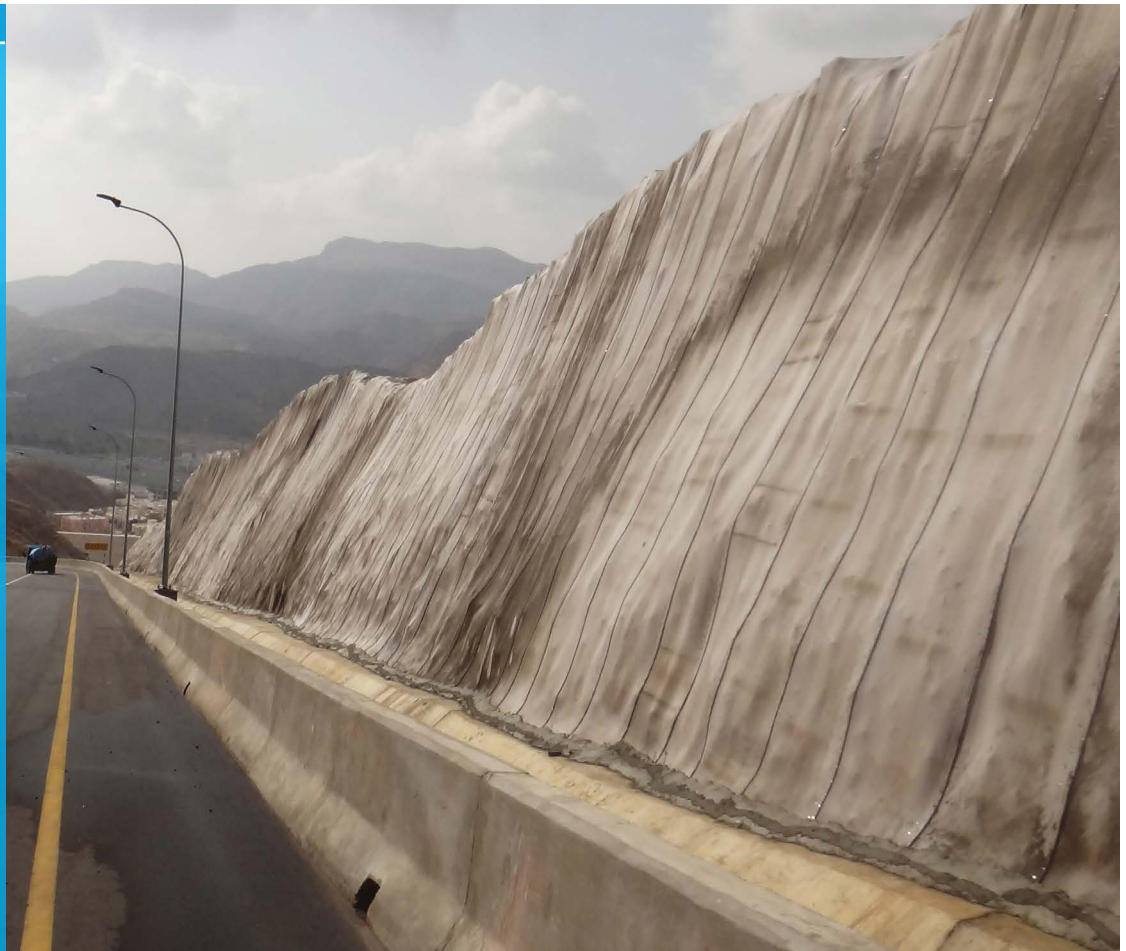
Completed installation

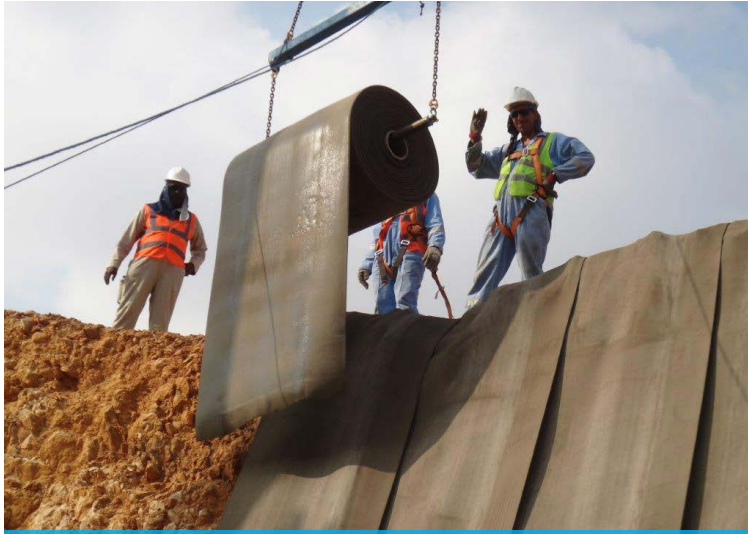
CC being lifted into position

Loose rock was removed from the face of the slope to ensure intimate contact between it and the CC. Bulk rolls of 8mm thick CC (CC8™) were delivered to site and mounted onto a spreader beam which was then hung from a crane. The rolls were lifted to the top of the slope and the leading edge was placed in an anchor trench and pegged with 380mm stainless steel pegs. The rest of the CC was then unrolled down the entire height of the slope and cut to length, avoiding wastage. This process was repeated with each layer overlapping the previous by 100mm. The overlaps were sealed with CT1 sealant and screwed at 100mm centres in 2 offset rows. Pegs were also inserted where needed down the face. These extra precautions were taken due to periodic high flow rates over the face of the slope. At the base, a mortar was used to seal the CC to the concrete substrate and to the pipes installed to allow the egress of water, preventing the build up of hydrostatic pressure behind the CC. Hydration was achieved using a 200 gallon small tanker at the crest of the slope and a bowser at the base. Due to the high temperatures a second hydration was undertaken an hour later.

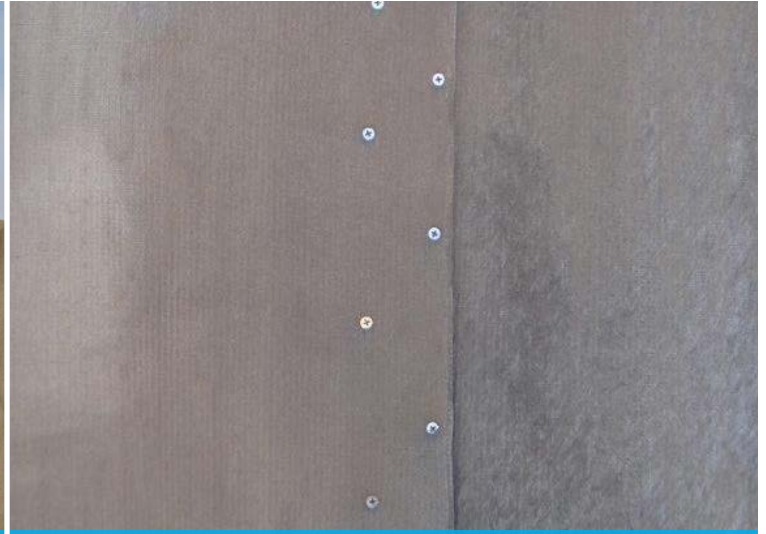
CC jointed with two offset rows of screws

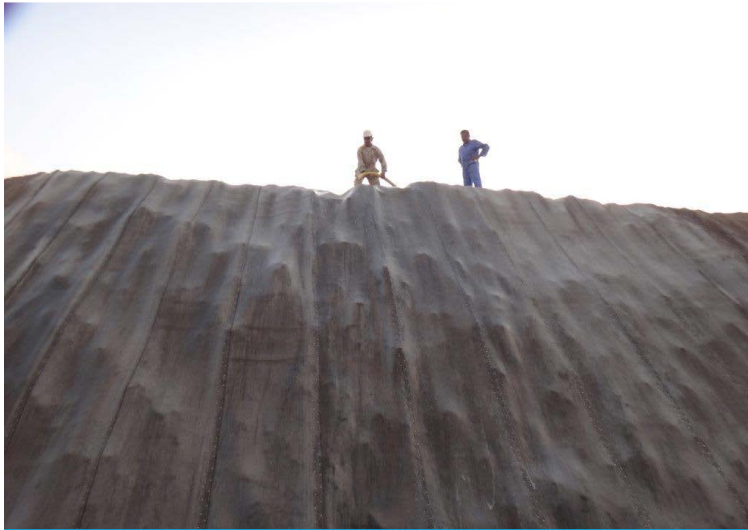
Hydration

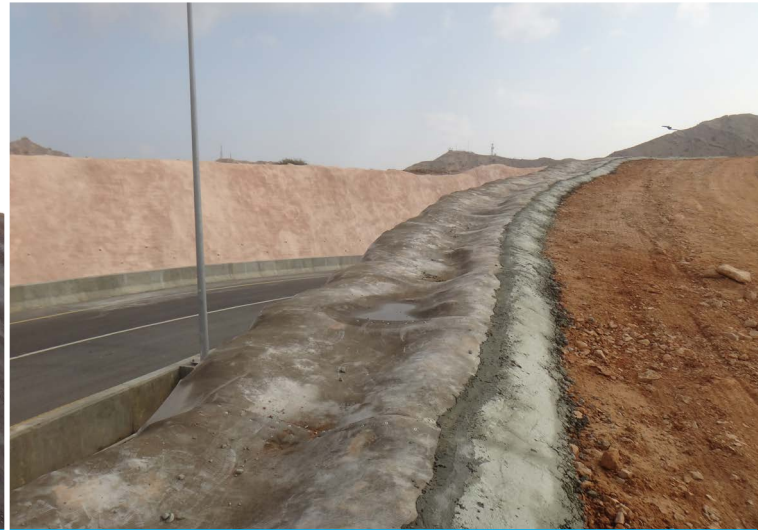
Anchor trench at the crest of the slope

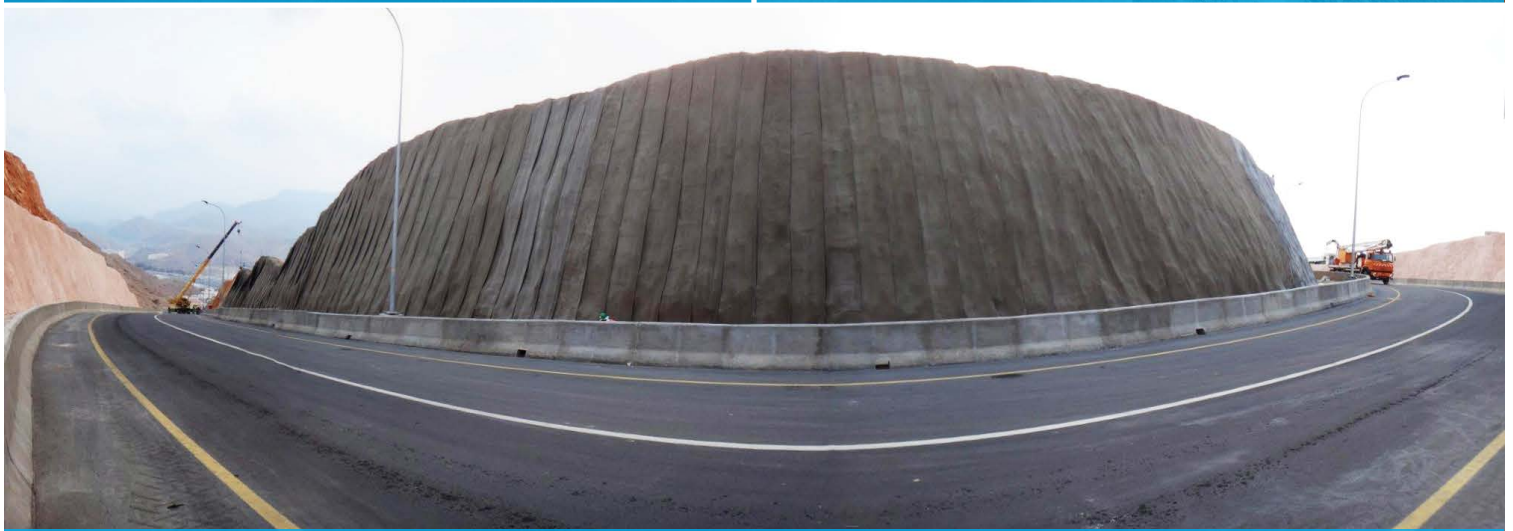
The finished project
