07.06.11 Slope Stabilisation Case Study : Classified

In May 2011, Concrete Canvas (CC) was specified as the surfacing material for a 2.3m high bund surrounding a remote storage facility. A total of 2900sqm of CC5 was installed on a sand base in order to protect the slope against the effects of wind, rain and long term environmental degradation.

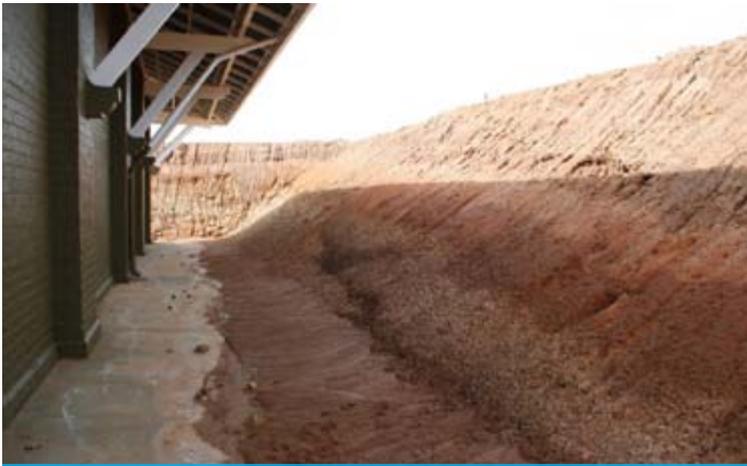
Traverse prior to CC lining

The traverse batters were excavated to a maximum of 30° to the vertical ensuring surface flow was directed into the 600mm wide spoon drains at the base of the bund. A 50mm sand base course was applied to the traverse prior to the installation of the CC to allow free drainage. The CC was supplied as 200sqm bulk rolls and installed on site using plant mounted spreader beams. The material was unrolled into position and fixed into the batters using 500mm soil pins with washers. Each CC layer was anchored top and toe of the batter by a minimum of 300mm and overlapped 100mm between adjacent sheets. Weep holes were drilled into the base of the Canvas at 3m centres once the CC had set.

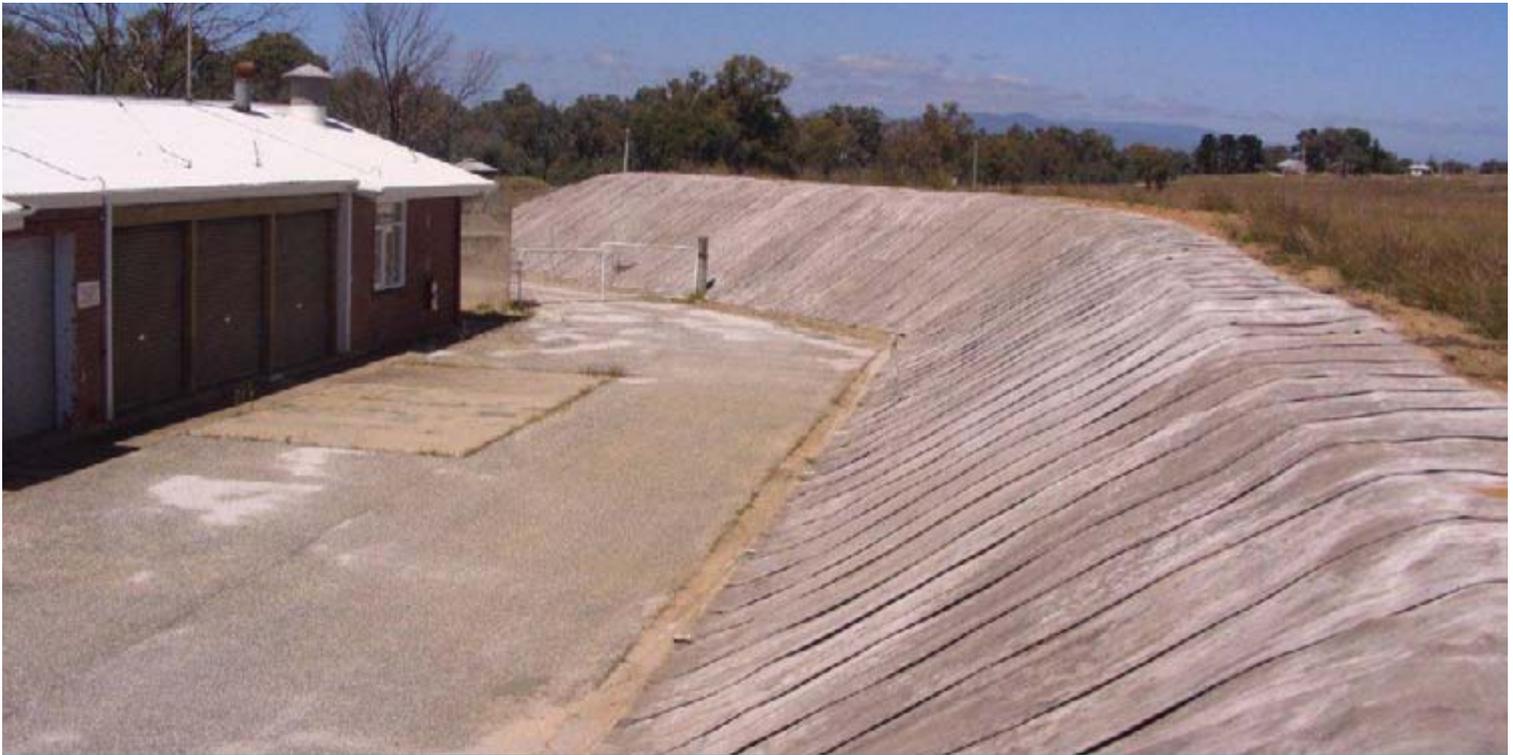
Completed CC lined traverse
