## Project Info

**CC** CC5™ Bulk Rolls

**G** Vicuña, IV region, Chile.

In May 2016, Concrete Canvas® GCCM\* (CC) was used to line a drainage channel at Vicuña, IV region, Chile. The objective was to stop water infiltration in an irrigation channel and to improve the local water management system. The idea of using reinforced concrete was discarded due to the cost and amount of time it would take to construct the channel.

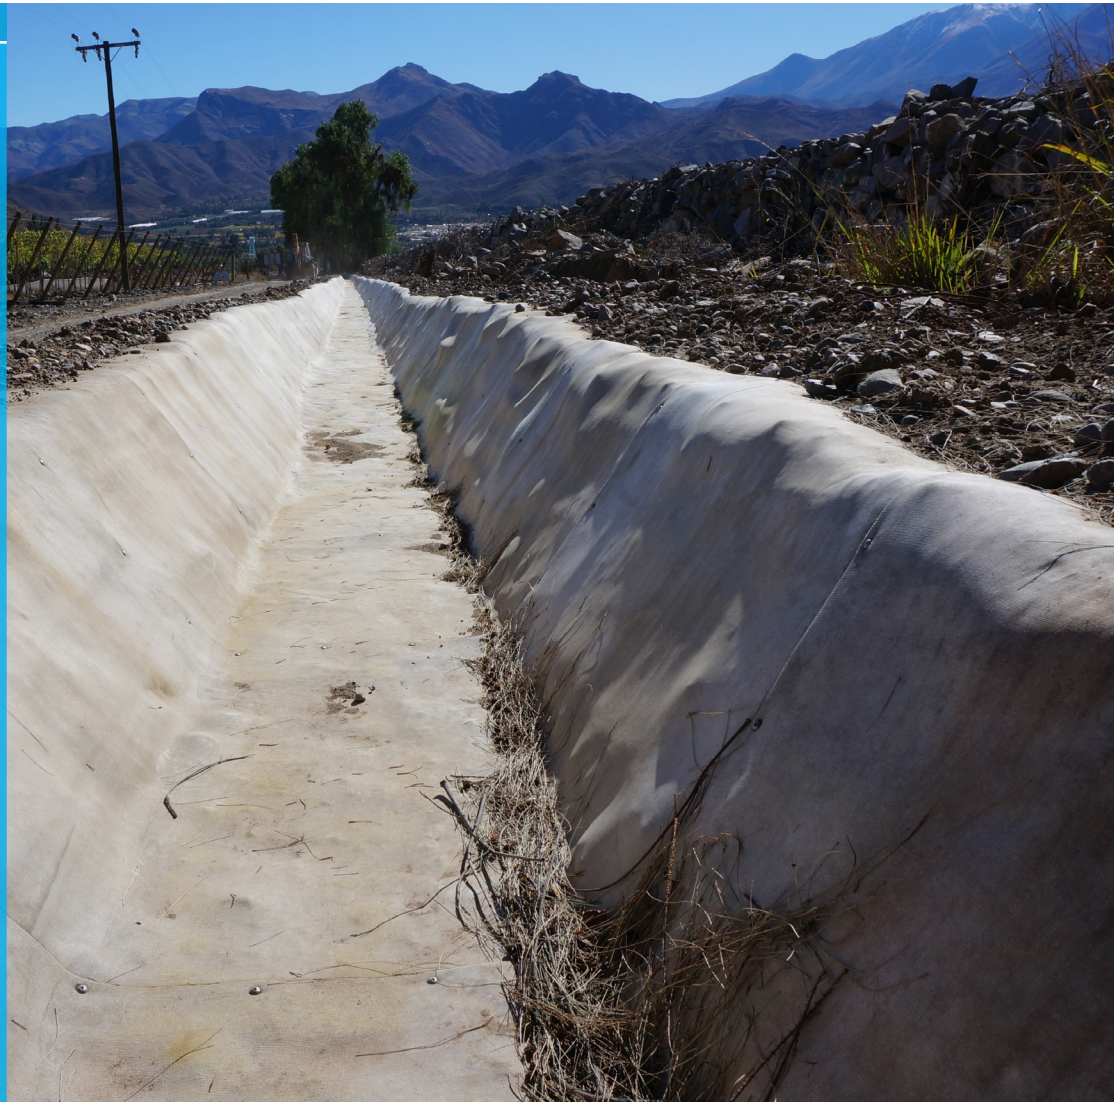
*The completed installation after hydration, before water flow*

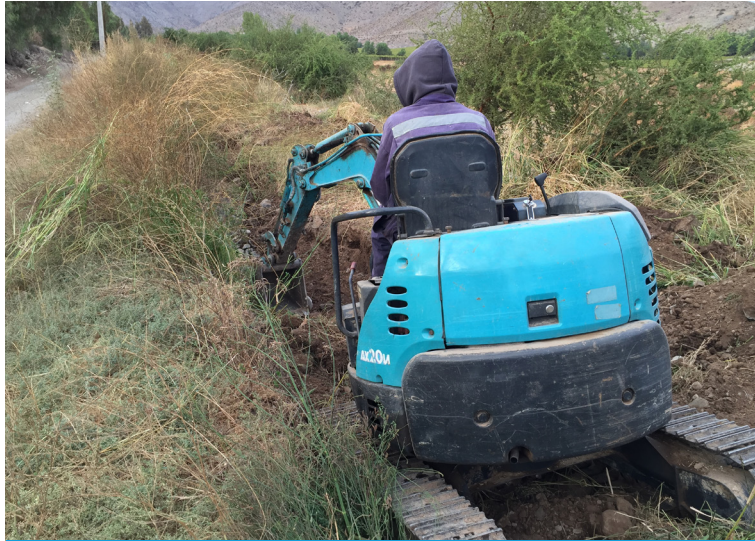
*Vegetation was removed, excavated and levelled with a mini excavator*

Vegetation, trees, and rocks were removed, excavated and levelled with a mini excavator, the profile of the channel was formed by compacting the earth with the use of a wooden mold.

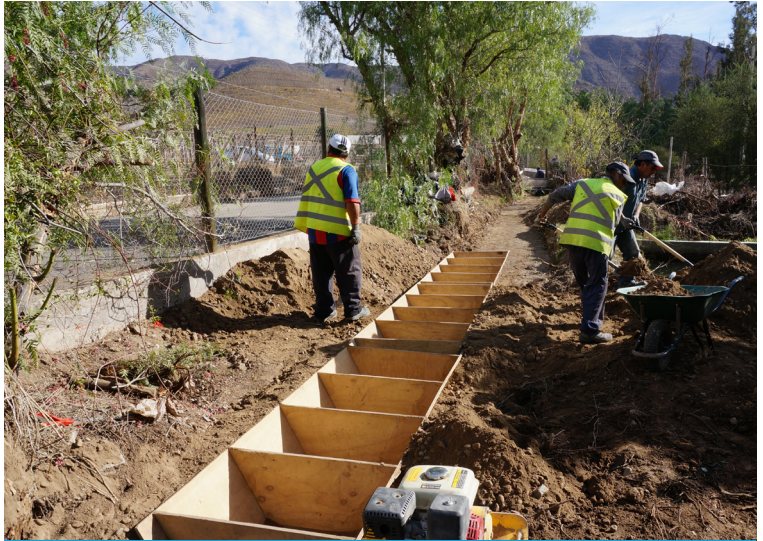
*The profile of the channel was formed by the use of a wooden mold*

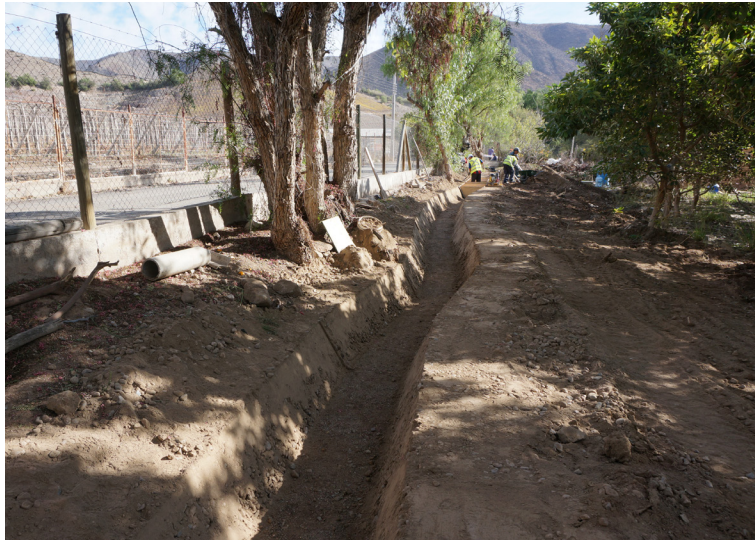
*The complete graded channel profile*

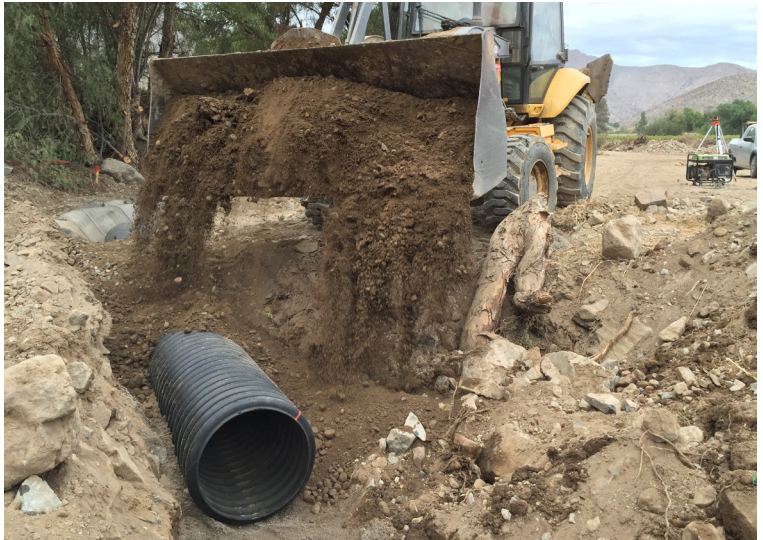
*Pipes were installed underneath roads affected by the channel*

The installation of CC required approx 10 days with a team of 5 people, the complete project took 1 month, with the install of water gates, pipes underneath roads and reconditioning the asphalt of the roads.

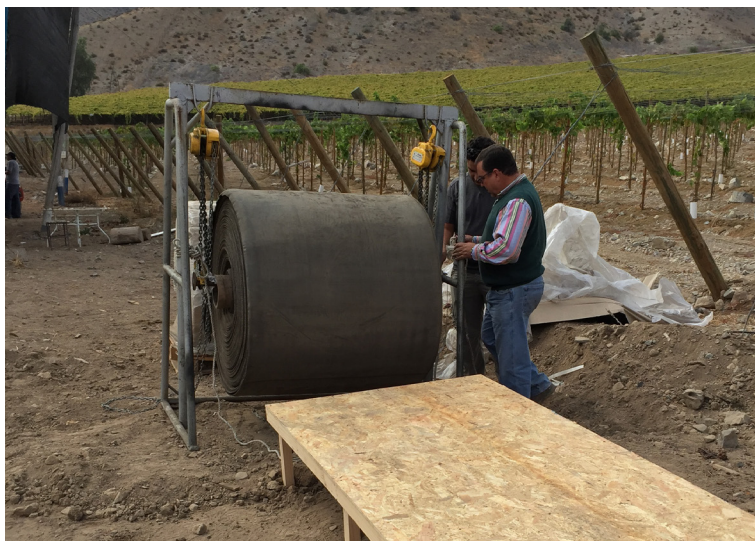
*The CC was mounted onto a spreader beam and cut to the required length*

The Concrete Canvas was supplied on bulk rolls. The spooled CC was mounted onto a spreader beam frame and cut to the exact length required using knives, eliminating waste and accommodating any variations in the channel profile. CC's main advantages over conventional concrete are speed and ease of install, cost savings, durability and environmental friendliness. Overlapped in the direction of water flow by 100mm, adjacent layers were screwed together using SS screws at 200mm centres. The outside edges of the Canvas layers were captured in a backfilled anchor trench after being pinned to the ground using 250mm steel ground pegs. Hydration was completed via a roadside 1000ltr water tank and motor pumps.

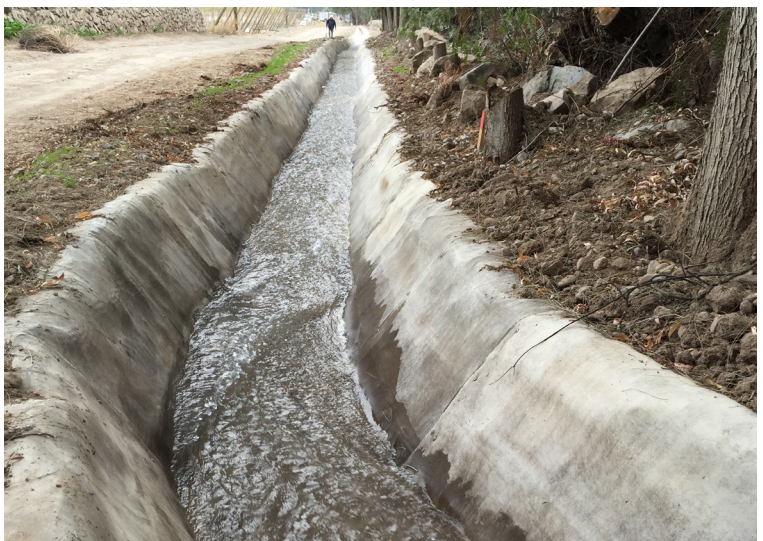
*The completed installation*

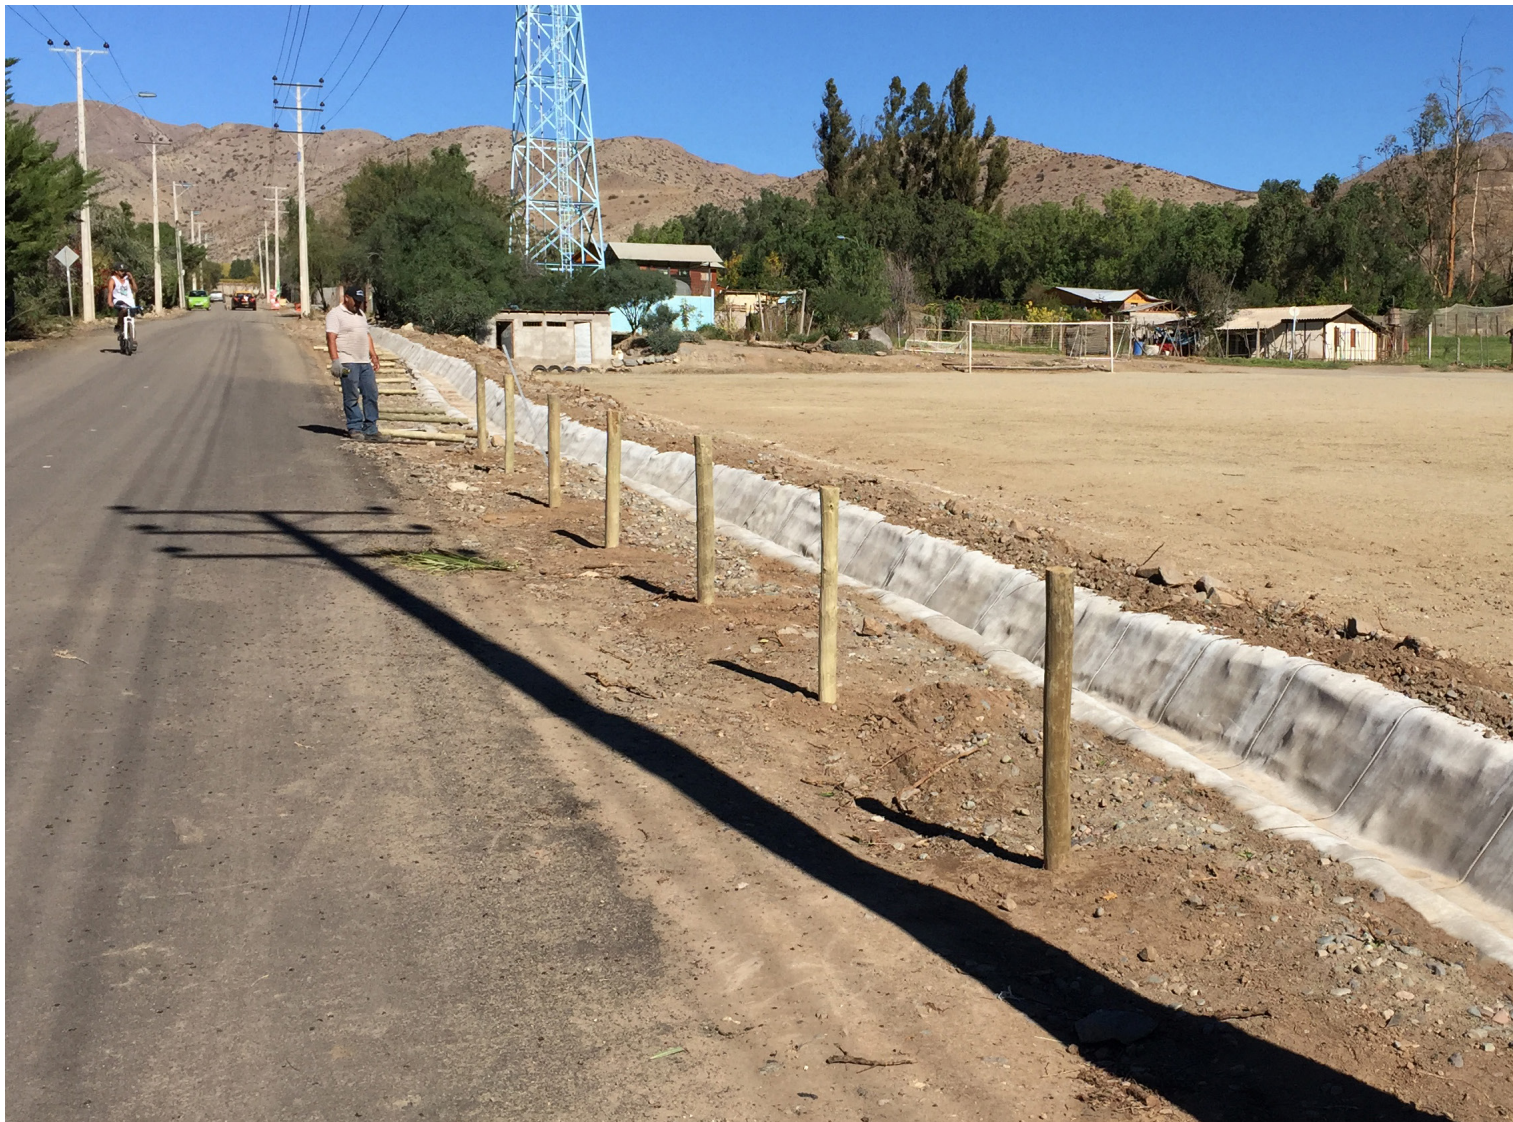
*The completed installation in use prior to being fenced off*

The project was very successful, the community now has 70% more water than they did previously and it takes just 6 minutes for the water to travel down the length of the channel, as opposed to over 45 minutes that it used to take. The client was extremely happy with the result and have also used CC to work on a project for the second stage of the same channel.
