CC13 & CC8
batch rolls

Aysen, XV region
Chile

CC used for time critical
remedial work of a fish
farm, lining a cracked
and dilapidated concrete
reservoir.

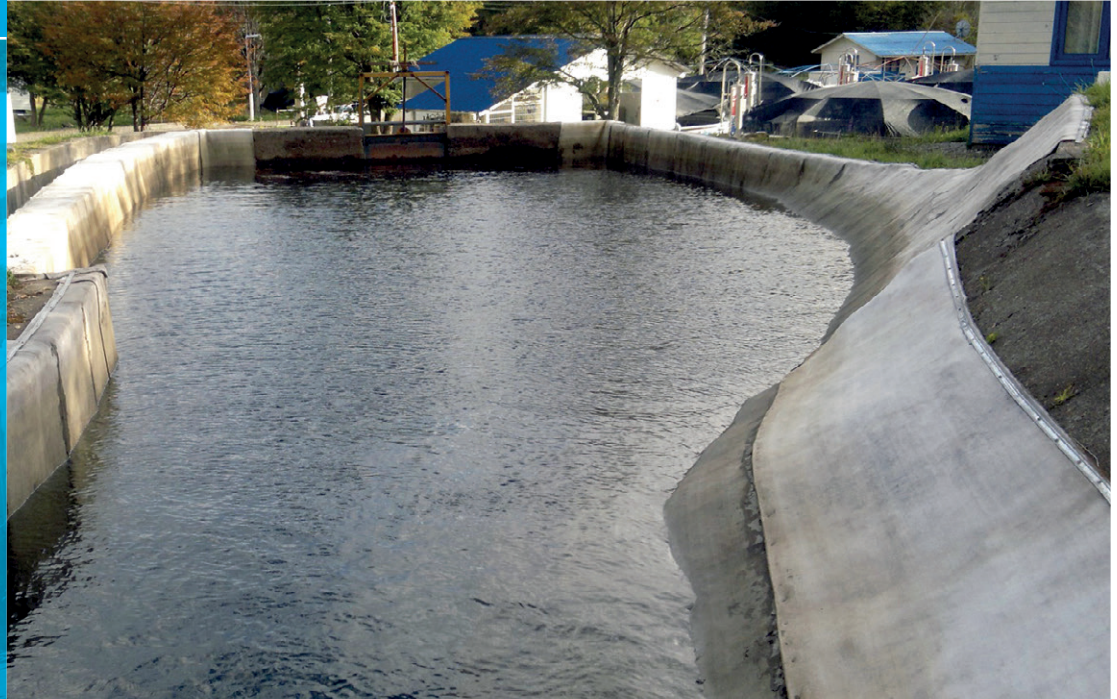
Reconditioned fish farm reservoir which was restocked 1 day after CC installation

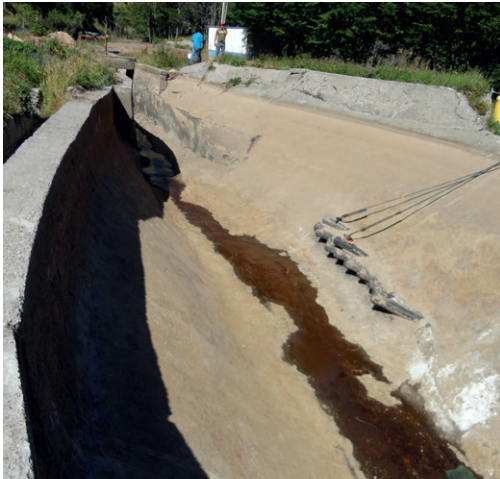
Dilapidated concrete reservoir

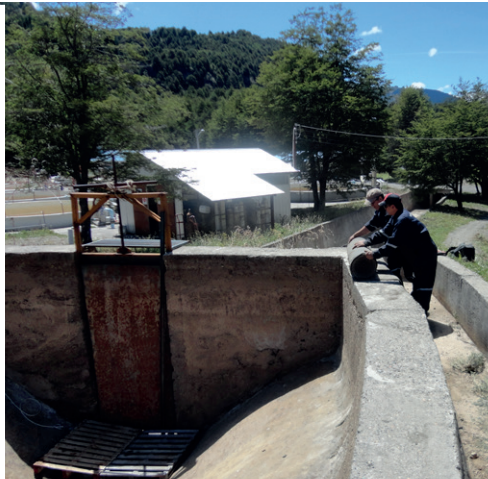
Unrolling CC8 batched rolls into position

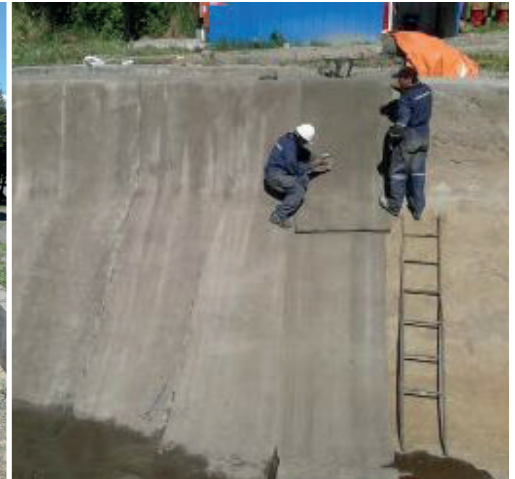
Fixing CC to the existing concrete substructure

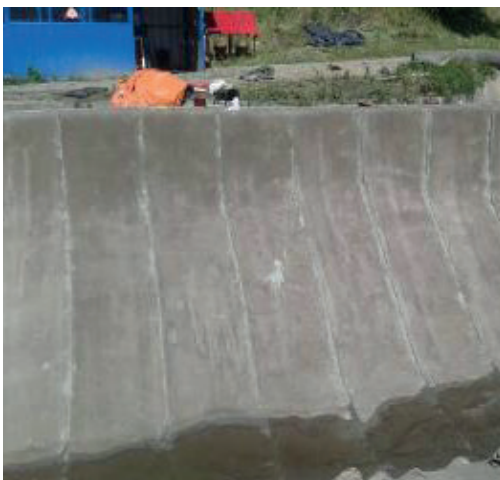
Lined concrete reservoir with sealed joints

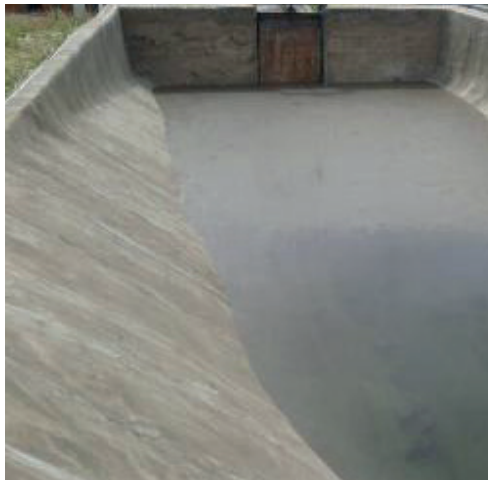
Refilling the basin to hydrate the CC

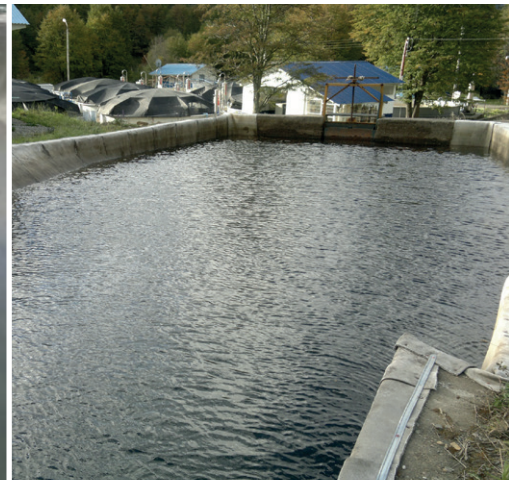
Completed reconditioned fish reservoir
