## BUND LINING

In May 2015, Concrete Canvas® GCCM\* (CC) was used to remediate a bund at a remote tank storage facility in Cook, in the Cooper Basin of South West Queensland, Australia, owned and run by Santos. The existing bund had been affected by erosion which compromised its integrity. Clay capping, cement treated fill and shotcrete were all considered as possible solutions. These options were deemed unfavourable as they would either require too much earthwork (impractical due to access restrictions), or would have been too expensive.

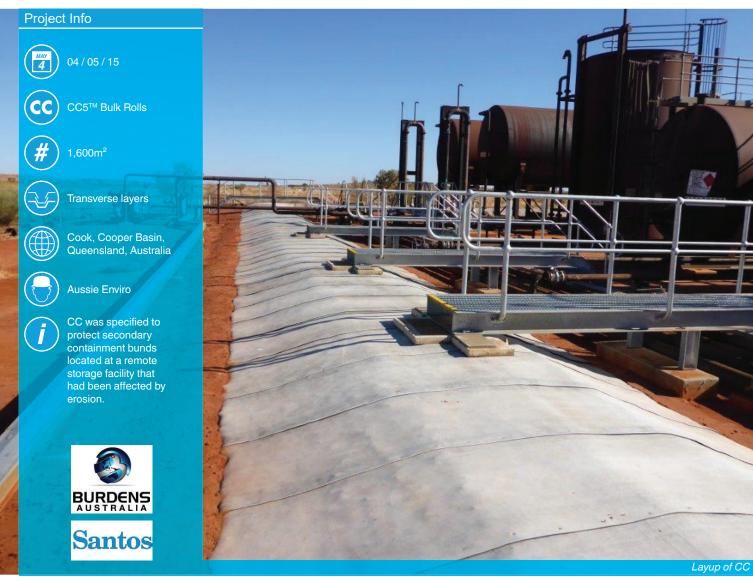
Due to the site access issues, hand tools had to be used to complete the majority of the re-profiling required, before anchor trenches were dug at either side. CC5™ was then unrolled on the flat and cut to specific profile length, carried to site by hand and deployed transversely across the bund, with each layer overlapping the previous by 100mm. The overlaps were jointed with screws at 200mm intervals using an autofed screwdriver, and ground pegs were inserted through the overlaps to fix the CC in the anchor trenches. Hydration was achieved using a bowser and pressure hose with spray nozzle attached, after which the anchor trenches were backfilled to prevent water ingress under the CC and provide a neat termination.

In total, 1,600m² of CC5™ were installed in just 5 days by 3 people. The use of CC allowed for concrete installation where it would not have otherwise been possible due to the limitations of conventional concreting methods. The client was pleased with the speed and neatness of the install.
