REMEDIATION

CC8™ Batched Rolls

Andacollo, Chile

Surface recovery of a corroded concrete acid tank containing 17% concentrated sulphuric acid. Completed installation provided a renewed solid surface on which to install HDPE lining. Project completed in 8 hours by 4 people, compared to 21 days to came into contact with acid during installation but this did not affect setting or performance.

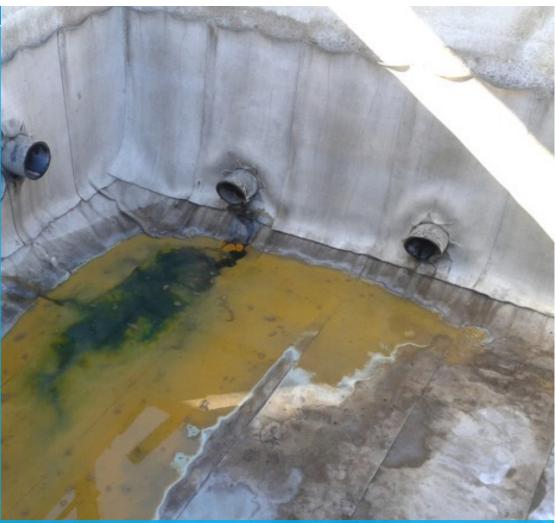
Completed lined acid tank 9 hours after hydration
