CC8™ Bulk Rolls

Oil Distribution Site, UK

CC8™ used to line a butyl rubber lined tertiary containment lagoon to provide fire resistance, protection against puncture and a secondary impermeable layer.

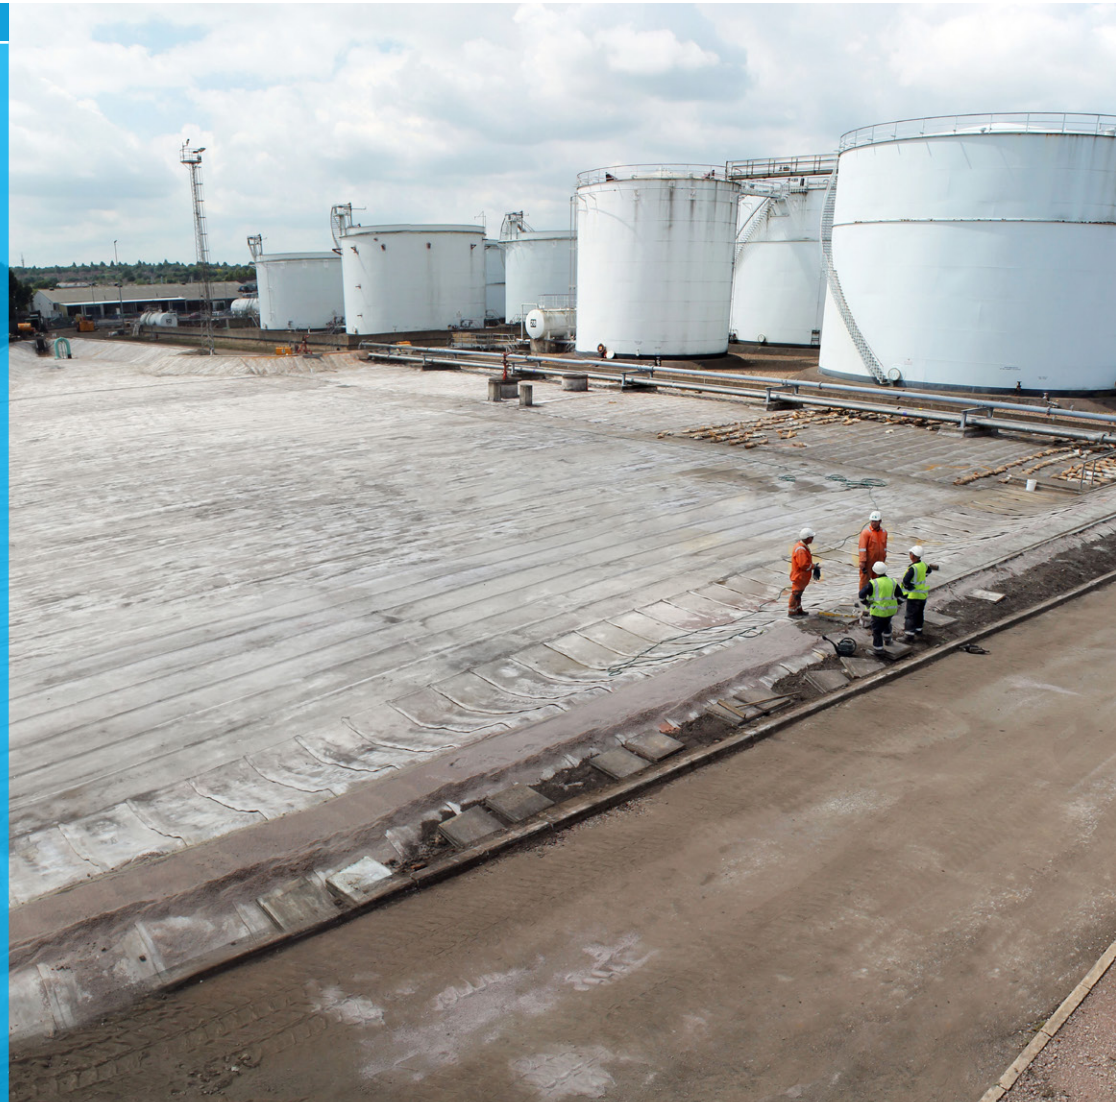
Completed installation

In April 2014, Concrete Canvas® GPCM* (CC) was installed as a fire resistant and impermeable protective layer to a 0.75mm butyl rubber lined tertiary containment / firewater run off lagoon at an oil distribution terminal site in the UK.

6125m² of CC8™ material was installed directly onto the incumbent liner which had reached the end of its serviceable life and had been degraded through 15 years of weathering, puncture and UV damage. The project was completed successfully over a 9 week period by Moulding Contracts Limited which included additional civils works associated with the upgrade of existing penstock systems and outfall discharge.

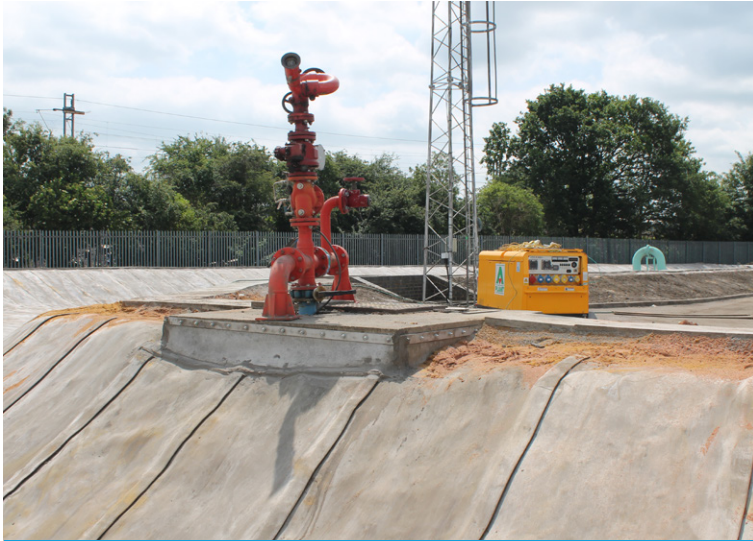
Sensitive nearby infrastructure

CC had been specified over a number of alternative solutions including shotcreting and GCL's (Geosynthetic Clay Liners). The sensitive nature of the surrounding infrastructure and the restricted site access prohibited sprayed concrete solutions where rebound could cause issues.

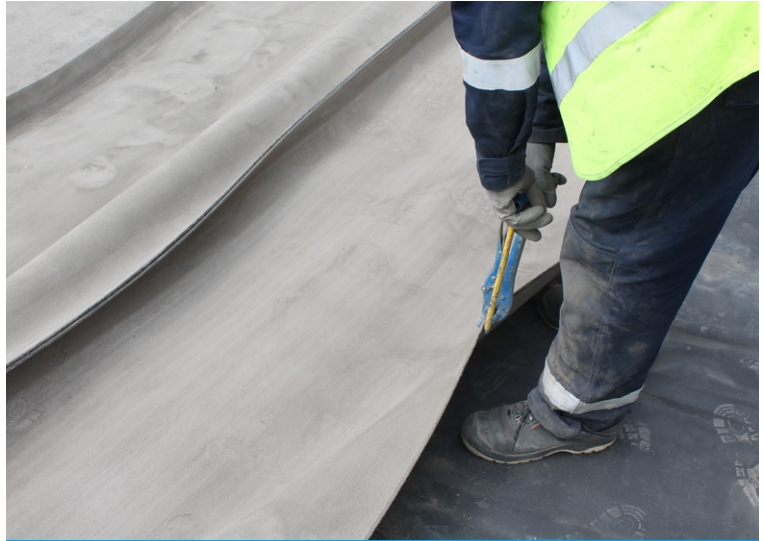
CC being laid directly onto the existing liner

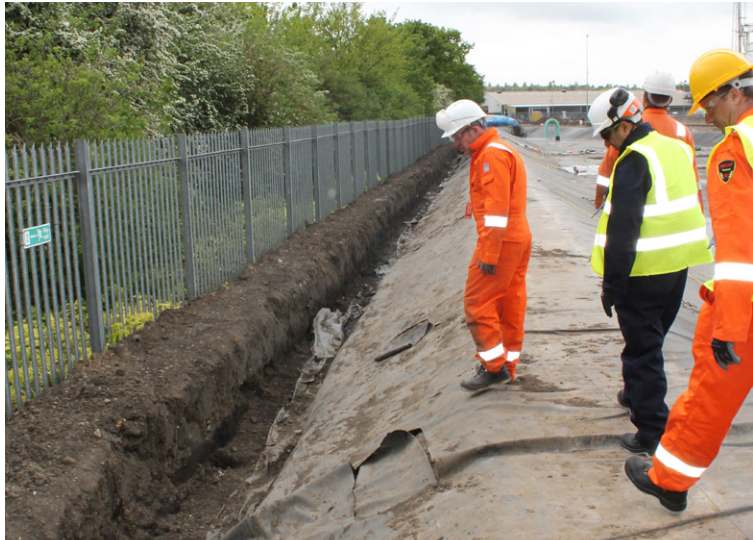
Excavated anchor trench

The incumbent butyl liner was fixed along its perimeter by concrete flagstones or within anchor trenches. These were temporarily removed to release tension in the liner to reduce significant void space between the liner and substrate. Where required, cuts outside the lagoon were made into the liner to further release tension to provide intimate contact between the liner and substrate. Care was taken to ensure the integrity of the internal lining system was not compromised.

The section along the eastern bank of the lagoon adjacent to a fence perimeter had been backfilled covering the original lagoon lining up to the level of the flagstones. This was excavated, with the fill retained for backfilling following installation.

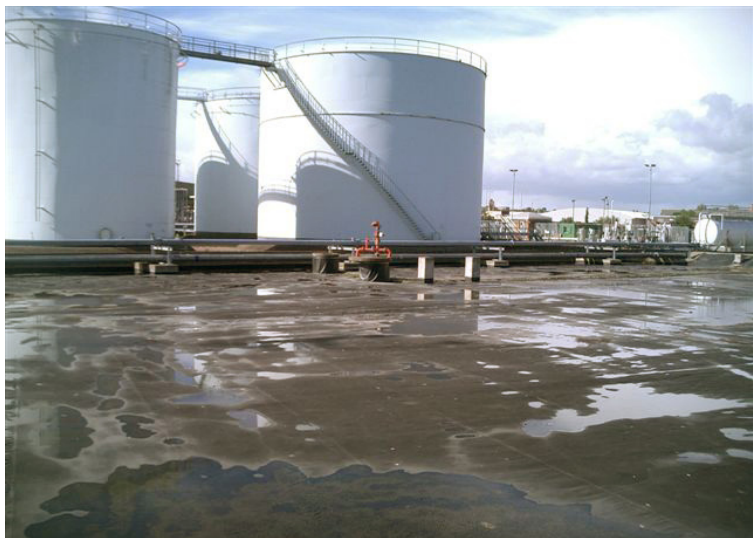
Surface water before removal

Due to differential settlement of the sub-grade a degree of surface lying water within the lagoon was noted. This was removed via pumps and squeegees prior to installation. This was undertaken to prevent premature hydration of the lead edges of the CC prior to welding and grouting.

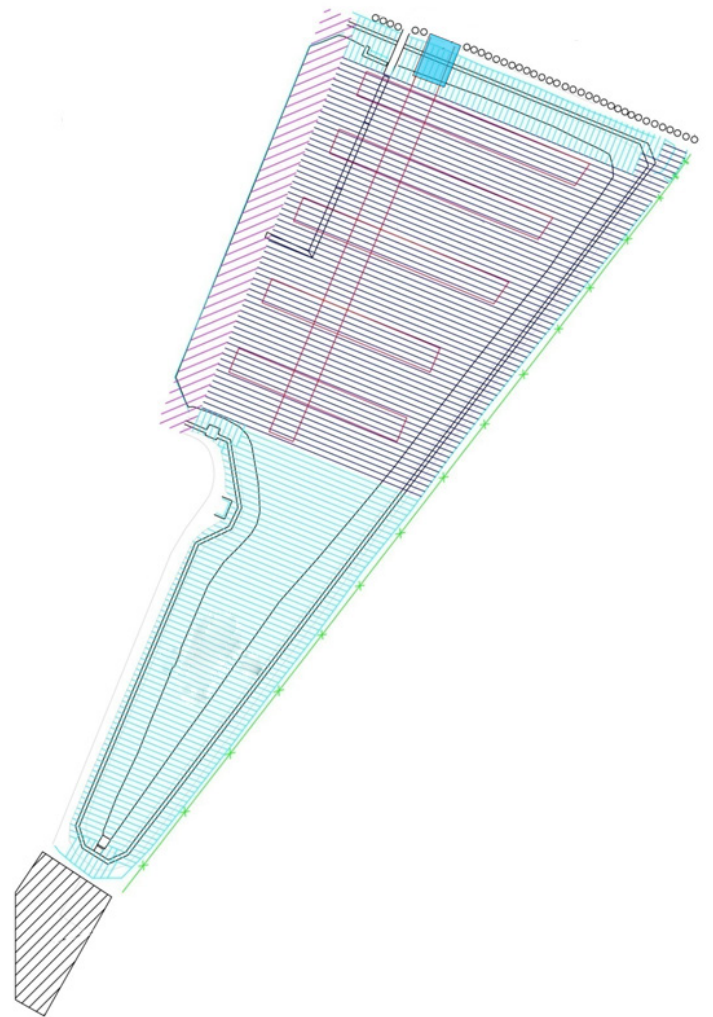
Deployment Plan

A deployment plan was predetermined to ensure maximum efficiency by maintaining a 90° pattern and avoiding cross welds on batters. Furthermore the plan aimed to minimise the number of grouted seams and ensure welded seams were shingled in the direction of the designed fall within the lagoon.

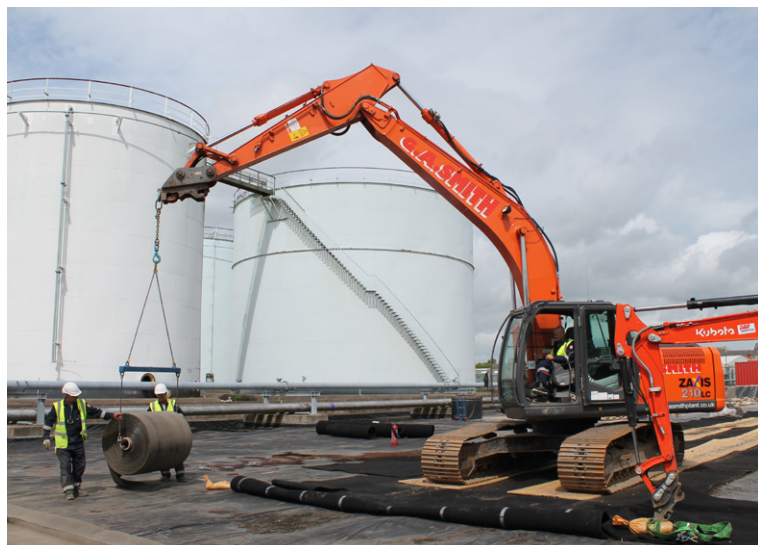
20T excavator manoeuvring a bulk roll to the lagoon centre

To locate the 1.5T bulk rolls to the centre of the lagoon whilst protecting the integrity of the butyl liner, it was required to provide temporary access tracks down the centre of the lagoon with a protective geotextile (HPS30) and 20mm ply boards. A 20T excavator could then position CC8™ bulk rolls from the storage area at the northern bank, to the centre point of the lagoon.

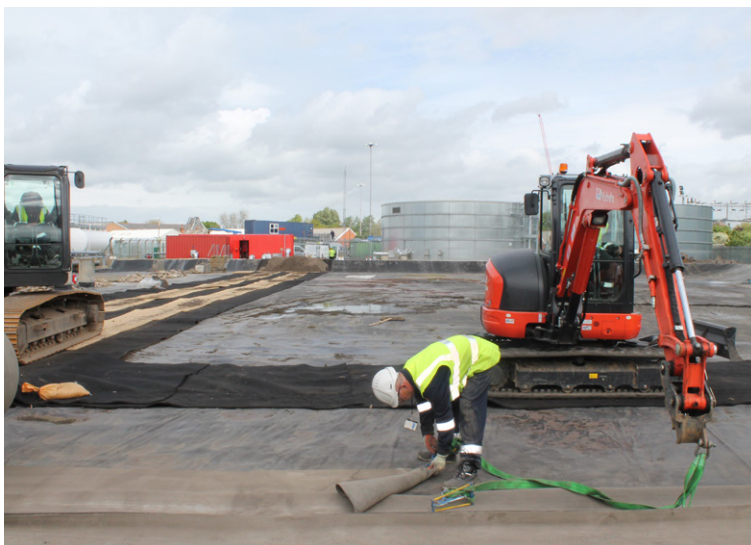
Attaching the leading edge of the CC to the 5T excavator

By attaching the leading edge of the bulk roll with mould grips to a smaller 5T rubber tracked Hitachi excavator, CC could then be spooled across the width of the lagoon, avoiding any need for physical handling of the CC lengths. It was required to deploy sections of CC manually beneath the service corridor on the western bank. This provided no significant issues as rolls were cut to man portable lengths to avoid excessive manual handling.

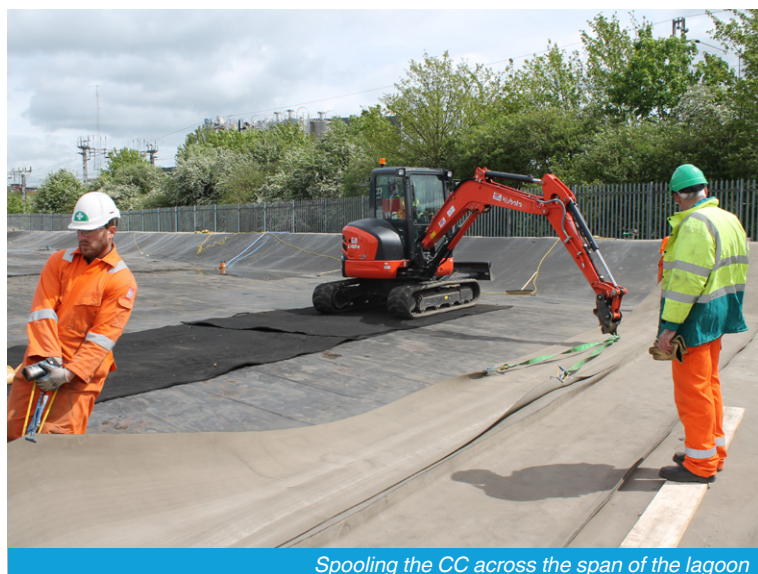
Spooling the CC across the span of the lagoon

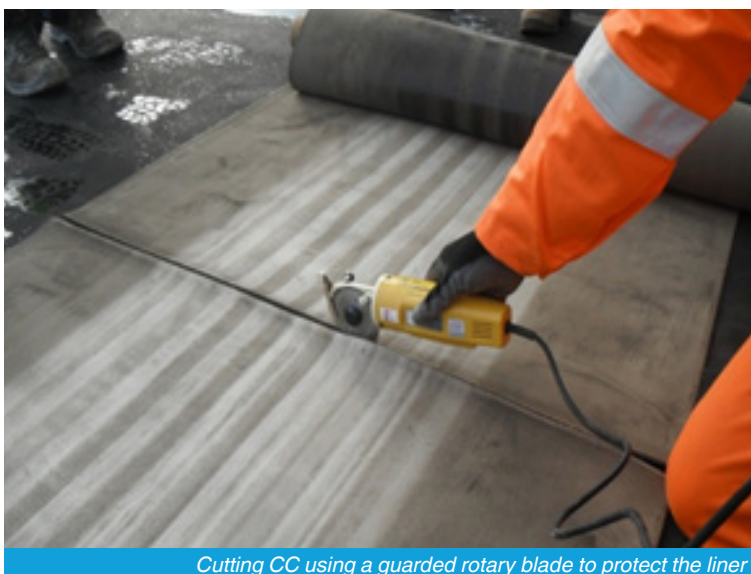
Cutting CC using a guarded rotary blade to protect the liner

Once each CC layer had been spooled to span the width of the lagoon from the spine, it was cut to length using a powered rotary blade with safety shield. CC is conventionally cut to length using open bladed utility knives, but these were banned from use on site. The safety guard on the rotary blade also minimised risk of damage to the butyl liner beneath.

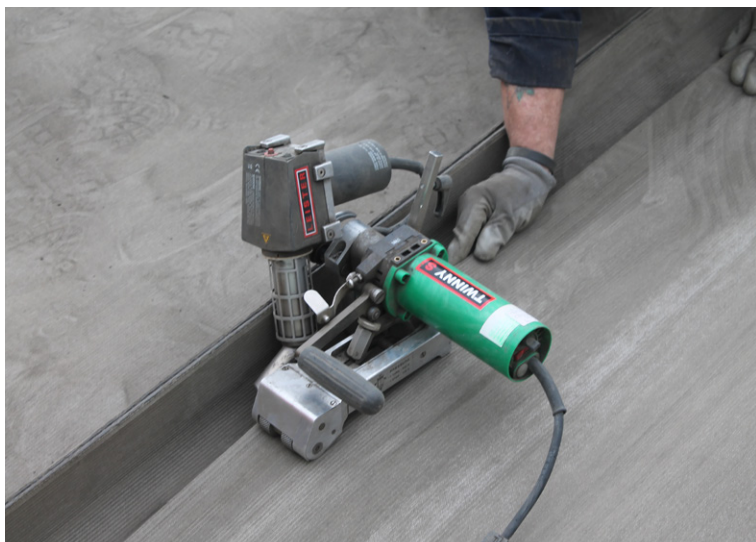
Thermal bonding of prayer joint

Adjacent layers of CC were positioned such that they formed a 'prayer' joint where the two rear PVC faces of the material were brought together before folding over and thermally bonding. Thermal bonding was completed using a Leister Twinny S model at a rate of approximately 2.5m/minute.

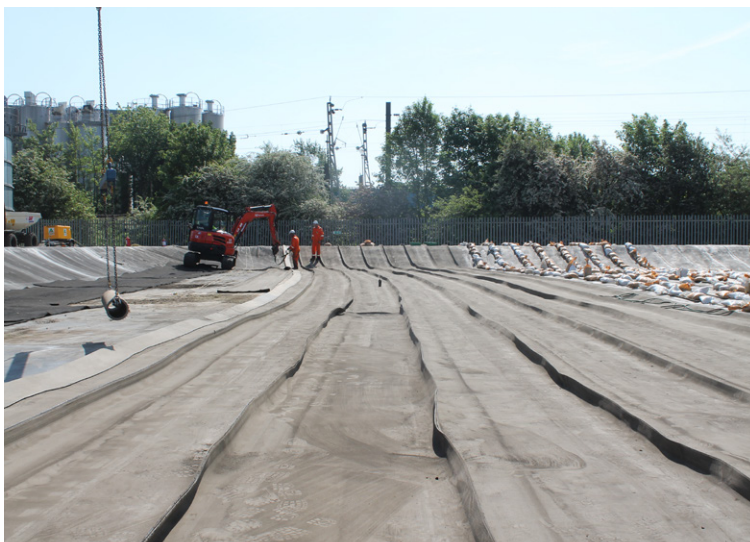
Welded joints prior to hydration and sandbagging

Once thermally bonded, the leading CC edge was teased out with mould grips to recover overlapped material by reverting the joints to the vertical. The joints were then subsequently folded flat and compressed with strips of 10mm ply board and surcharged with sand bags prior to hydration to minimise the profile and prevent perched water traps. The Twinny S welder was calibrated each day to take into account ambient temperatures and trial welds were tested to destruction to measure the effectiveness of the weld settings. An indication that a weld of maximum strength has been achieved is where de-lamination of the PVC backing from the CC occurs in a basic pull test.

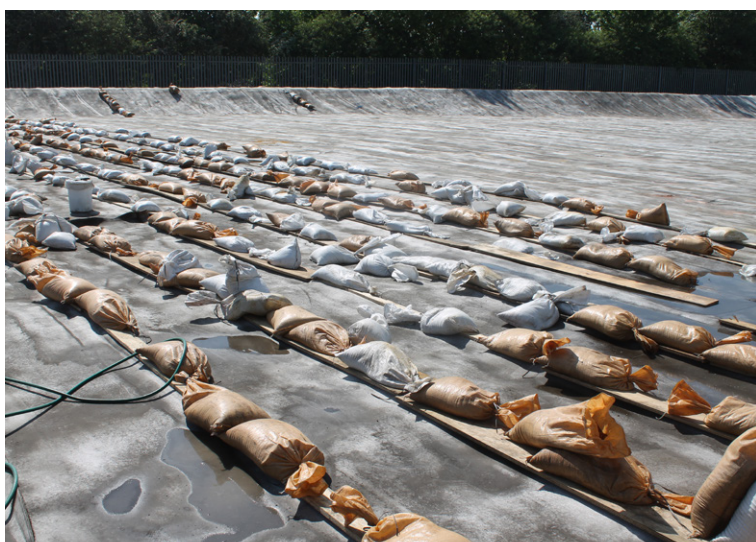
Joints weighted down after hydration

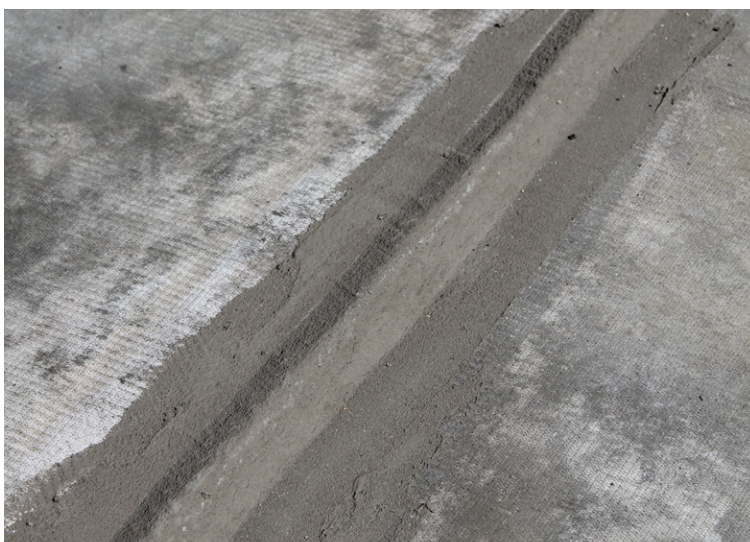
Grouted joints where welding not possible

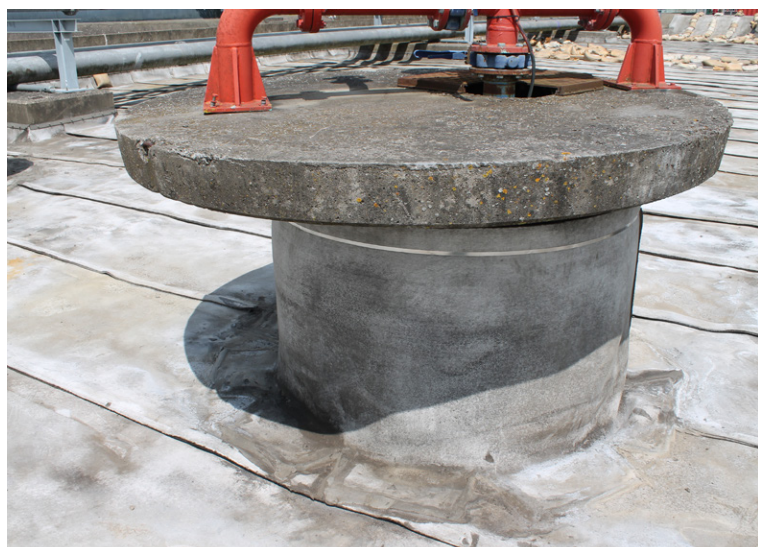
Hydrant up stand wrapped in CC collar secured at top with band

At terminations between CC and the existing concrete infrastructure, the CC was lapped up the fixture by a minimum of 150mm before applying a continuous 5mm bead of CT1 sealant between the PVC face and the fixture. The leading edge was then secured in position with a clamping band around circular fixtures or 100mm x 5mm galvanised steel bar along flat edges. The fixings to the concrete headwalls and steps were Fischer stud anchors which maintained a minimum of 75mm wall anchorage. Once the full area of CC had been installed, the flag stones around the perimeter of the lagoon were replaced and the excavation along the eastern bank backfilled.

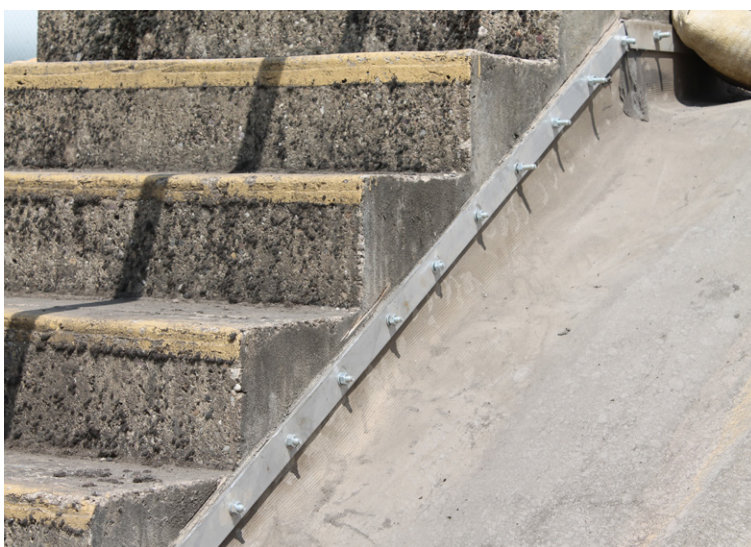
5mm plate with Fischer stud anchors at 100mm centres

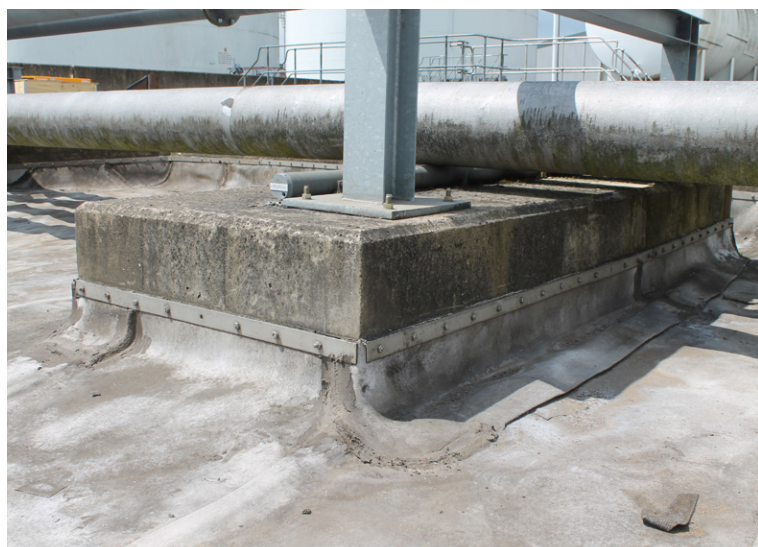
Grouted corner joints of concrete plinth

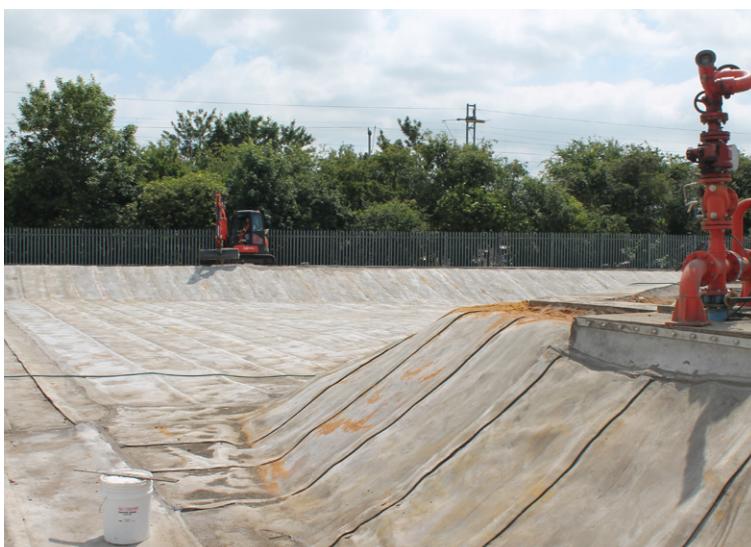
Corner detail

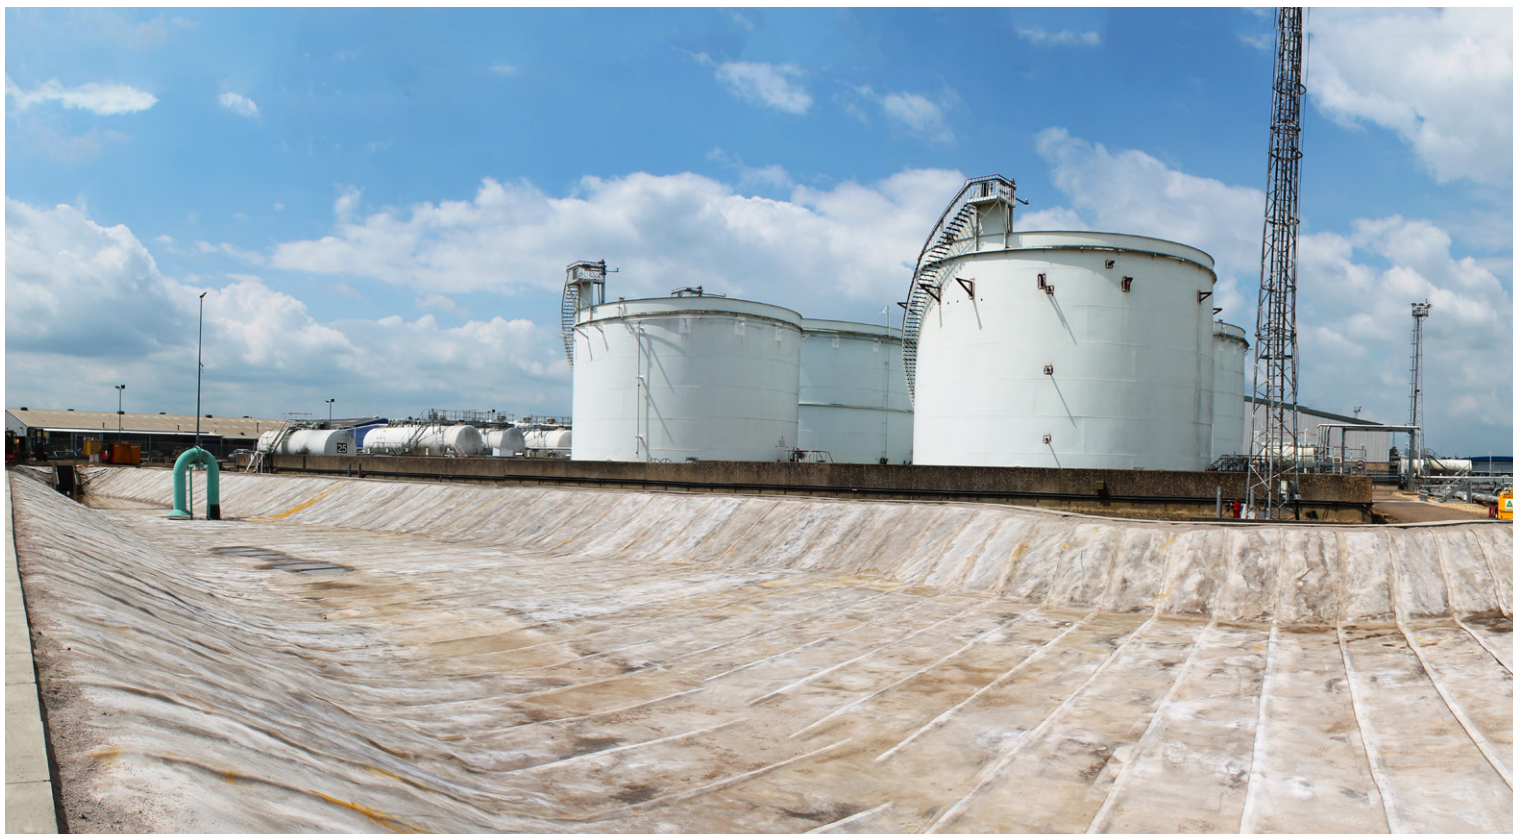
Narrow South end of the lagoon

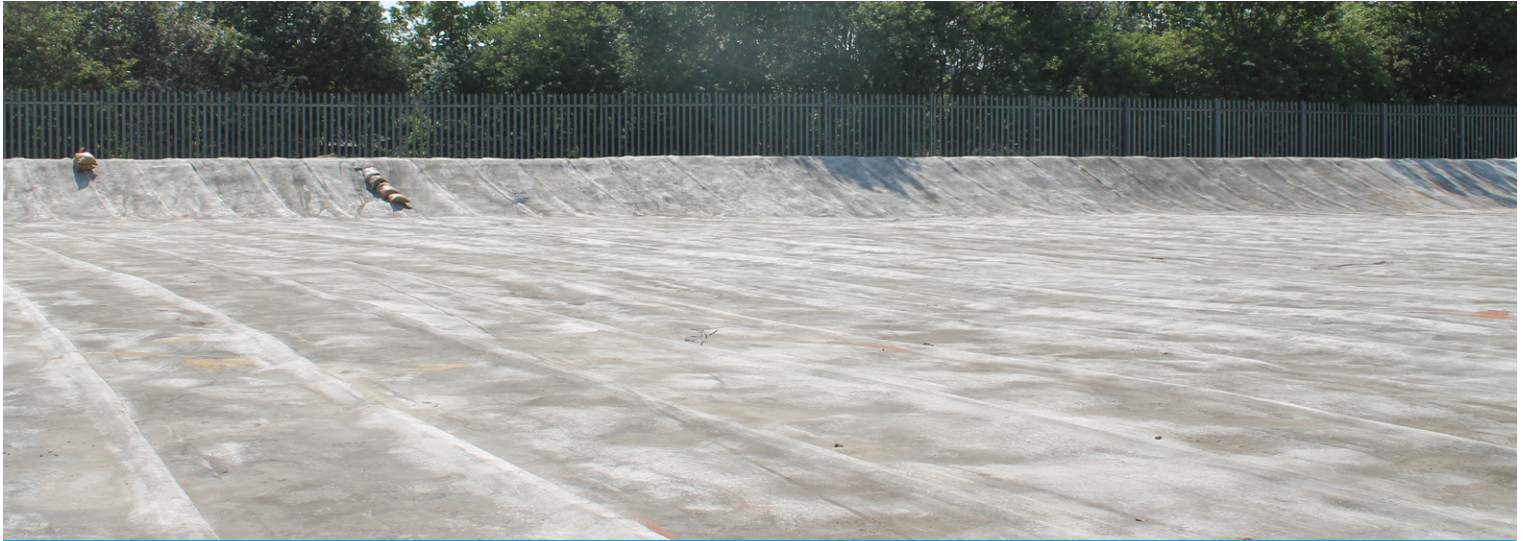
Completed installation

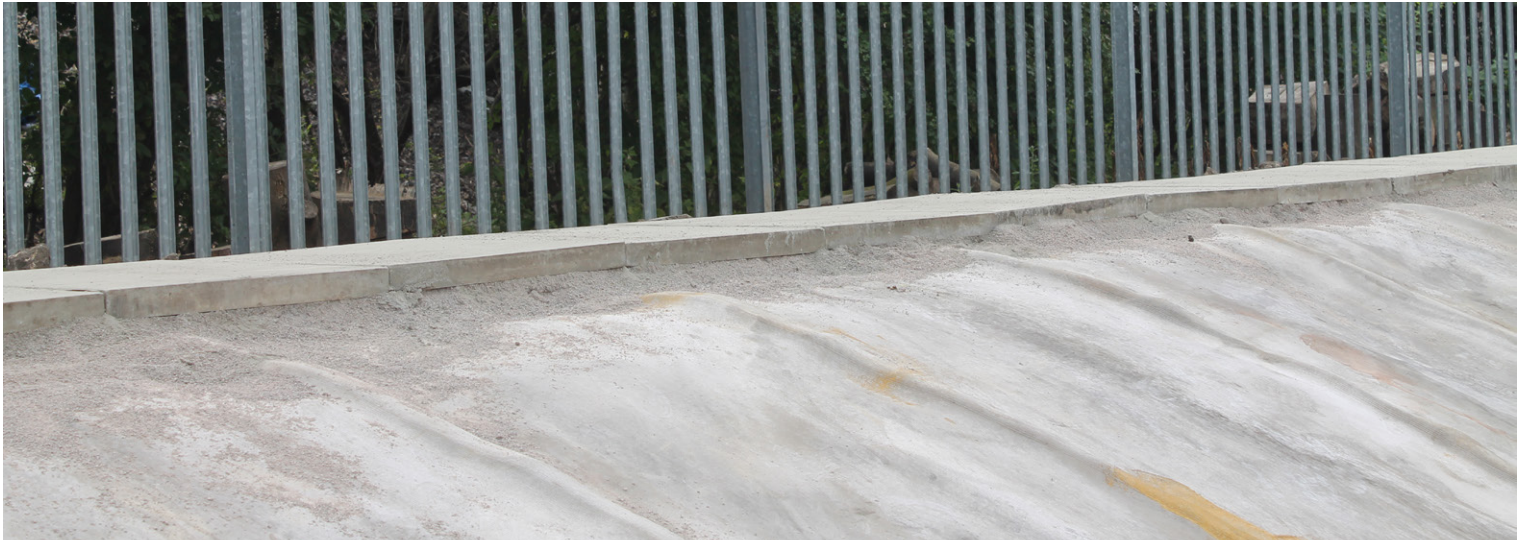
Edge finishing: replacement of flag stones and backfilling along palisade fence

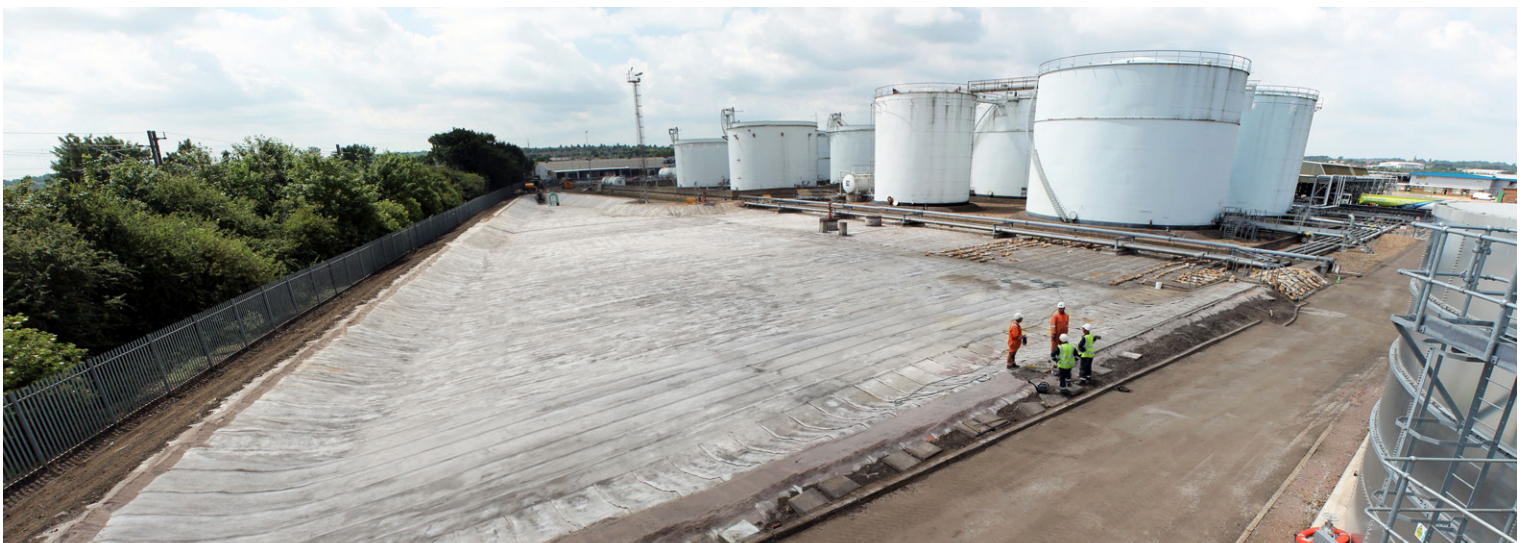
Completed installation
