CC5™ Bulk Rolls

Pedra Branca Mine, Agua Azul do Norte, State of Para, Amazon Region

CC5™ used to provide erosion protection to slopes at the entrance of the Pedra Branca Mine.

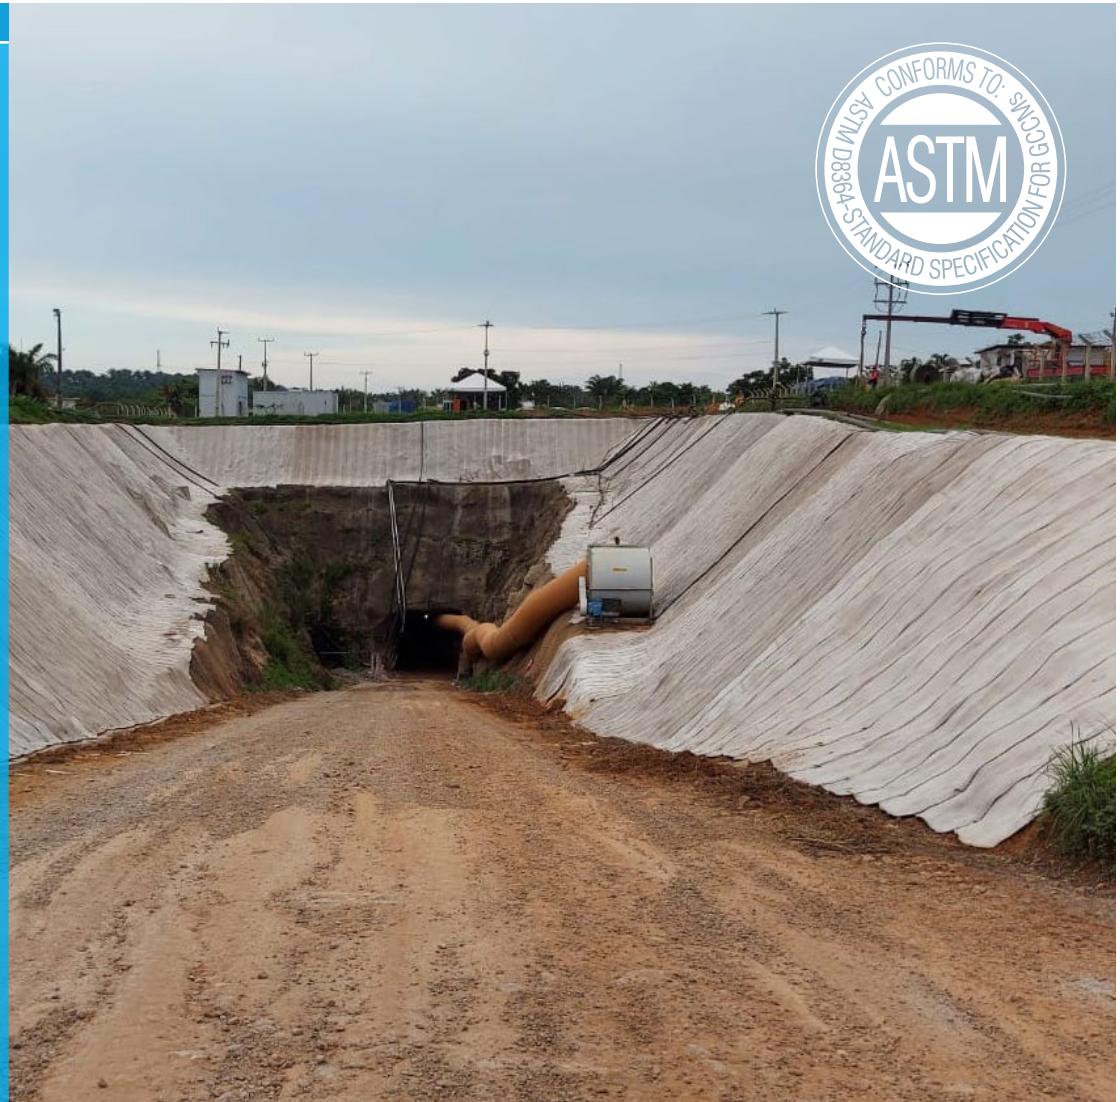
Completed CC5™ Installation

The installation was carried out by 6 installers on three different fronts and took a total of 57 days, with CC5™ taking 25 days to install. The client was satisfied with the delivery and implementation of CC5™ and is willing to expand the application on site.

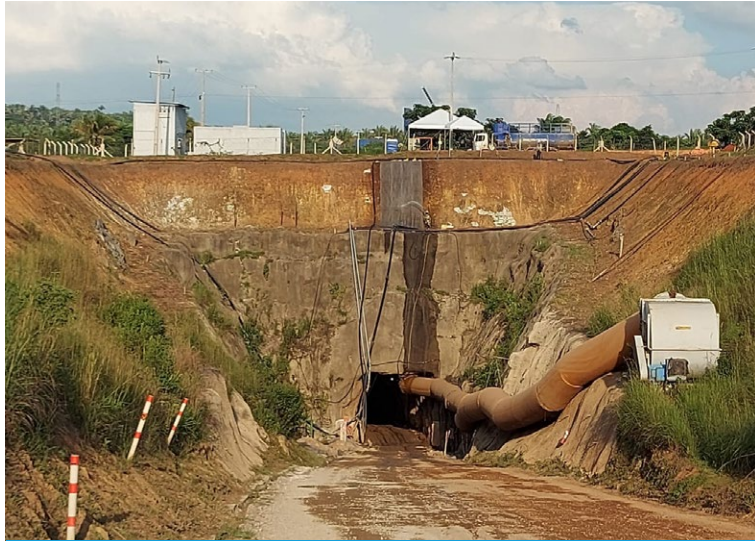
Mine entrance prior to works carried out

An erosion protection solution was required to prevent further erosion of the soils on the steep slopes located at the entrance of the Pedra Mine, as the initial construction of the infrastructure for the exploration of the mine left the slopes around it stripped of vegetation, leaving them susceptible to weathering and erosion.

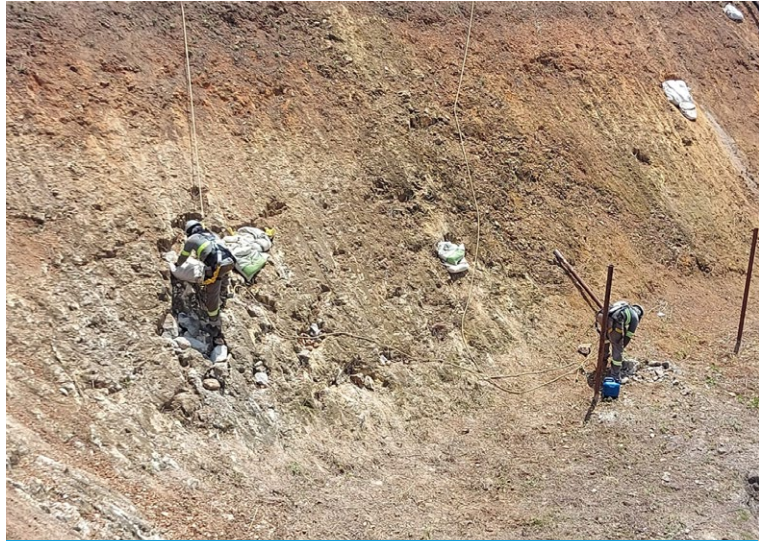
Contractors filling slope irregularities with sand-cement bags

Prior to works commencing the slopes had to be prepared, which consisted of cleaning and removing the existing vegetation and filling any voids with sand-cement bags to correct any irregularities and create a uniform profile.

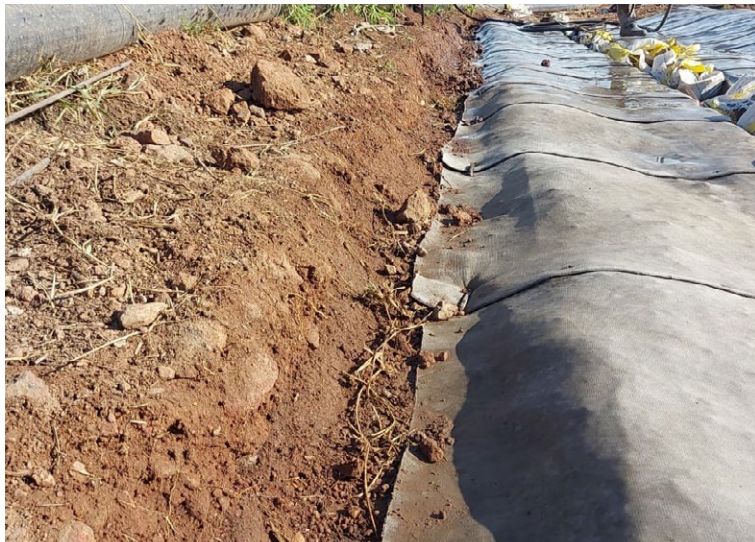
CC5™ secured with 500mm steel pegs at the base of the anchor trench

When all preparation works to the slopes were completed, the CC5™ was brought onto site in Bulk Rolls and were craned into place with the use of a spreader beam, laid vertically down the 25m slopes with 100mm overlaps to each adjacent layer. At the crest of the slope an anchor trench was dug and the CC5™ was secured with 500mm steel pegs and back filled with earth. Just in front of the anchor trenches, a crest drain was formed by excavating and draping the CC into it. This could collect any surface runoff and divert water away from the slope face and entrance of the mine. The slopes were too steep to secure the overlapping layers of CC5™ without the use of safety climbing equipment, so the contractors abseiled down the slopes and secured each overlap with an 8mm thick continuous bead of Concrete Canvas Ltd approved adhesive and 25mm stainless steel screws, installed every 200mm by a self-feeding screwdriver.

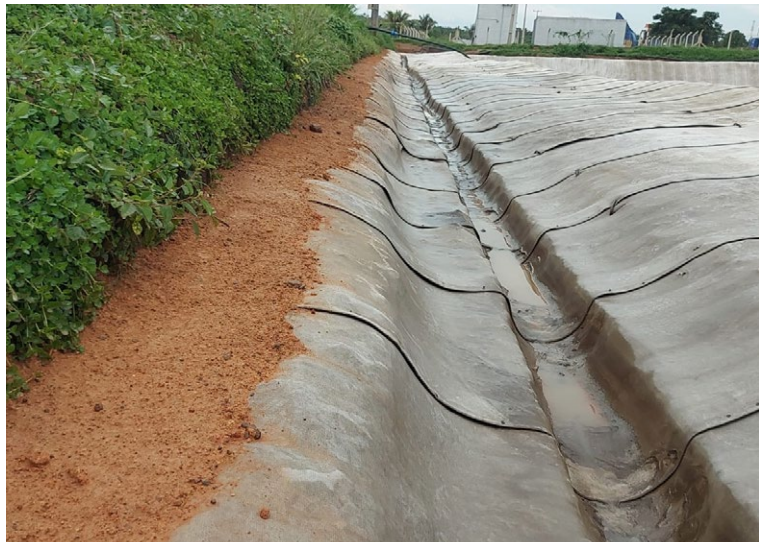
A crest drainage channel was formed in CC and the anchor trench back filled with soil

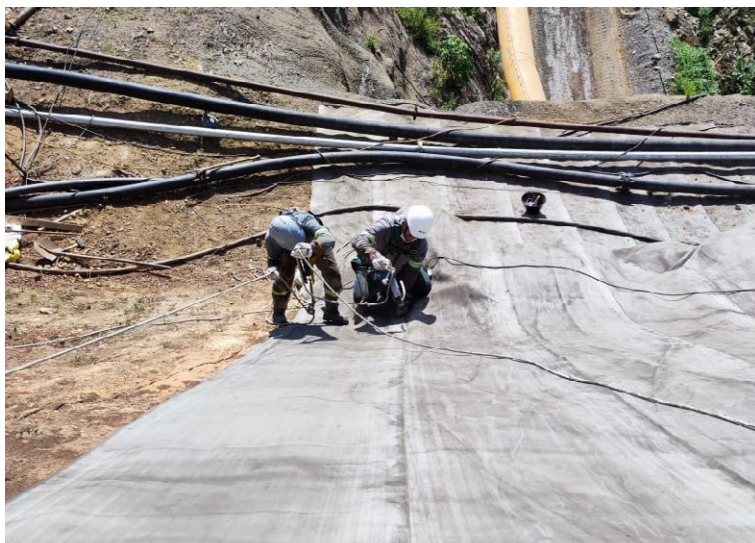
CC5™ overlaps secured with sealant and 25mm screws

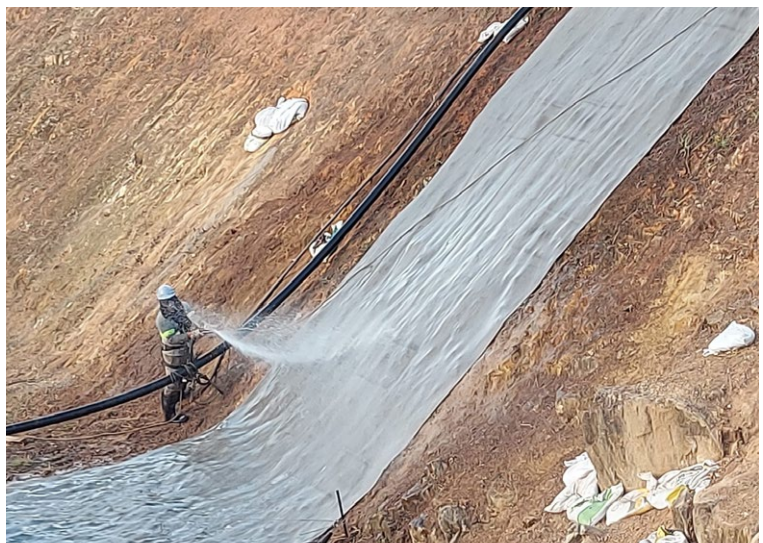
CC5™ hydrated with the use of a hose

When installing the workforce had to deal with high-temperatures above 30°C and daily precipitations. To counter the adverse conditions, water trucks were brought onto site daily and pumped water via hose to allow CC5™ to be frequently hydrated throughout the day.

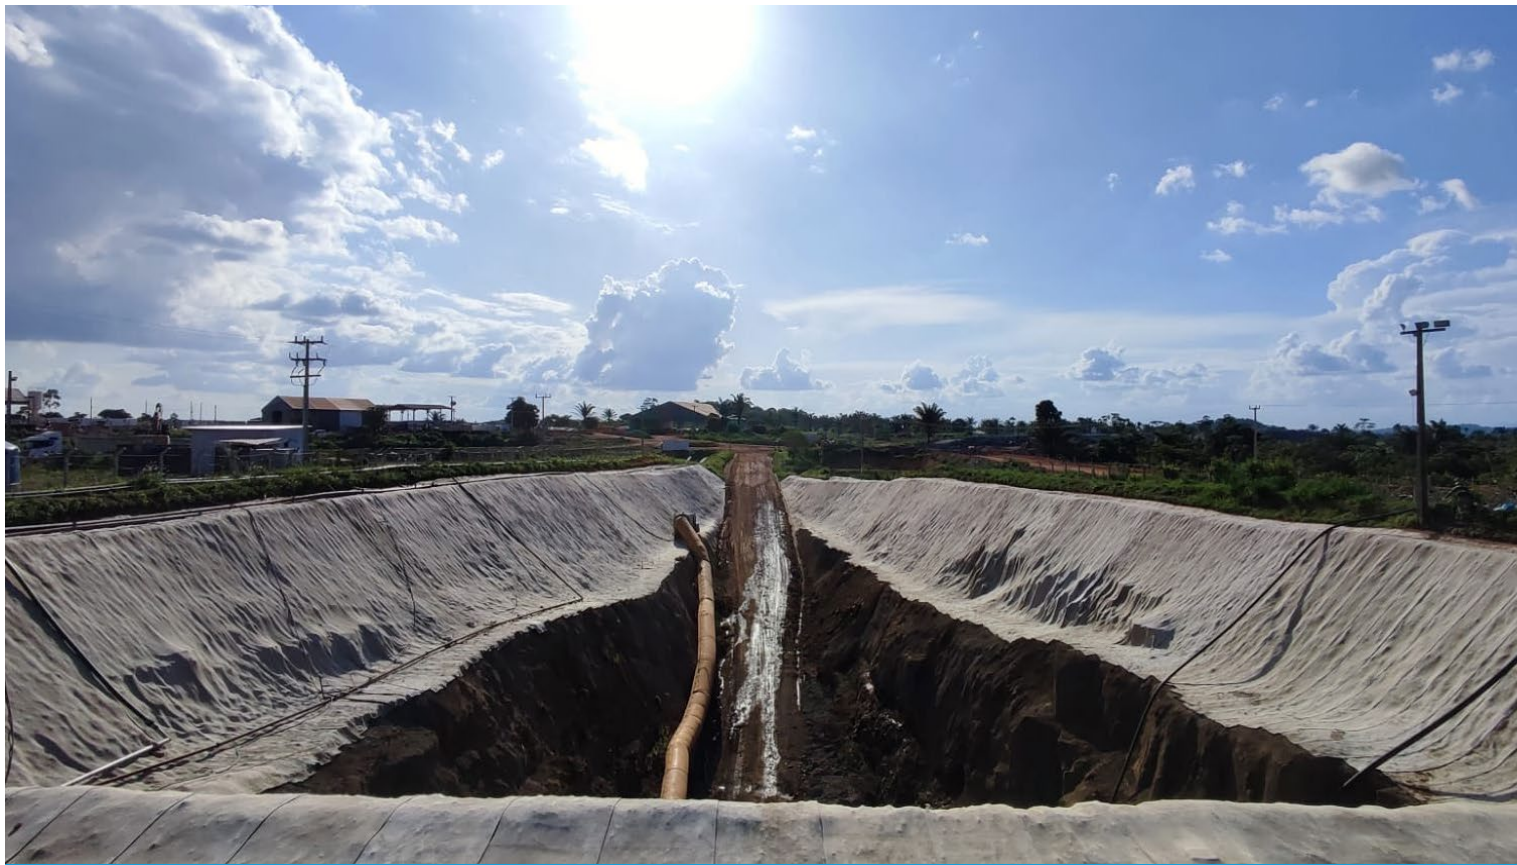
CC5™ fully hydrated
