CONCRETE CANVAS® *Concrete on a Roll*

Root Resistance Testing

Based on testing to - DD CEN/TS 14416:2005 "Resistance to Roots"

GEOSYNTHETICS TEST REPORT

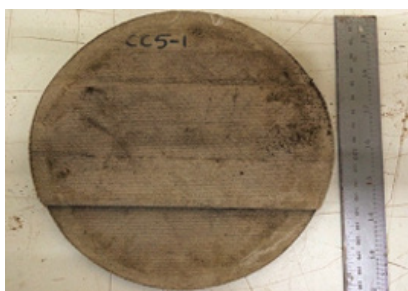
Figure 1: Upper surface after test. No root penetration

Both the exposed (top) side and underside of the material was examined and in all cases there was no evidence of root penetration through either the material or the joint.

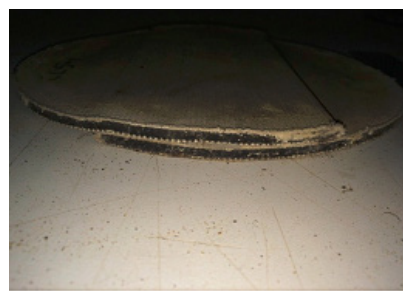
Figure 2: Joint after test. No root penetration

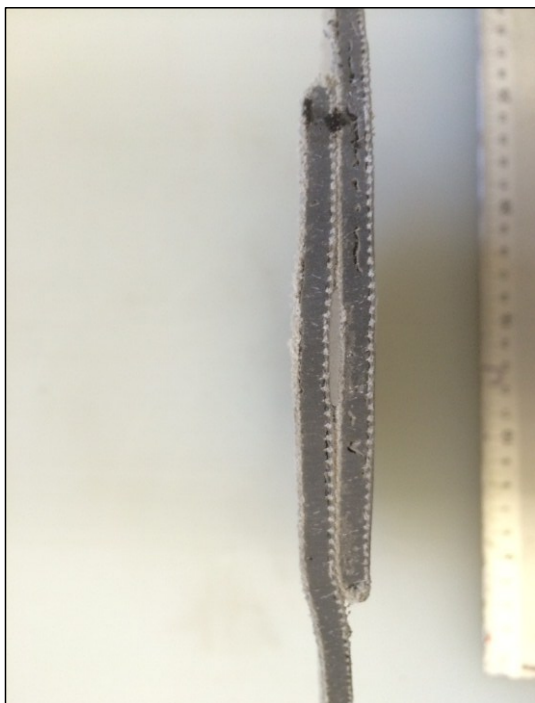
Figure 1. Typical overlap section (joint) prior to exposure

Three samples of CC5 overlap sections (Figure 1) were placed in soil into which seeds of lupin were sown. The seeds were grown during the period 23/05/2014 - 01/08/2014. At the end of the test the samples were examined to see whether the barrier/joints had been penetrated by the roots of the young plants.

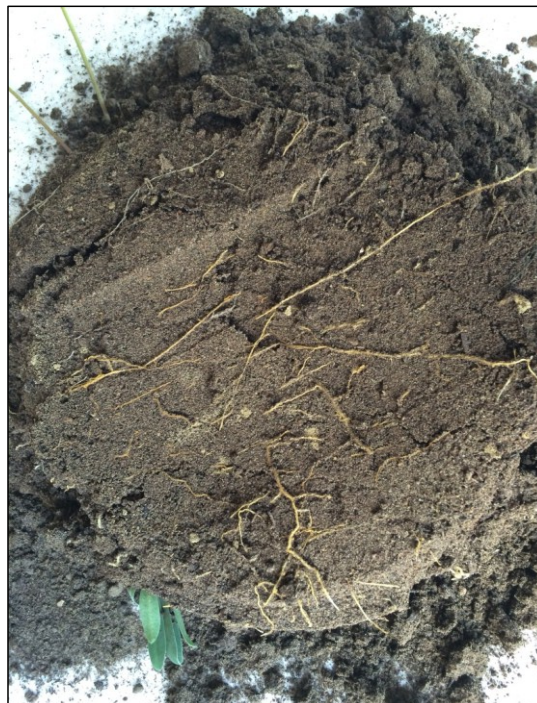
Figure 2. Typical root system at the CC5 interface after testing

Both the exposed (top) side of the barrier and the underside of the barrier have been inspected, and there is no evidence of penetration (either through the material or the joint) from the roots on any of the samples tested. Photographs have been taken to show both surfaces and joints of the test samples.

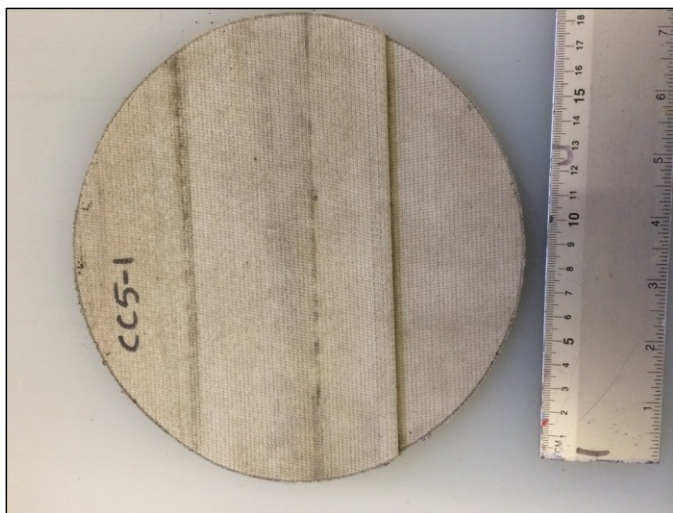
Figure 3. CC5-1 Before the test (upper surface)

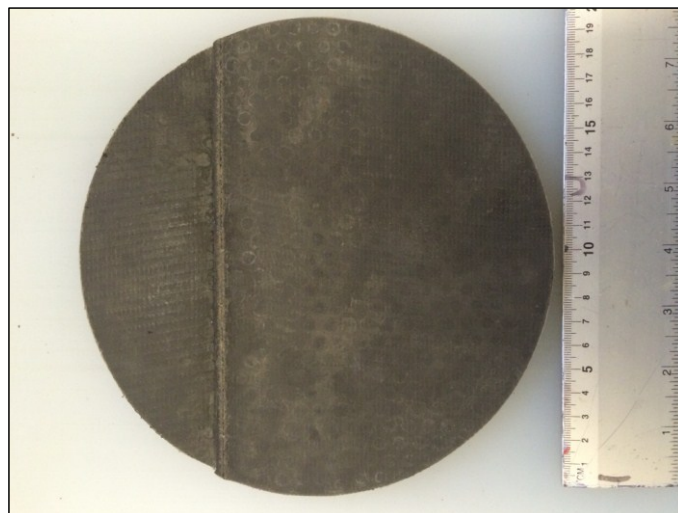
Figure 4. CC5-1 Before the test (lower surface)

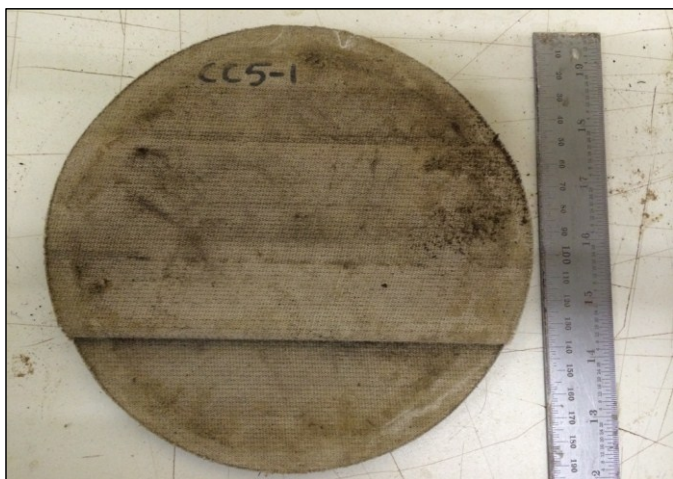
Figure 5. CC5-1 After the test (upper surface), no root penetration

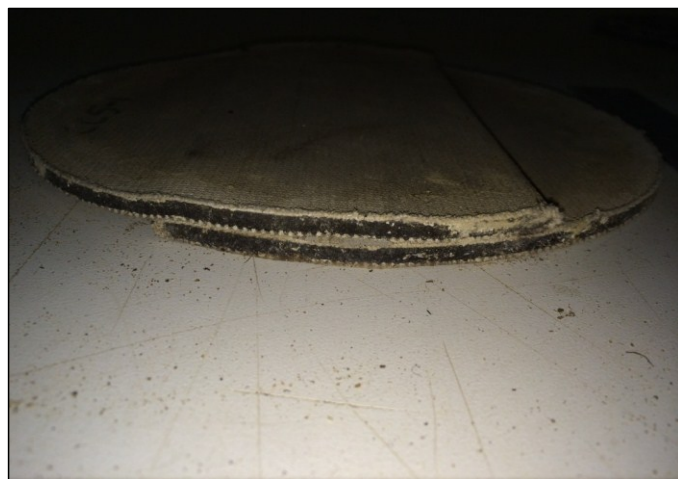
Figure 6. CC5-1 joint after the test, no root penetration

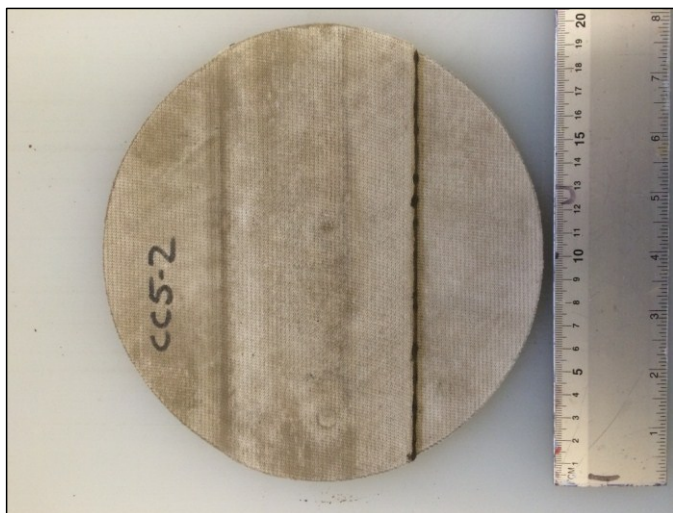
Figure 7. CC5-2 Before the test (upper surface)

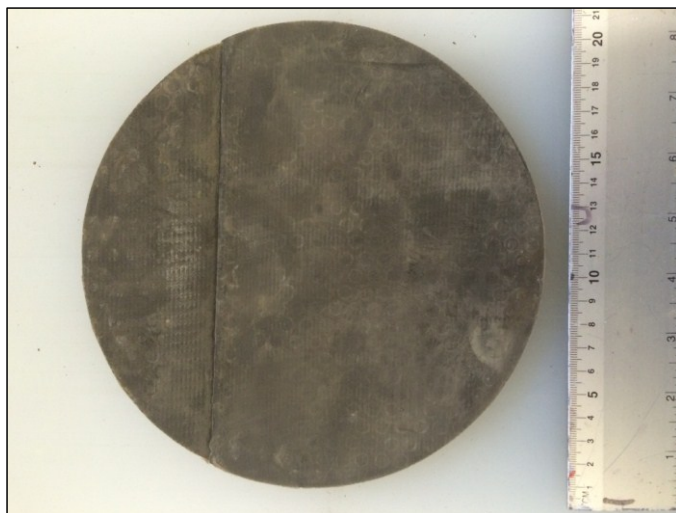
Figure 8. CC5-2 Before the test (lower surface)

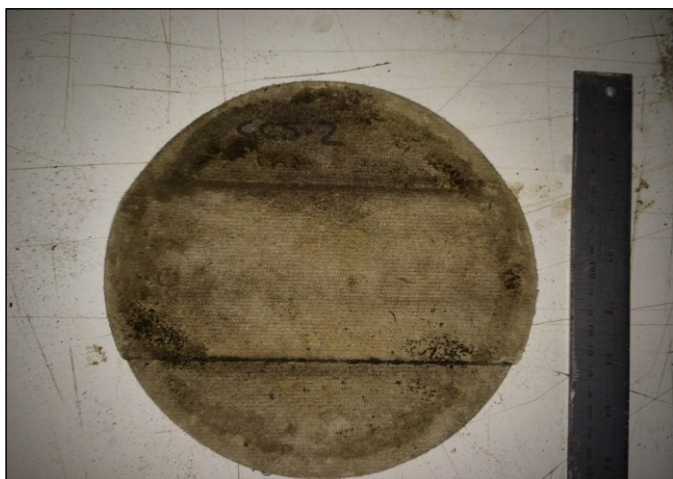
Figure 9. CC5-2 After the test (upper surface), no root penetration

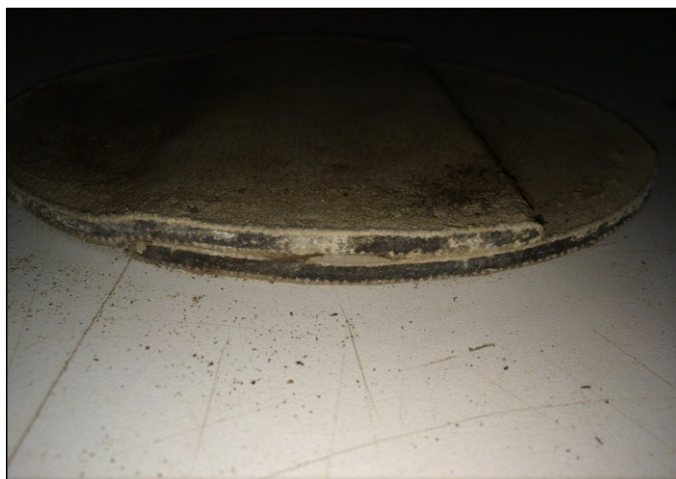
Figure 10. CC5-2 joint after the test, no root penetration

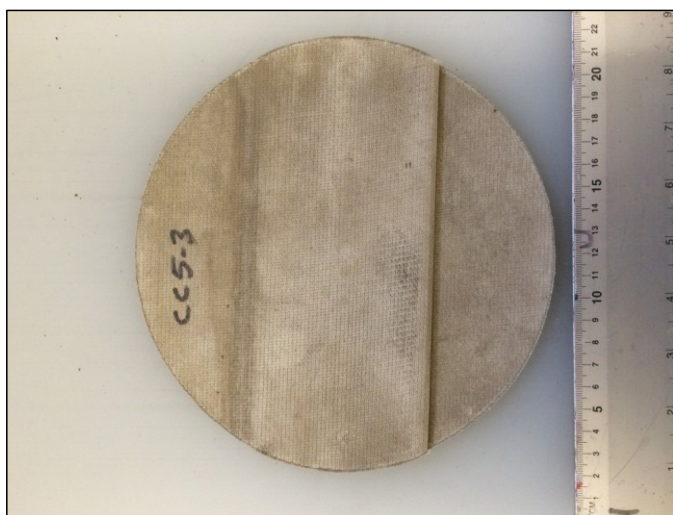
Figure 11. CC5-3 Before the test (upper surface)

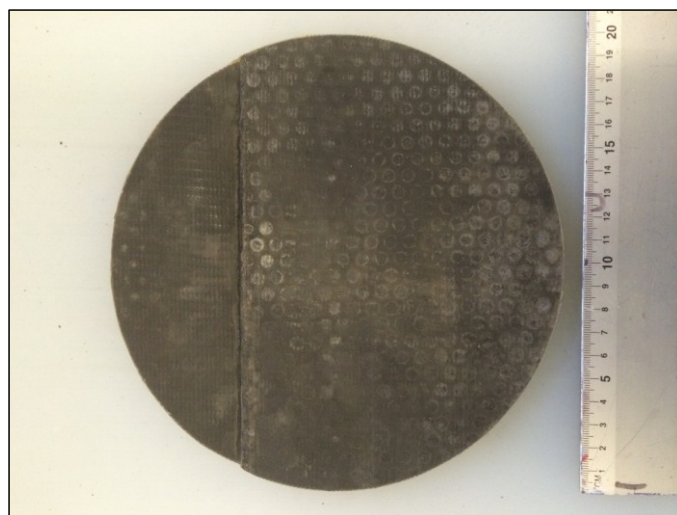
Figure 12. CC5-3 Before the test (lower surface)

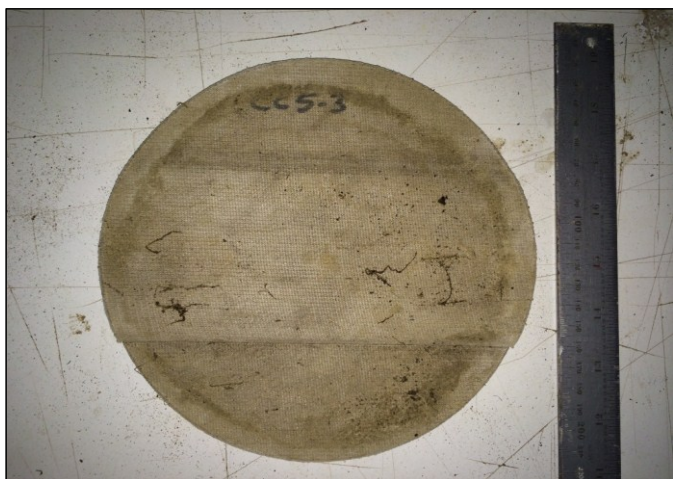
Figure 13. CC5-3 After the test (upper surface), no root penetration

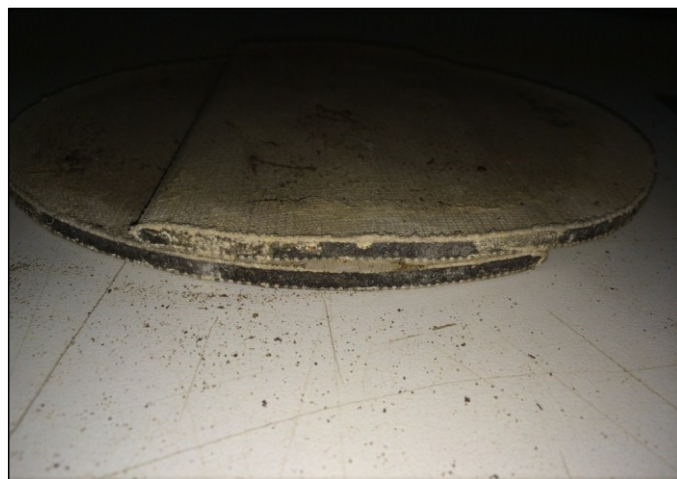
Figure 14. CC5-3 joint after the test, no root penetration
