# **CONCRETE CANVAS®** Concrete on a Roll

## BANK EROSION PROTECTION CASE STUDIES

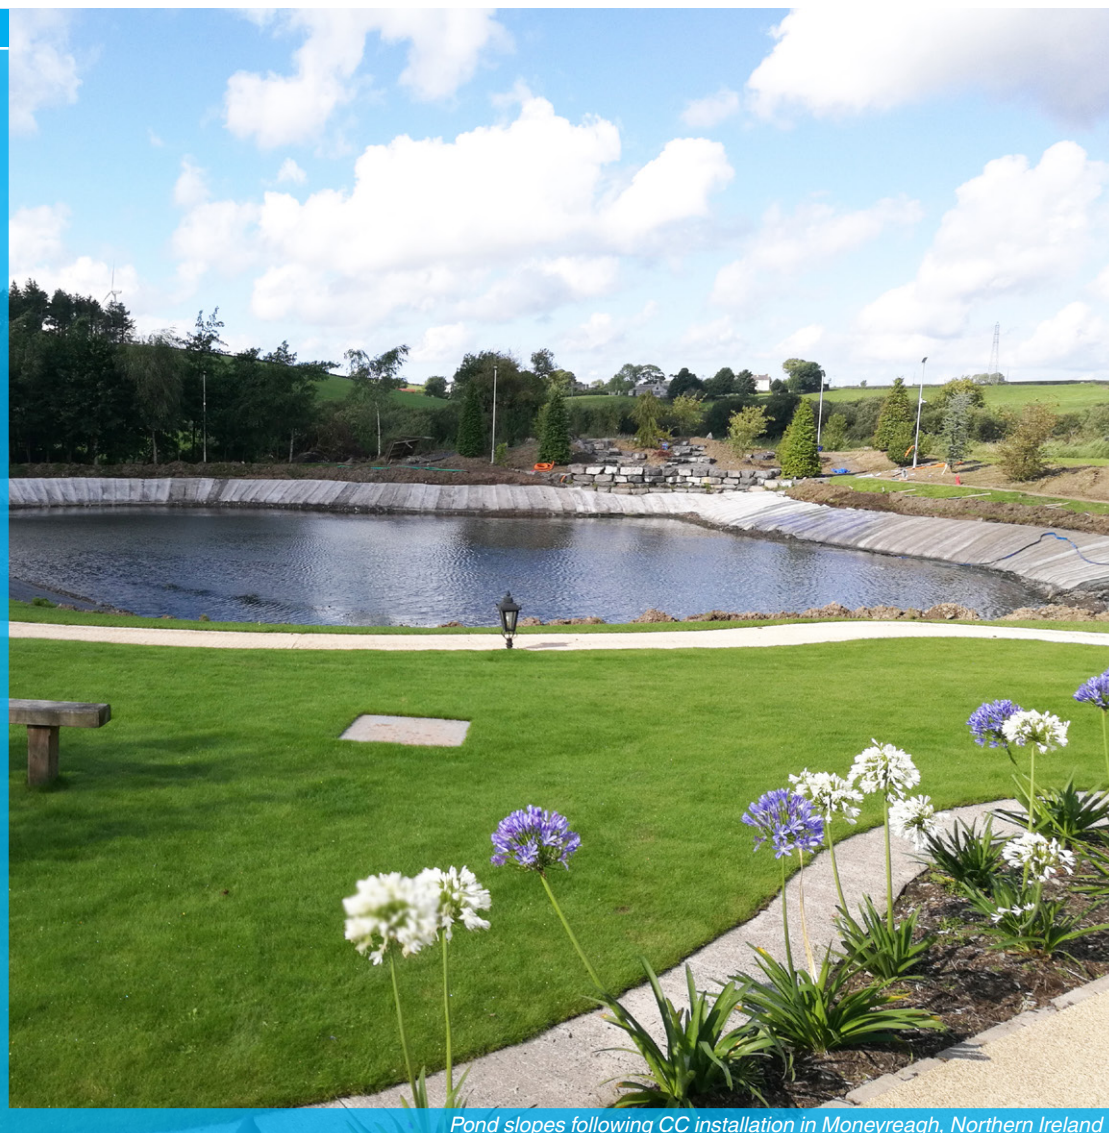
*Pond slopes following CC installation in Moneyreagh, Northern Ireland*

In August 2018, Concrete Canvas® GCCM (CC) was used to provide erosion protection for a pond embankment in Moneyreagh, a small village south of Belfast. The pond was originally lined with clay for a golf reservoir, but erosion of the pond embankment meant an erosion protection solution for the slopes was required. The bottom of the pond would remain unlined to reduce the build-up of hydrostatic pressure. Poured concrete was considered but CC was chosen due to its speed and ease of installation and its flexibility in terms of site access, as the use of heavy plant was not possible.

The installation team were impressed by the speed and ease of installation of CC on a site with heavily restricted access. In total 1,200m<sup>2</sup> of CC5™ were installed in 3 days with a crew of 4 people without specialist training or plant equipment and will provide long-term erosion control for the pond embankment.

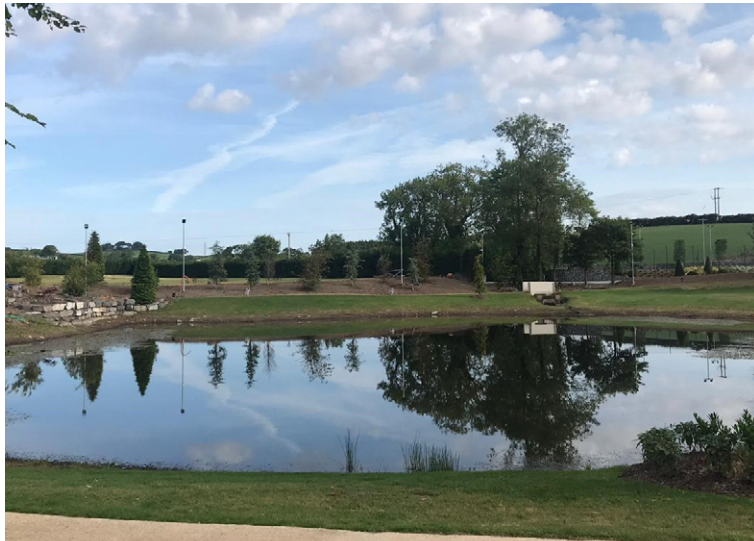
*Pond prior to works*

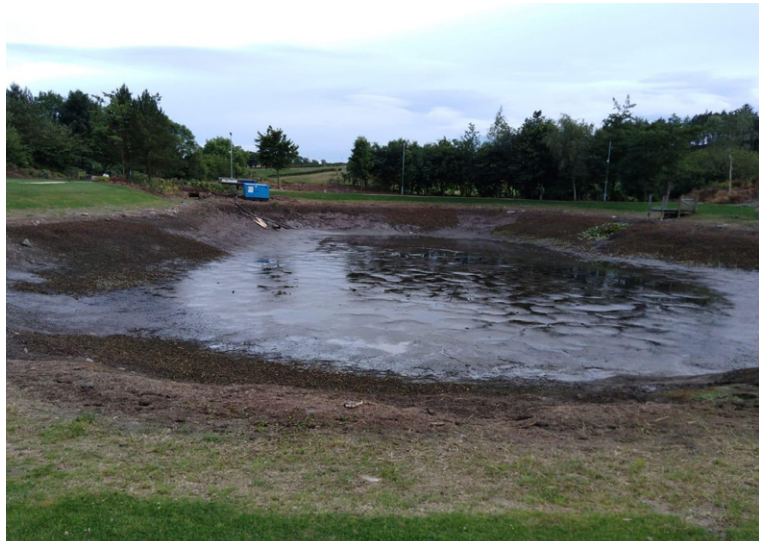
*Water pumped from pond*

Prior to installation, the water was diverted using pumps. The side slopes were then excavated to remove sharp or protruding rocks before laying and compacting crushed stone to ensure a smooth substrate. 300mm anchor trenches were dug at the crest and toe of the slope with a mini excavator.

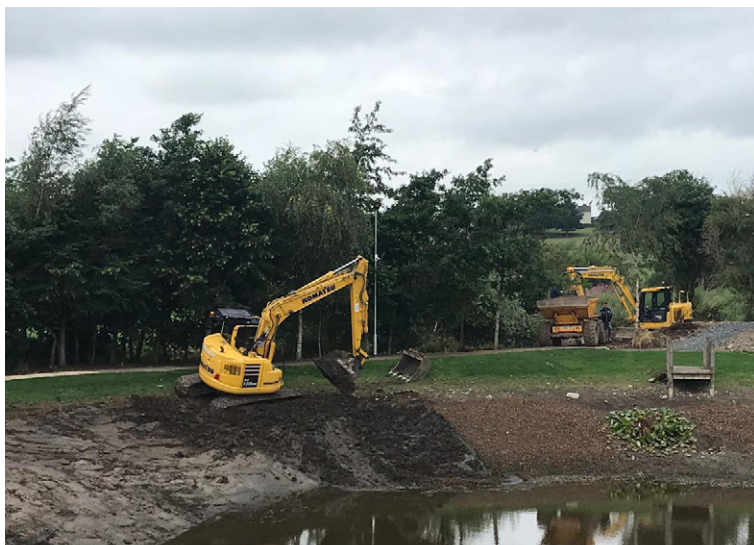
*Excavation of embankment*

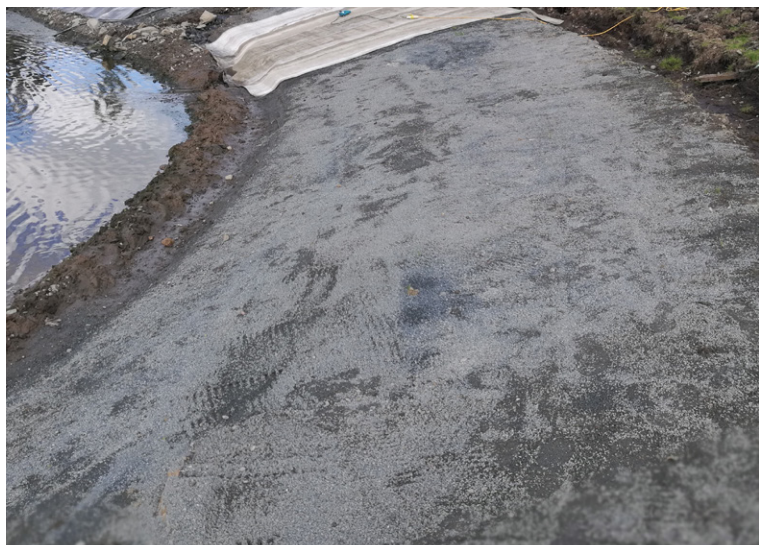
*Crushed gravel compacted on slope for optimum substrate*

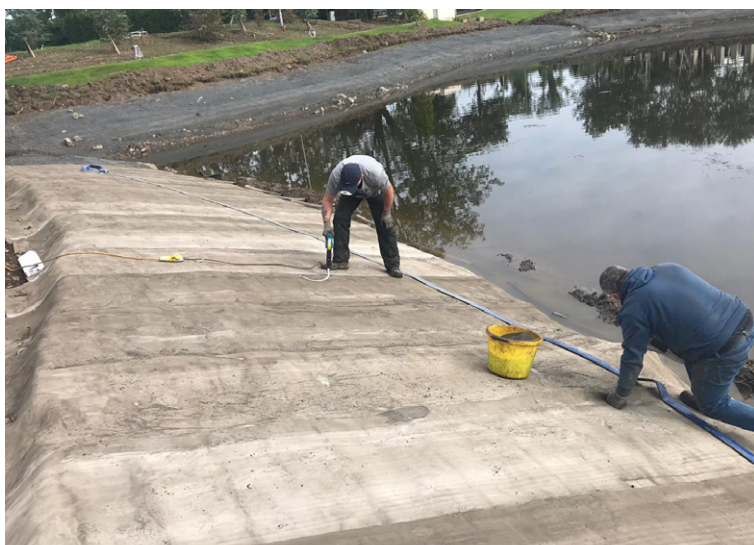
*CC overlaps jointed using screws, placed at 200mm intervals*

Batched rolls of CC5™ were delivered to site and cut with a disc cutter into 5 linear metre lengths to match the average height of the slope. The CC was fixed within the crest anchor trench using steel ground pegs. Subsequent layers were overlapped by 100mm and jointed using 30mm stainless steel screws. Following installation, the material was hydrated and the anchor trenches later backfilled, compacted and seeded.

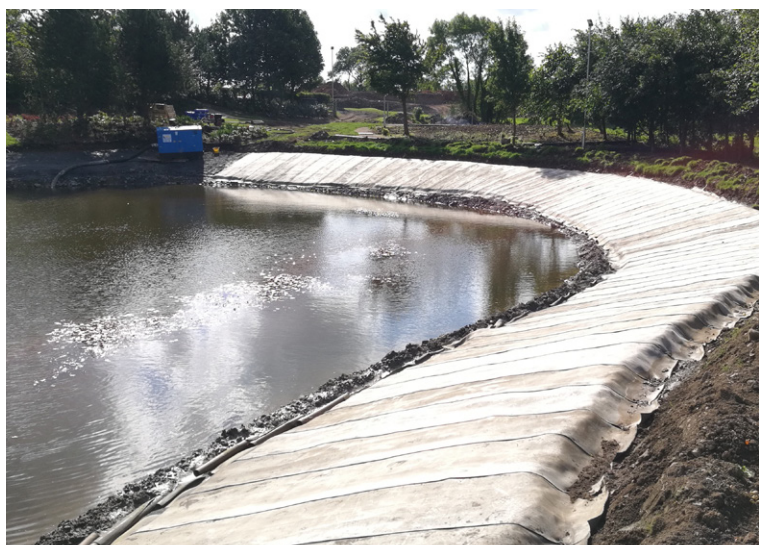
*CC secured into crest and toe anchor trenches*

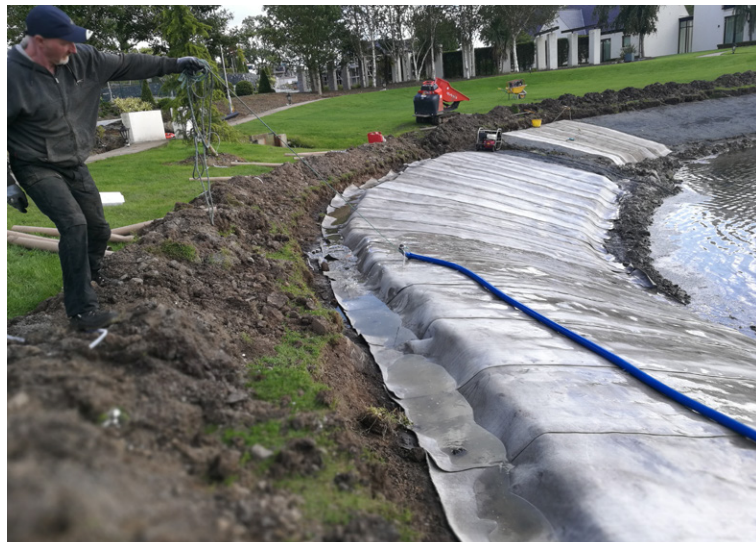
*CC hydrated at the end of each day*

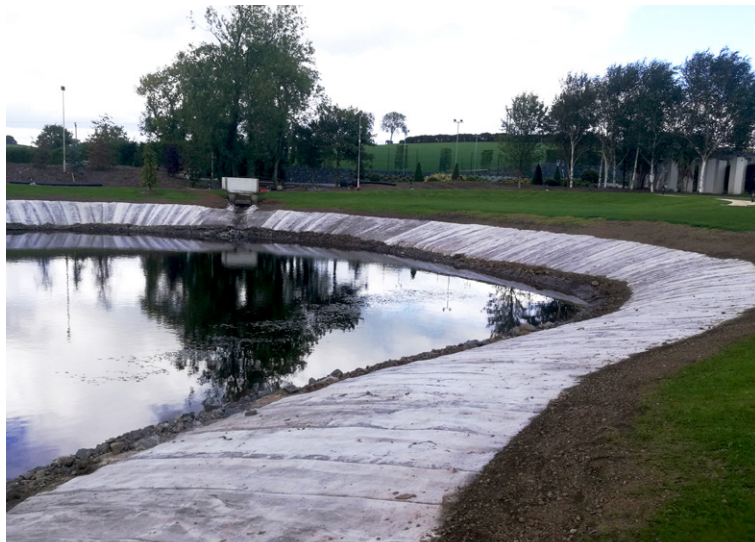
*Anchor trenches backfilled and compacted*

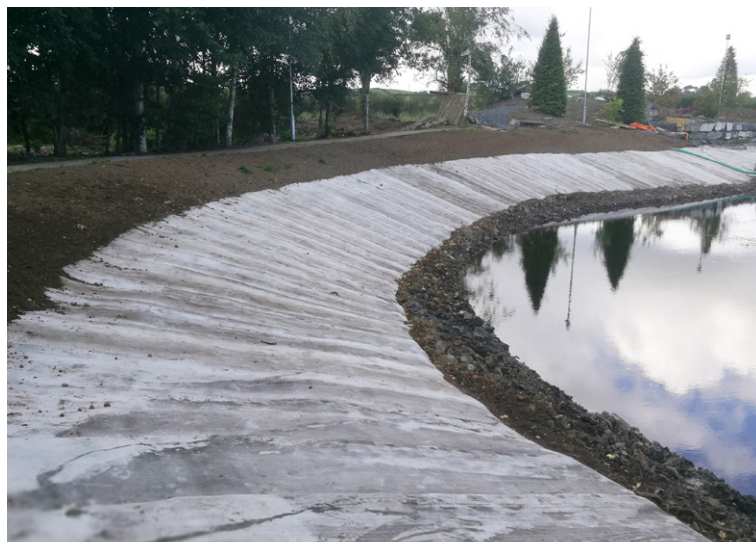
*CC easily accomodated corners of pond*

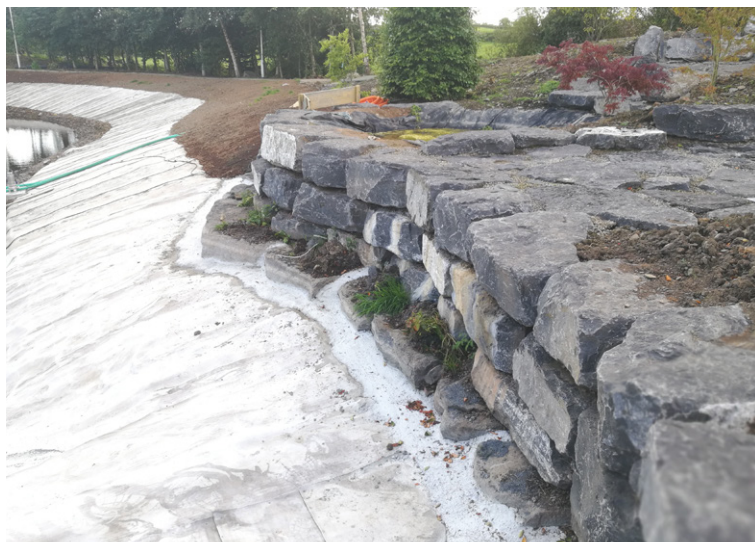
*Concrete fillet applied at CC and rock termination*

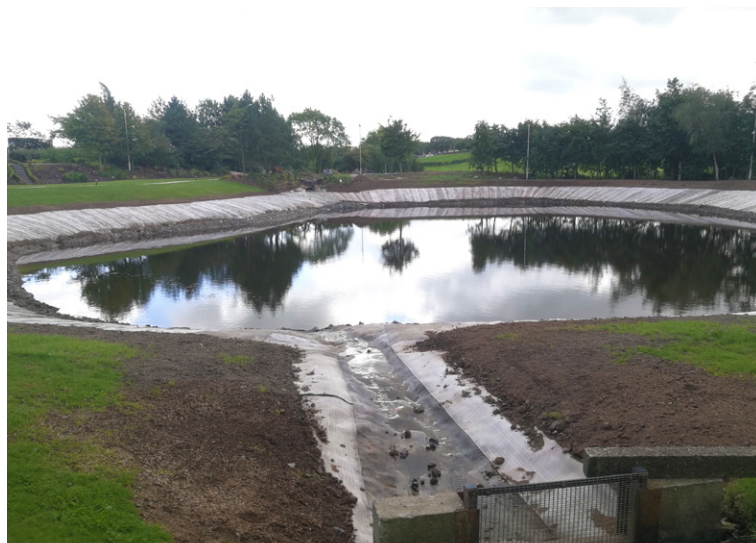
*CC lined pond inlet channel*

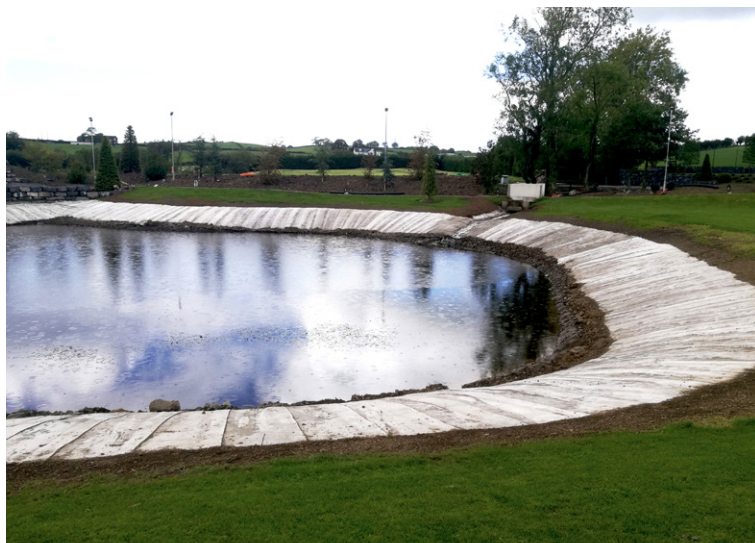
*Inlet channel and completed CC installation*

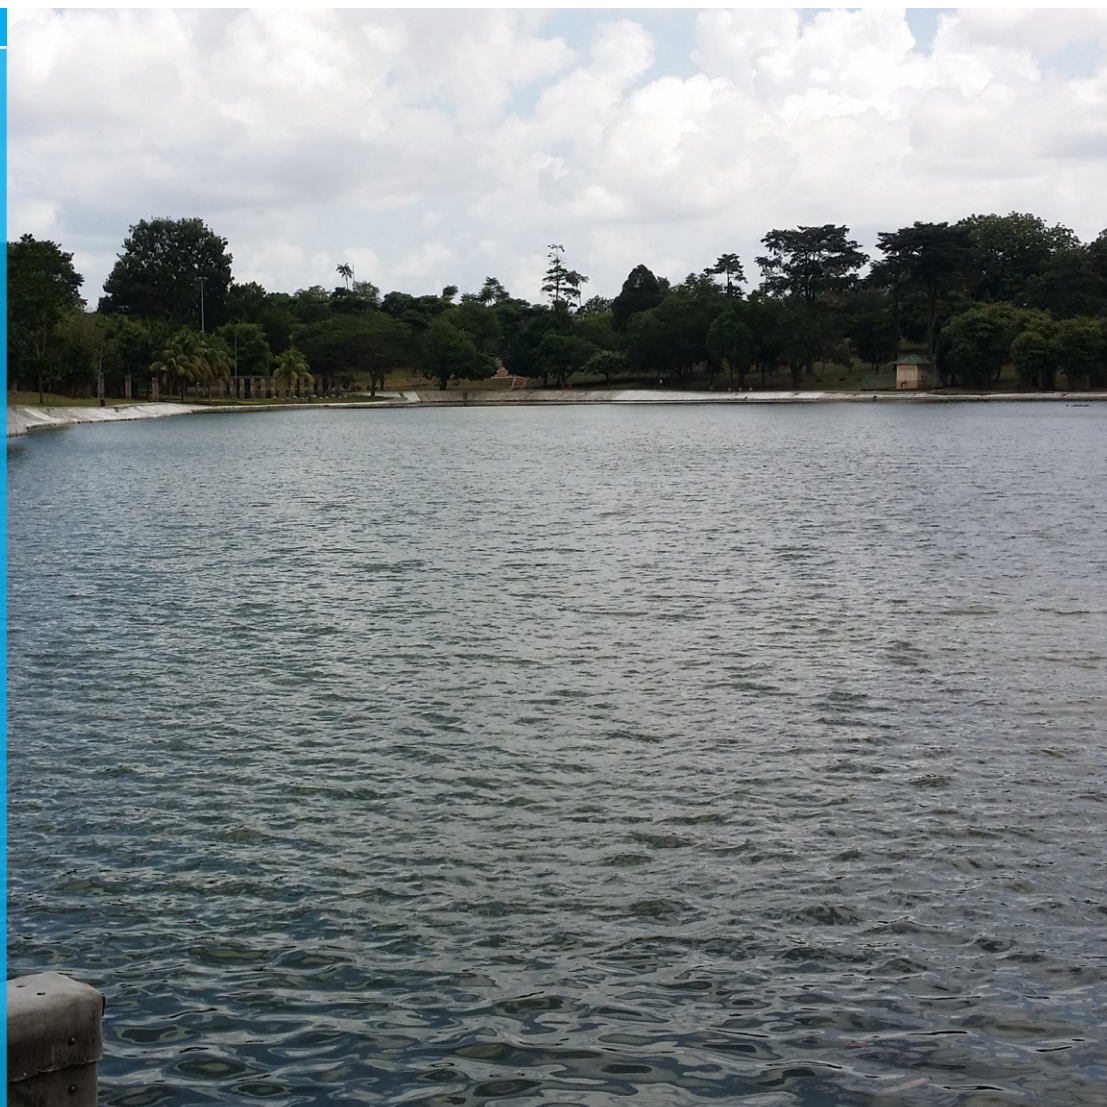
*Completed installation in Pasir Gudang Bahru, Malaysia*

In September 2017, Concrete Canvas® GCCM (CC) was used to remediate a number of slopes, guard rails and footpaths surrounding a recreational lake in Pasir Gudang, Johor Bahru in Johor, Malaysia.

2,800m<sup>2</sup> of CC5™ were installed in 30 days. The Pasir Gudang Municipal Council were impressed by CC's performance and the speed of install and are looking to specify CC for a slope protection project in the near future.

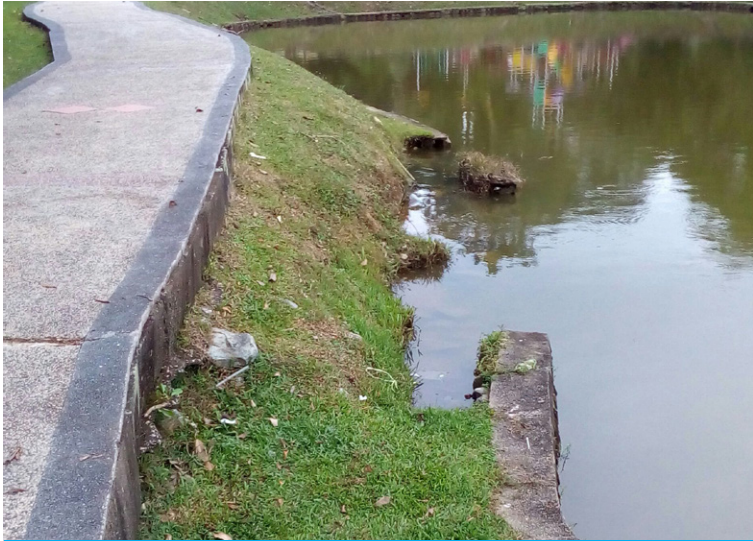
*Sections where erosion has caused the soil slope to collapse into the lake*

The lake is used for recreation and sees vast numbers of visitors each week. The slopes around the lake were deteriorating, leading to water from the lake seeping into the surrounding soil, destabilising guard rail foundations, causing concrete walls to collapse and creating dangerous voids. The local council planned to use sheet pile to remediate the slopes but it was CC's overall cost savings compared to alternatives that led to its specification. CC can also be installed without heavy plant and machinery, minimising disruption on site. The works were carried out by Edup Design Sdn Bhd for Pasir Gudang Municipal Council.

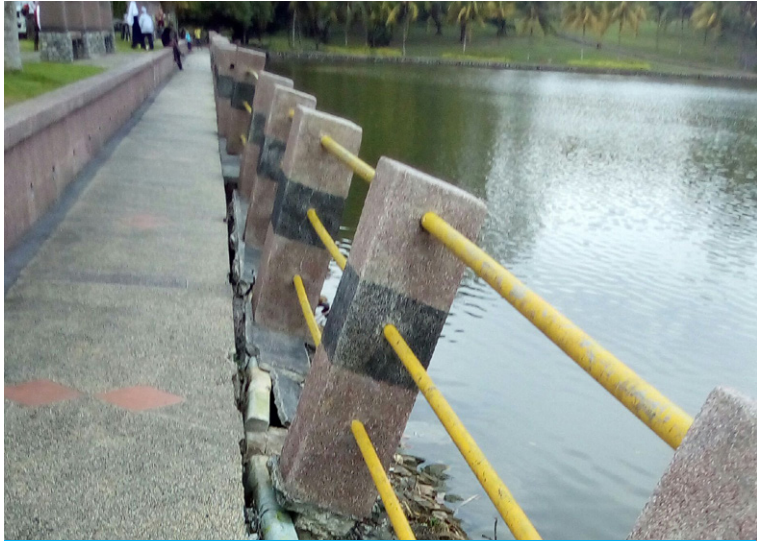
*Guard rails collapsing into lake due to erosion*

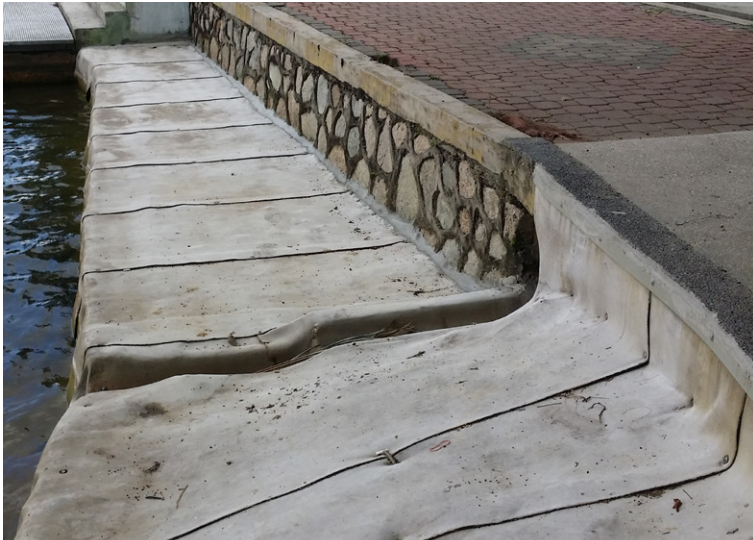
*Ground pegs, wall plugs, screws & poured concrete used to joint & fix CC*

Prior to installation, the slopes were levelled and the cracking and damage to existing retaining concrete walls were remediated using gabions which were submerged in the lake. The voids between the gabions and slope were filled with rocks. CC was then installed directly into the lake, as the material has a two-hour window of workability for it begins to set. The material was laid vertically from crest to toe on the slopes, and longitudinally around the edge of the lake where remediation of the paths was required. Poured concrete and grout were used to seal the exposed edges, while screws, wall plugs and ground pegs were used to fix and joint the CC edges and overlaps.

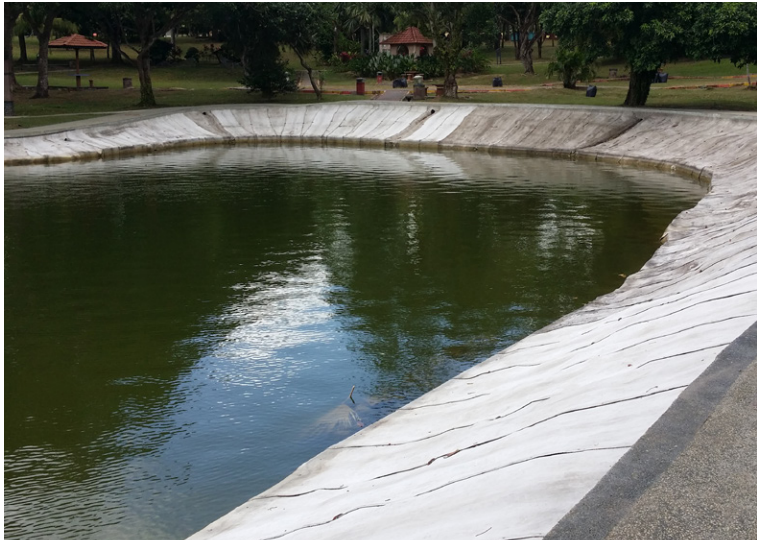
*CC was able to accomodate curved sections of slope*

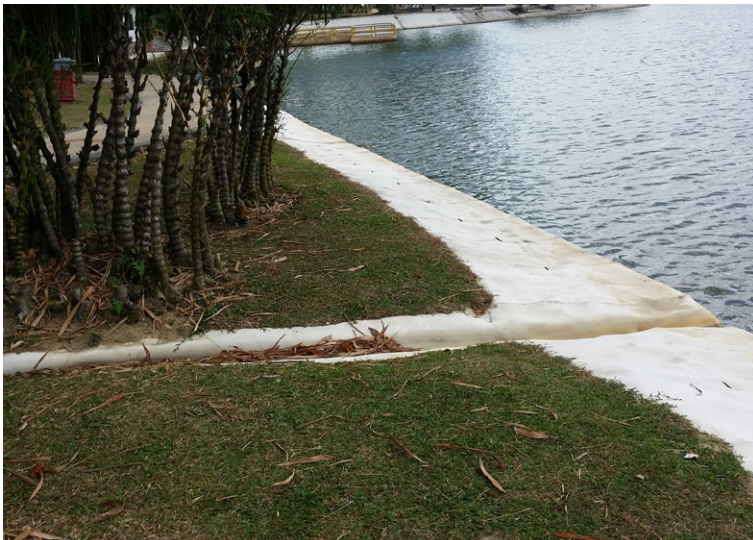
*CC buried in anchor trenches to preserve grassy areas above slope*

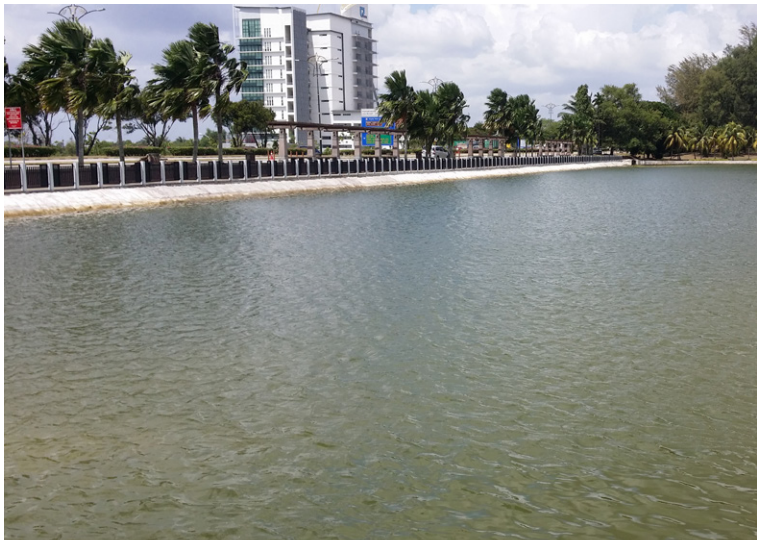
*Completed slope protection installation*

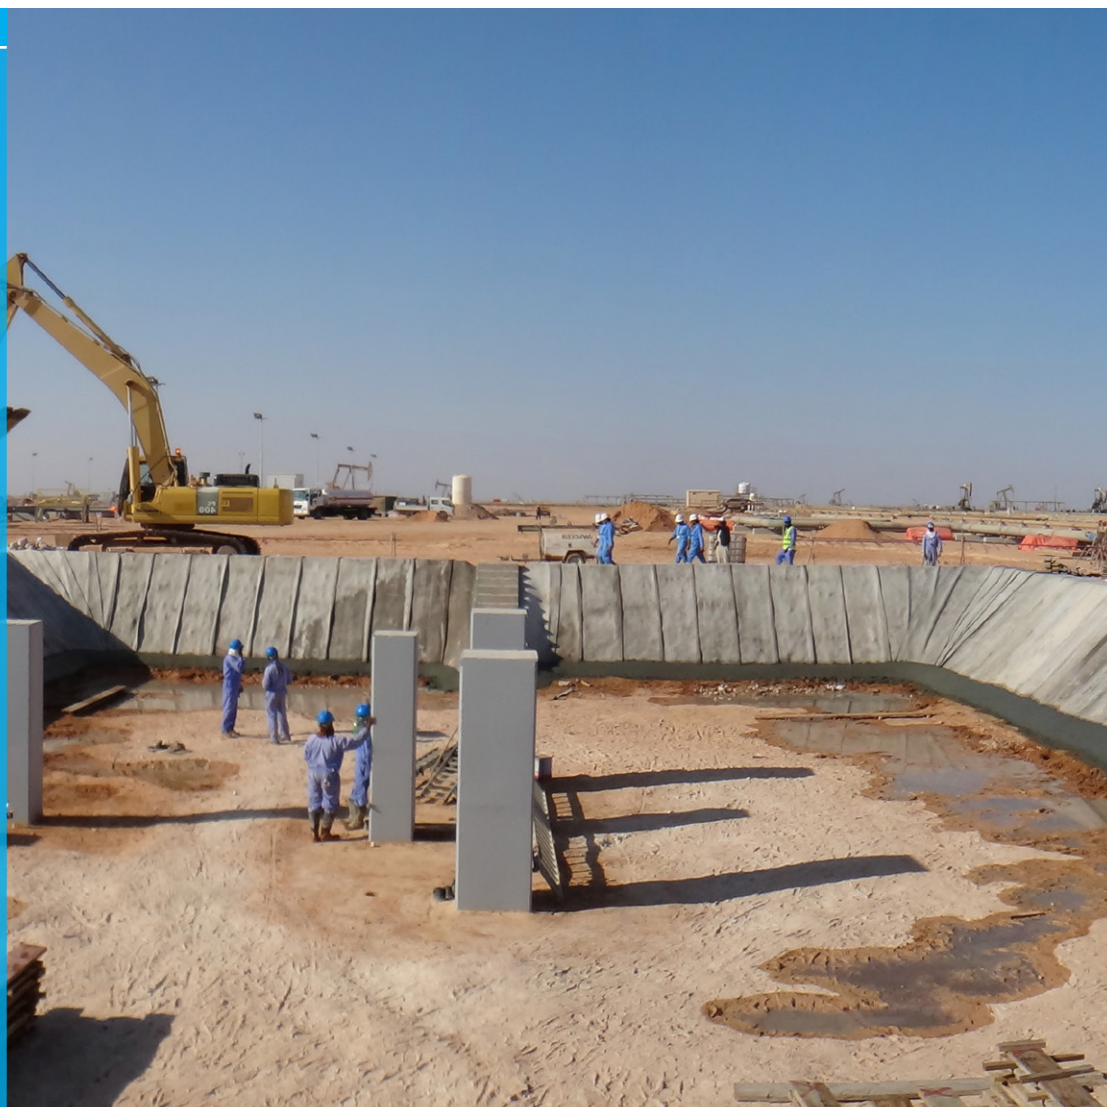
*Completed, lined blow down pit*

In January 2014, Concrete Canvas® (CC) was used in a trial to line the walls of a blow down pit in order to demonstrate the speed and ease of CC compared to traditional concreting methods. The primary aim was to improve impermeability and protect against weathering erosion.

The pit measures 37m long x 25m wide x 2.5m deep. CC had to accommodate concrete steps with handrails, concrete plinths, a sump pit and a concrete pillar. The substrate, which was made up of sands, unconsolidated rock and underlaying rock, provided a high degree of impermeability, as a result the pit base did not require lining.

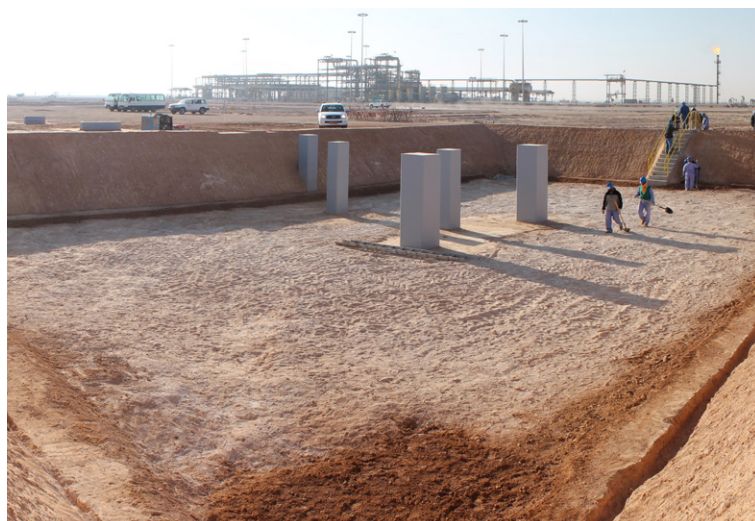
*Excavated pit prior to lining*

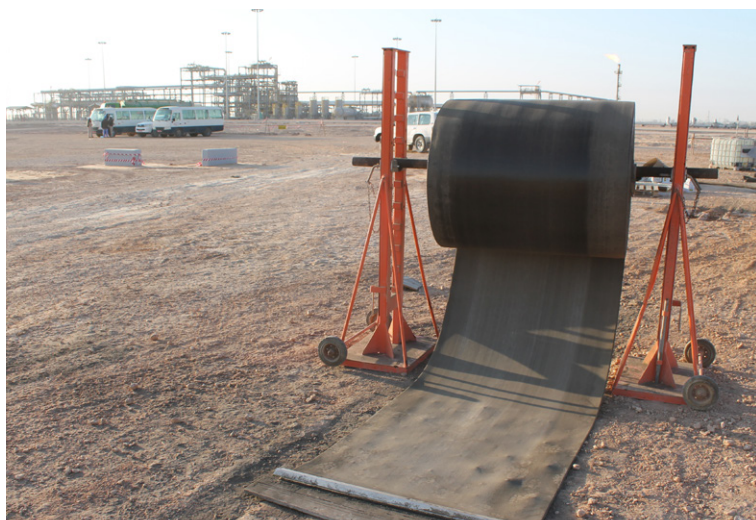
*CC was batched and moved to site by hand*

Anchor trenches were excavated around the outside and inside perimeters and the berm profiles levelled by removing protruding rocks to ensure a smooth substrate. Bulk rolls were delivered to site, batched to man-portable lengths and moved into position manually. Overlaps were thermally bonded and localised areas also sealed using grout. 250mm steel ground pegs were used to fix the CC to the substrate through the joints at the crest and toe. All joints were compressed and hydration started at dusk to avoid evaporation. Certain areas were rehydrated an hour later. The inner perimeter anchor trench was backfilled with concrete for an impermeable transition between the pit floor and CC-lined berm.

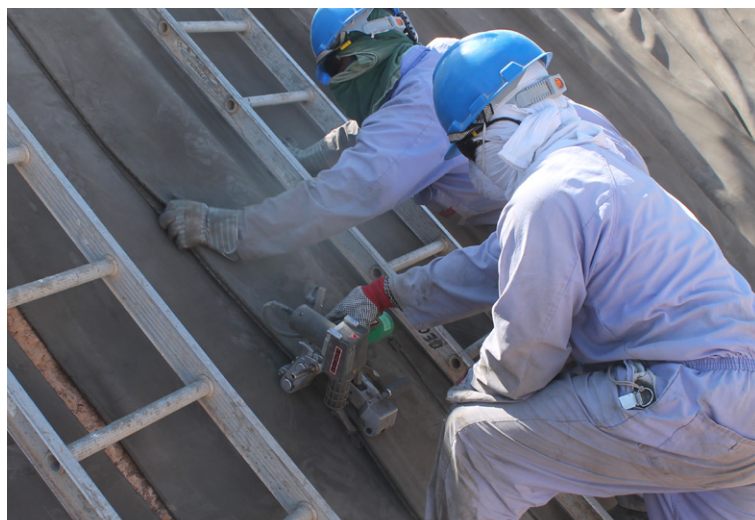
*Thermally bonding CC joints*

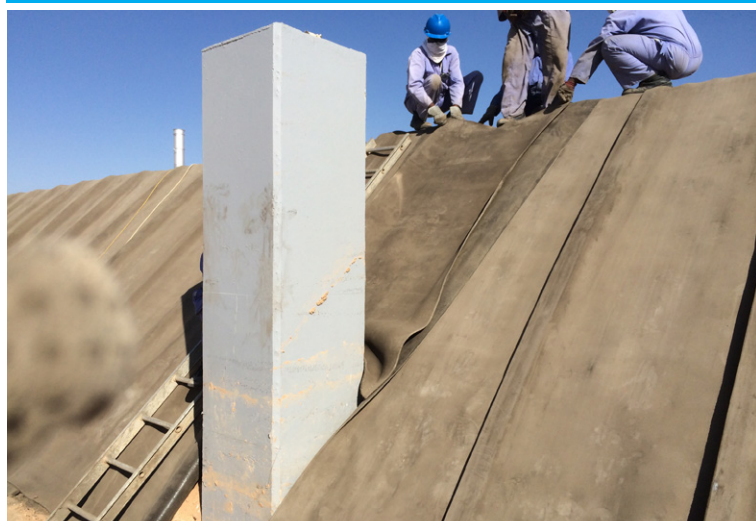
*Accommodating existing infrastructure*

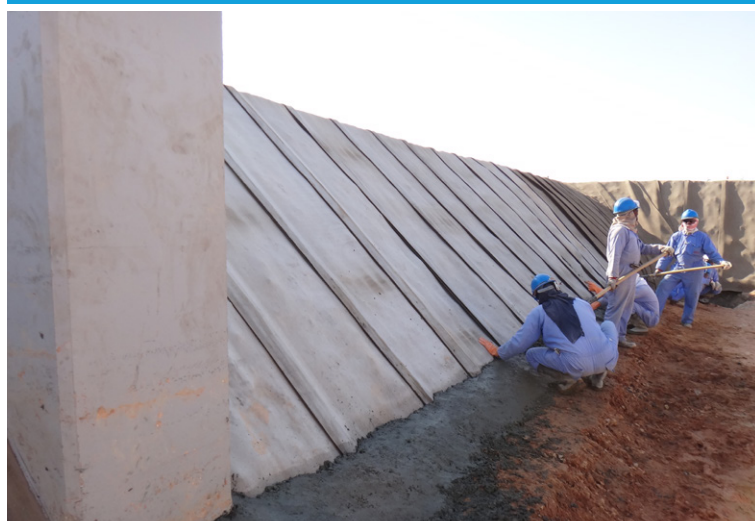
*Applying concrete backfill to anchor trenches post-hydration*

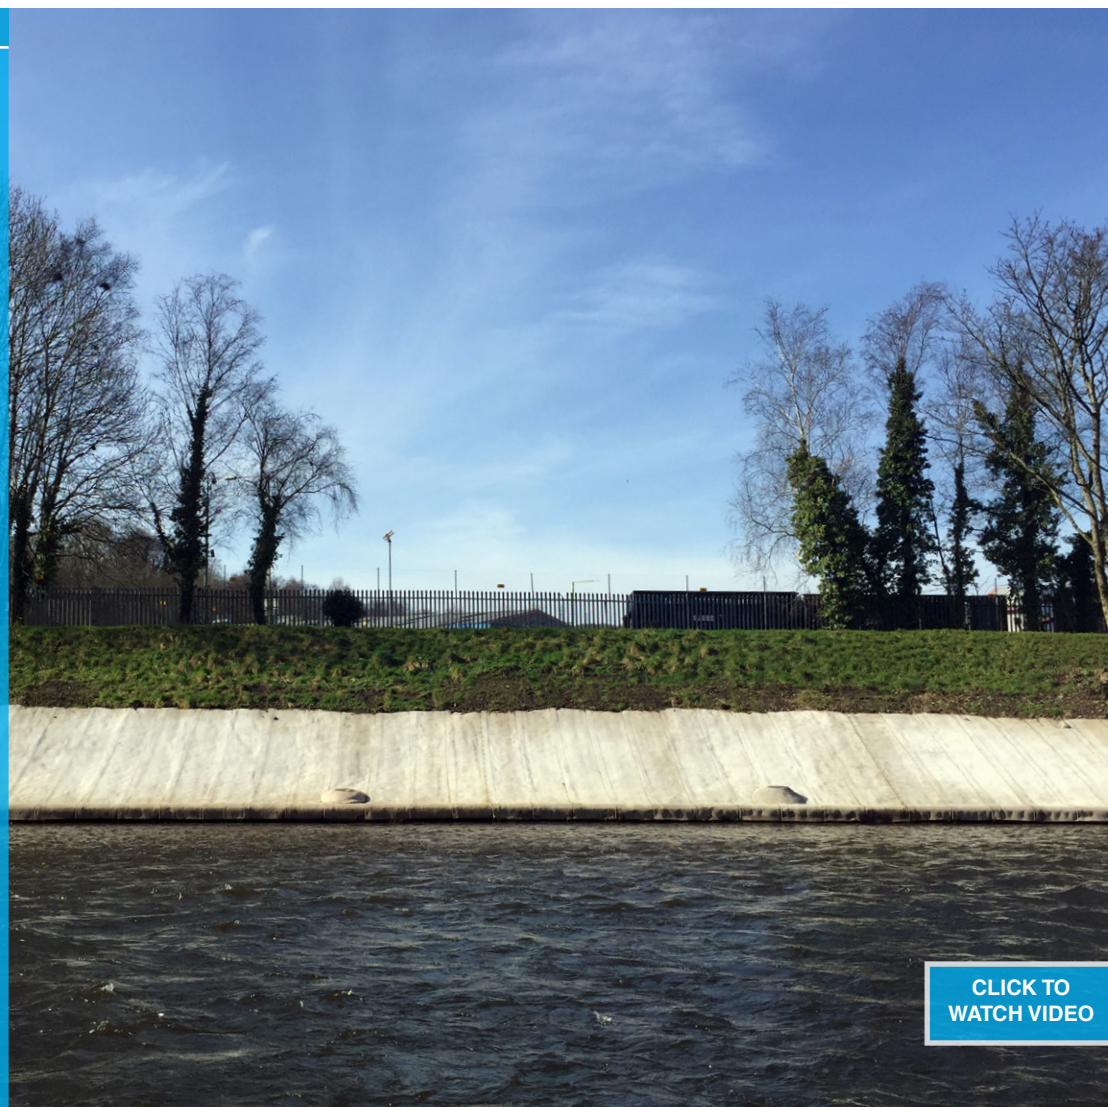
*Completed CC lined section of River Taff*

In November 2016, Concrete Canvas® (CC) GCCM was used to remediate sections of embankments of the River Taff in South Wales which were formed from grouted rip rap embankments believed to have been installed in the early 1950's. A particular section, within Treforest Industrial Estate, was heavily cracked, showing signs of severe spalling and established vegetation growth. Remediation was required to prevent further scour and undermining of a walkway along the crest of the bank.

Following similar successful works in Newport, Concrete Canvas Ltd were approached by Natural Resources Wales. The slope section was approximately 220 linear metres long and 4 metres high. The rip rap butted into a concrete kerb at the toe, which capped sheet piling beneath. It was considered to simply re-point sections of the rip rap, but this would be a costly, temporary solution and wouldn't address underlying drainage issues. Replacing the rip rap in its entirety would involve the costly excavation and import of fill in a difficult access area. Other solutions considered included sprayed and in-situ concrete and vegetation mats. These solutions required specialist contractors and equipment, could contaminate the river, would be time consuming and not adequately durable.

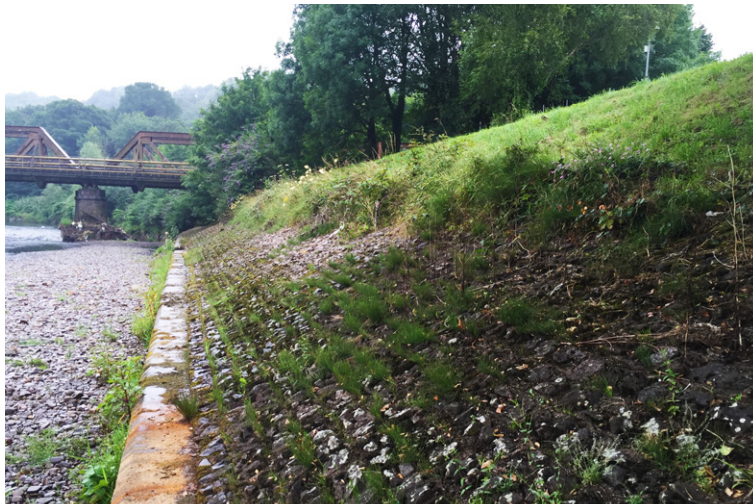
*Embankment prior to works, during low river levels*

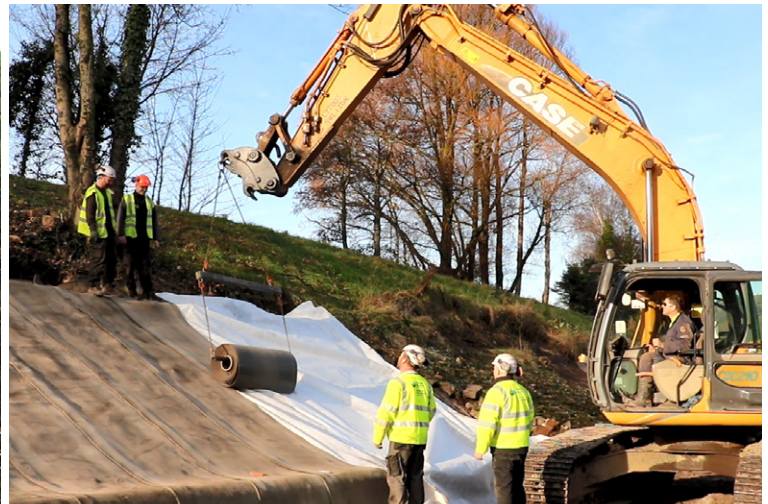
*Dispensing of bulk roll CC13 via spreader beam*

CC13™ was specified in order to maximise the durability and effectiveness of CC as an erosion protection solution and to withstand the potential fast flow velocities of the River Taff, shear force loads and the likelihood of impact from debris. CC was delivered via temporary access road and deployed from a plant-mounted spreader beam. The rip rap was removed using plant and the substrate graded to a uniform, smooth finish. A layer of separation geotextile was laid prior to deploying CC, mitigating washout of substrate fines through tidal action between CC joints.

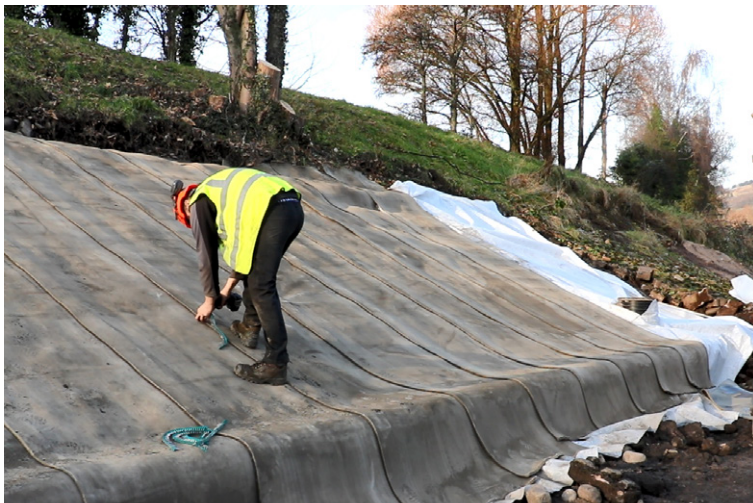
*Fixing of the overlapped CC layers using SS screws at 150mm centres*

CC was deployed vertically, allowing for installation in stages. CC layers were overlapped by 100mm in the direction of water flow and screwed together, creating a natural weep path and allowing the release of hydrostatic pressure. The top edges were captured within an anchor trench and each layer pinned to the substrate using 250mm galvanised steel pegs before being hydrated. At the toe, CC was draped across the full height of the kerb and captured to the vertical face using concrete masonry anchors with washers. The side edges were anchor trenched at the interface with the rip rap within concrete poured backfill to prevent water ingress. Drainage chambers were installed along the embankment.

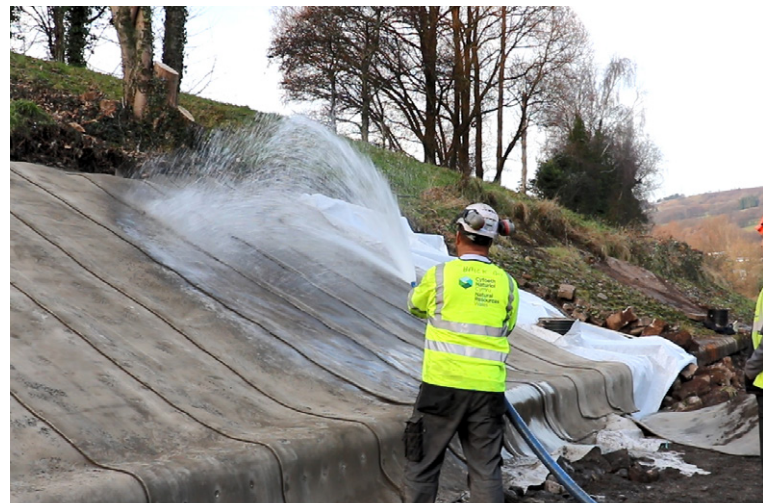
*Hydration of the CC lined sections using water from the River Taff*

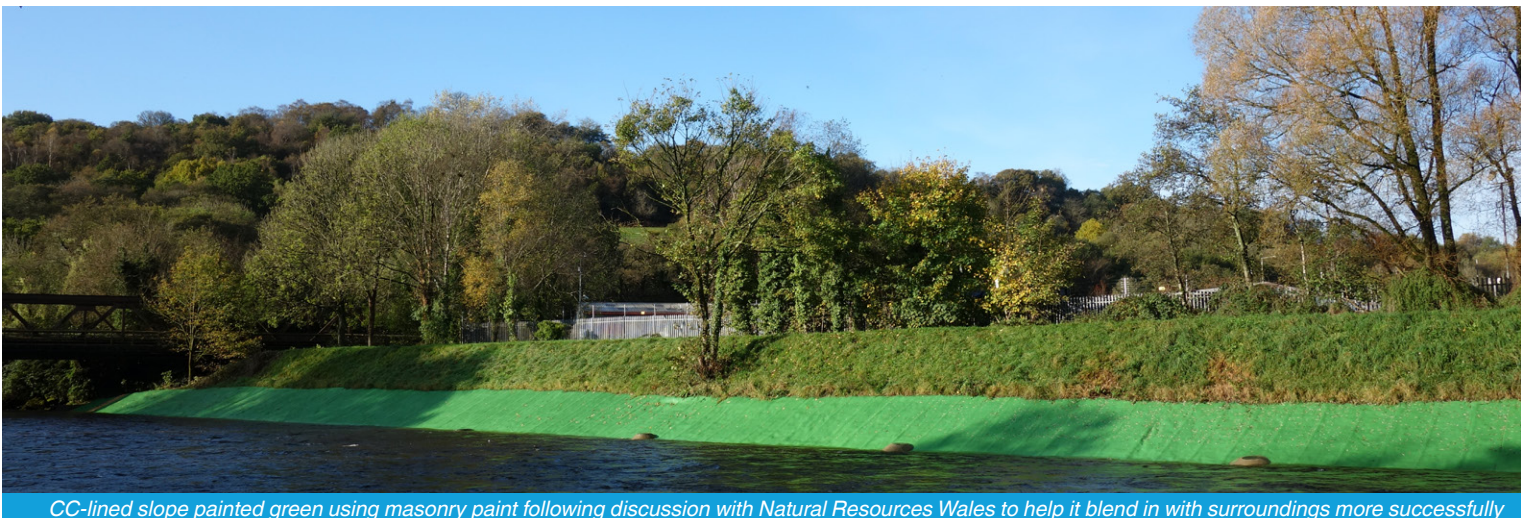
*CC-lined slope painted green using masonry paint following discussion with Natural Resources Wales to help it blend in with surroundings more successfully*

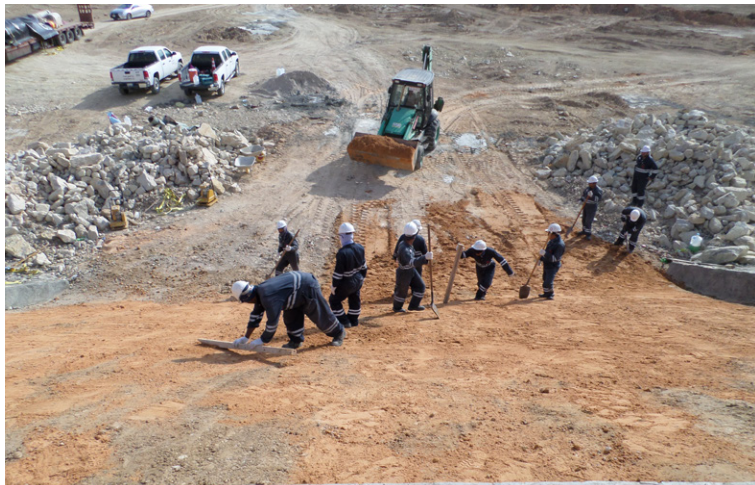
*Levelling and backfilling the substrate following compacting*

Sharp rocks were removed and initial levelling done by hand. Following compacting, backfilling and levelling were repeated using sand. Bulk rolls of CC8™ were delivered to site, deployed from a spreader beam, and cut to length using hand tools. The material was then transported and unrolled by hand from crest to toe, with layers overlapping by 100mm. CC was fixed to the existing concrete at the crest using stainless steel bolts and the edges laid in an anchor trench. CC was fixed to the adjoining rip rap using bolts and pegged inside pre-dug trenches along the sides and toe.

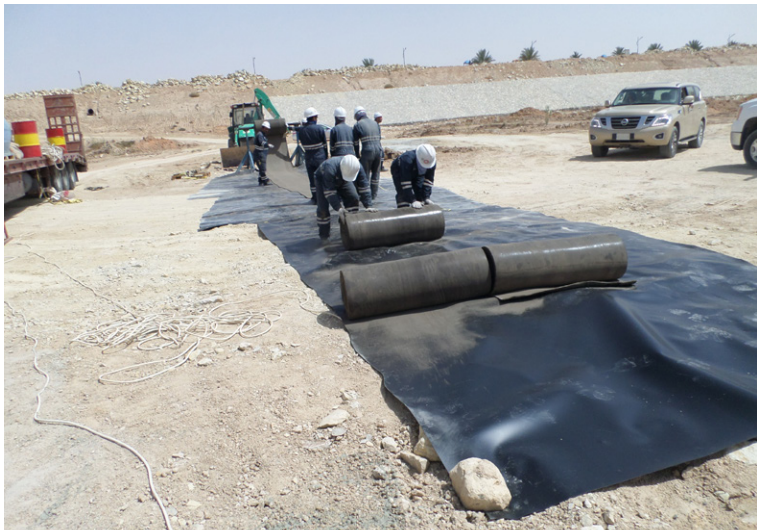
*Batched lengths of CC ready for transportation to site*

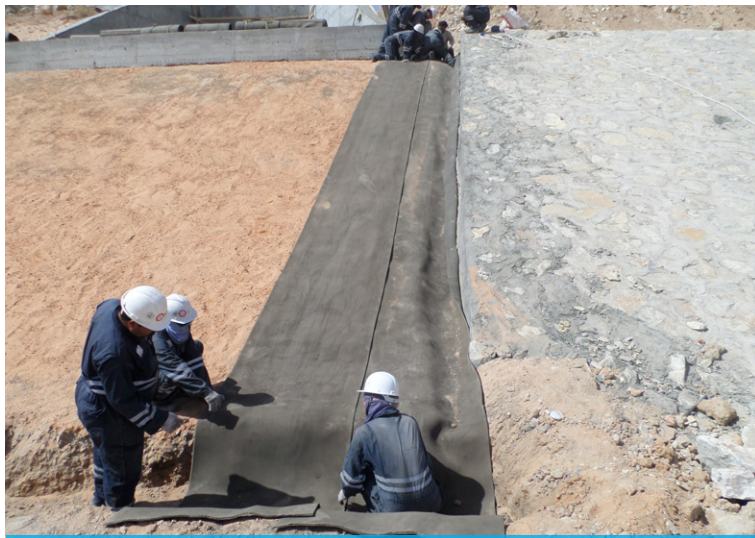
*Deployment of CC*

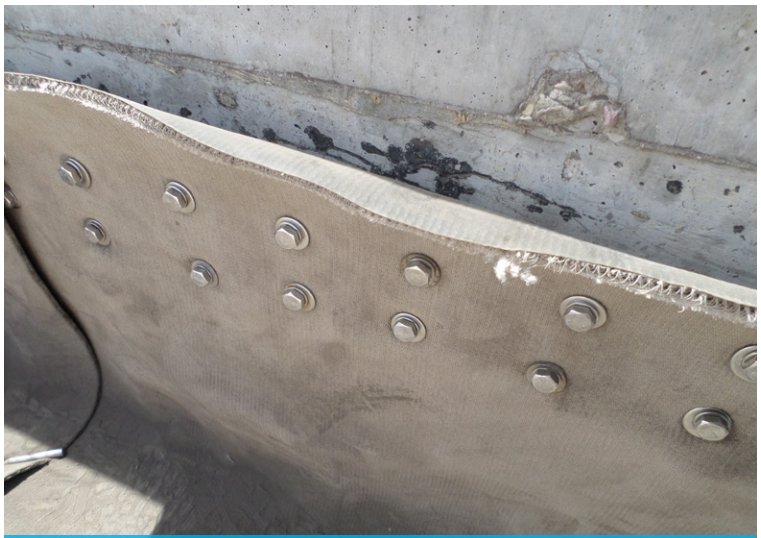
*CC fixed to existing concrete at crest using steel bolts*

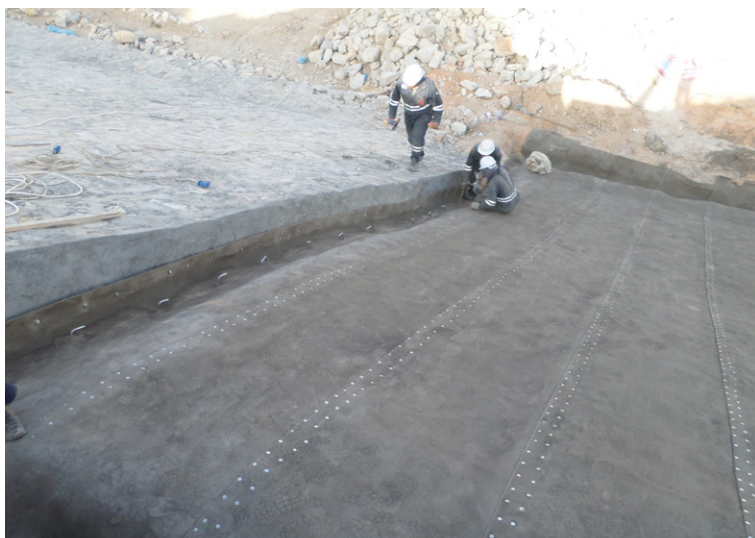
*CC secured with ground pegs and jointed using screws*

Overlaps were thermally bonded using heat guns and rollers, and fixed using stainless steel screws. All anchor trenches were then filled with concrete to prevent water ingress. The CC was hydrated using a hose and water tank and repeated multiple times due to the prevalent dry and hot conditions.

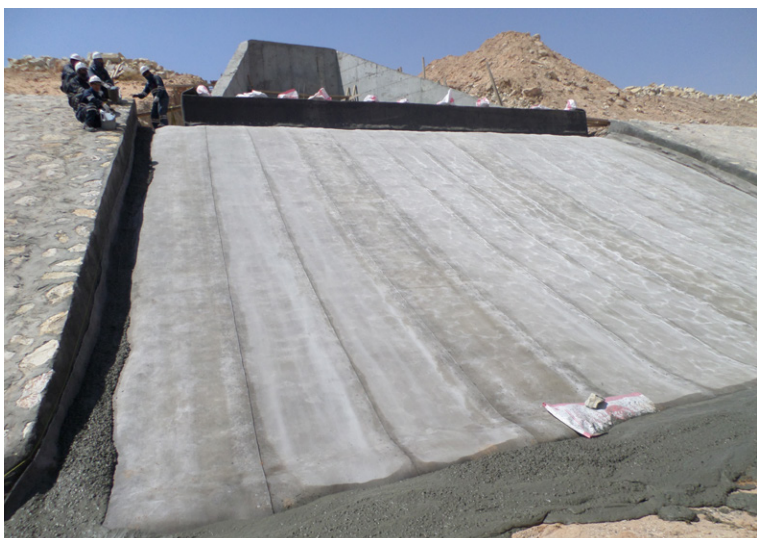
*Anchor trenches backfilled with poured concrete following hydration*
