# **CONCRETE CANVAS®** Concrete on a Roll

## BANK EROSION PROTECTION CASE STUDIES

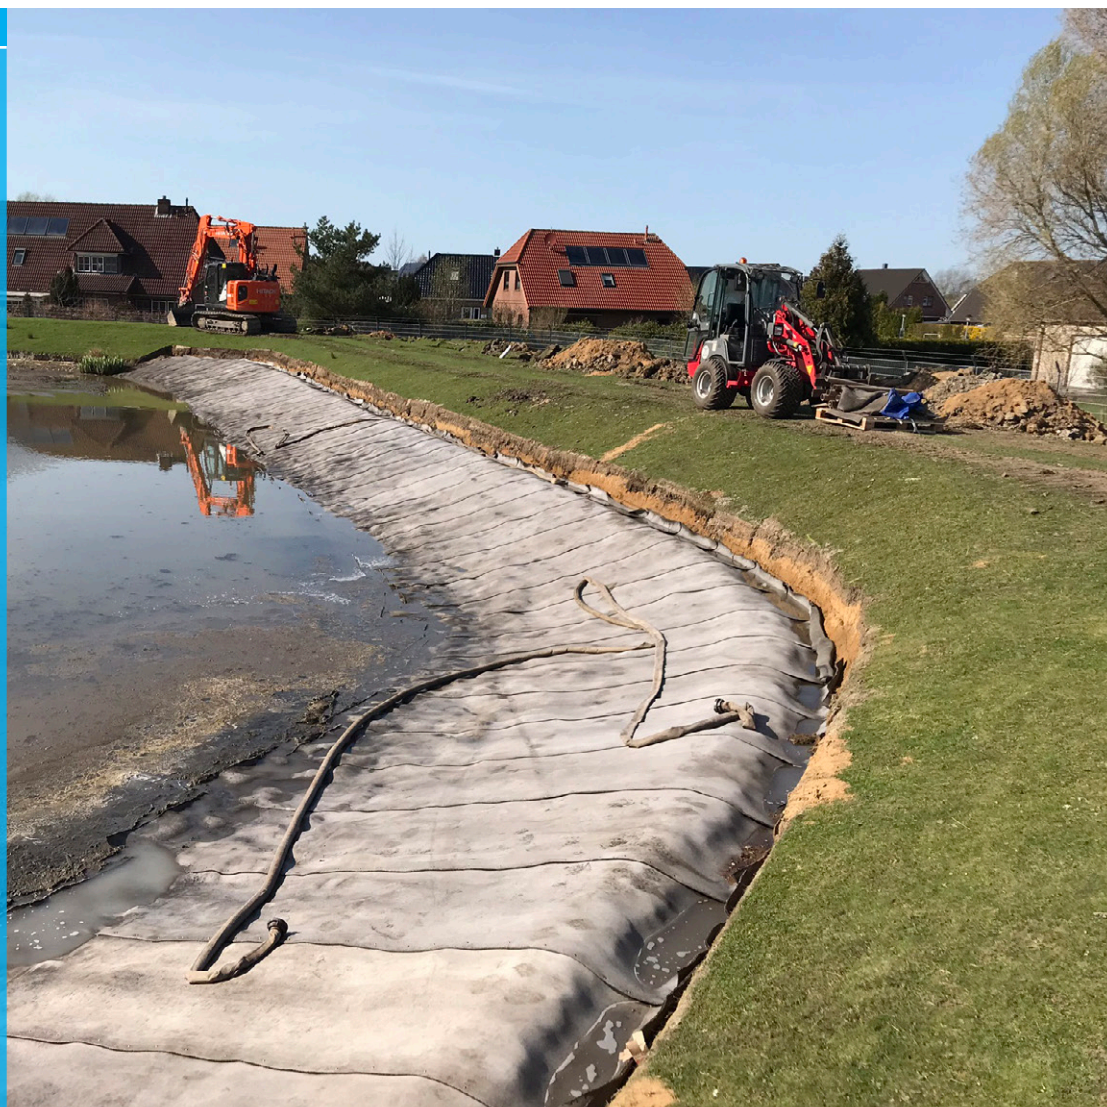
Completed CC installation in Wilster, Germany

In April 2018, Concrete Canvas® (CC) was trialled to provide erosion protection to sections of pond embankment in Wilster, Germany. The pond, owned by the local commune of Wilster (Amt Wilstermarsch), was losing water due to badly eroded sections of embankment. The works were carried out by Jens Maag Lohnbetriebe, with material provided by Beco Bermuller.

A total of 375m² of CC8™ were installed in 7 hours by a team of 4 people with no previous experience of installing CC, and on a site with access limitations. The trial was deemed a success, and the client was very impressed with the speed and ease of installation. The client is now looking into lining the remaining embankments of the pond using CC in the near future.

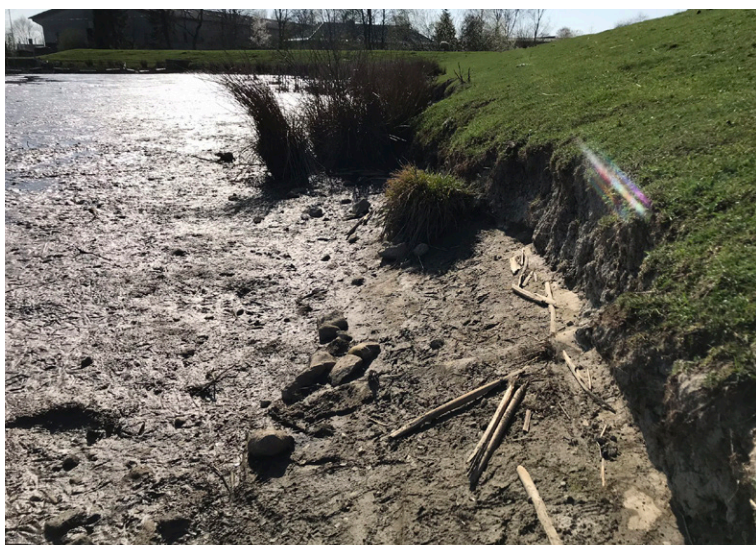
*Section of embankment affected by erosion*

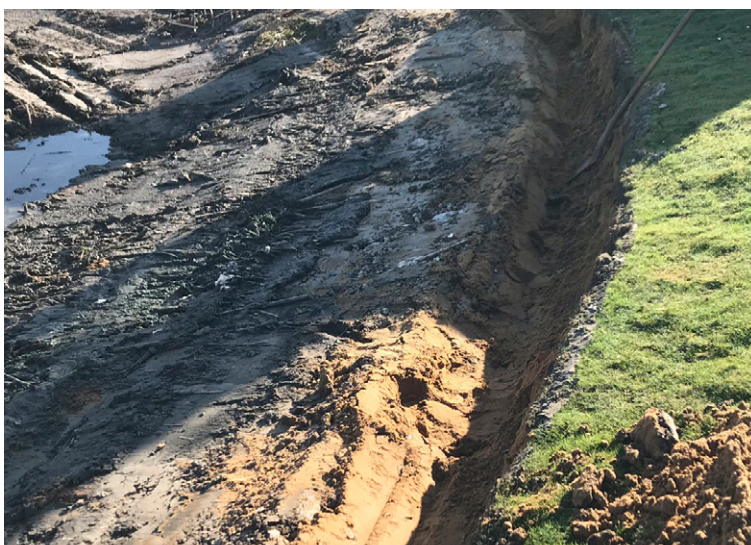
*Clay topsoil removed using a digger & an anchor trench was created manually*

In preparation for the installation, approximately 150mm of clay topsoil was removed from the sections requiring lining. The substrate was then graded to provide a flat, level surface and an anchor trench created at the crest. Batched rolls of CC8™ were delivered to site and laid vertically from crest to toe. Subsequent layers of CC overlapped the previous by 100mm, and were then jointed using 20mm stainless steel screws. 300mm ground pegs were used to fix the CC to the substrate through overlaps at the crest, while Platipus ground anchors were used to fix the material at the toe.

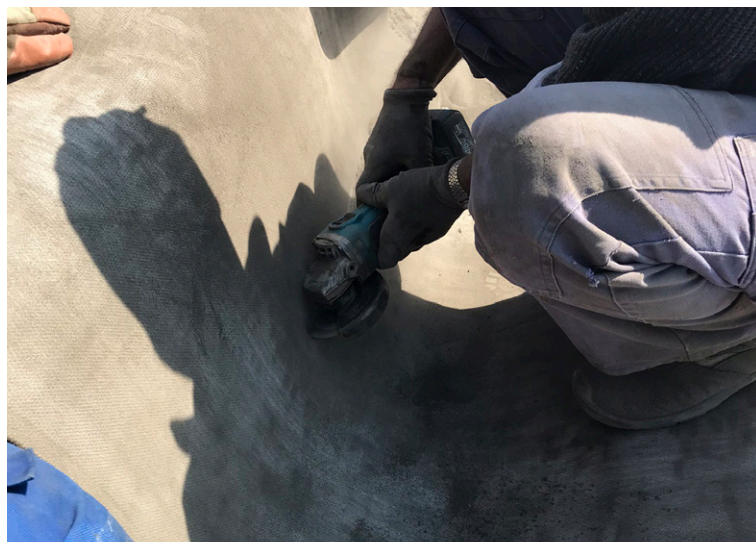
*A disc cutter was used to cut the CC to length*

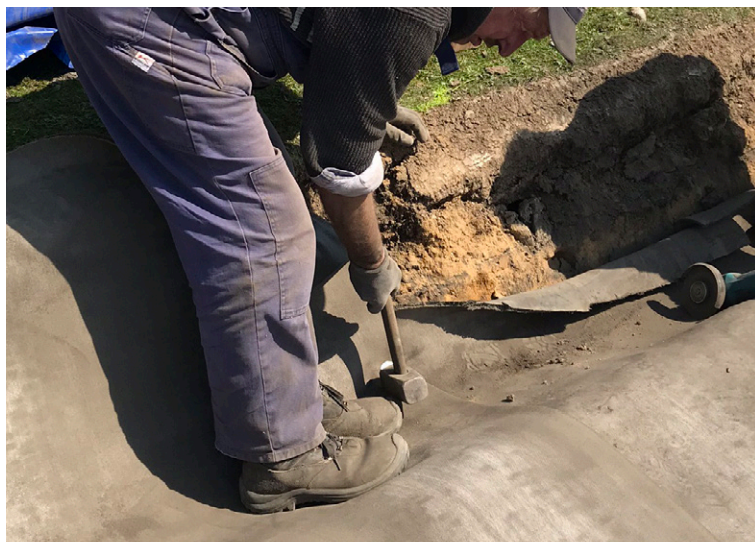
*Ground pegs were used to secure CC at the crest*

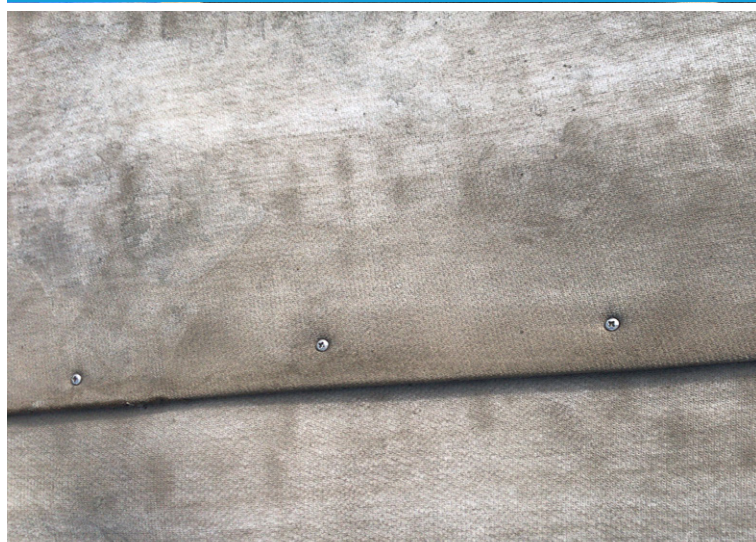
*Overlapped layers were jointed using stainless steel screws*

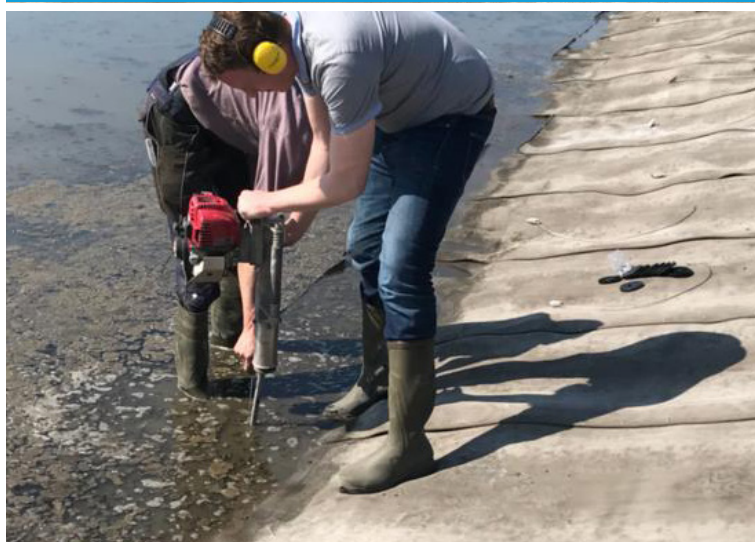
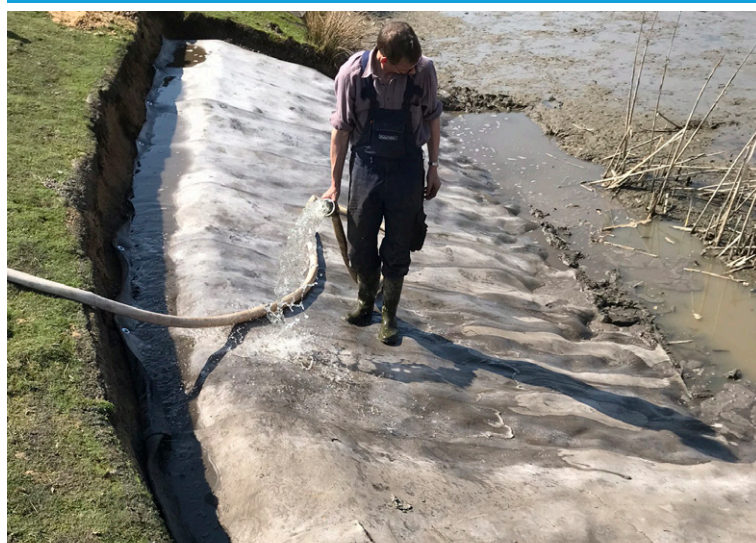
*Platipus ground anchors fixed the CC to the substrate at the toe*

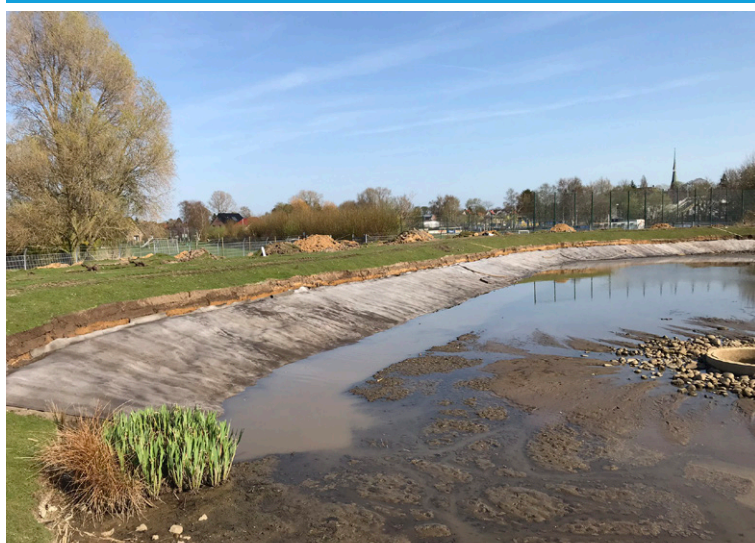
*Completed installation prior to placement of clay top cover*

Following installation, a hosepipe attached to a water pump was used for hydration and a layer of clay was used to cover the CC entirely in order to stabilise the slope from below, preventing further erosion and undermining.
