## BANK EROSION PROTECTION C

In February 2020, Concrete Canvas® GCCM\* was specified for a project in Ras Al Khair, Saudi Arabia, where an erosion prevention measure was required for embankment side walls.

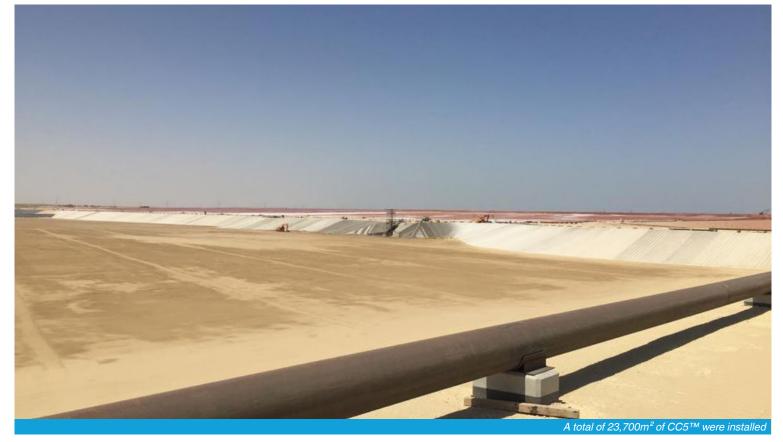
Prior to the installation, the slope was graded and compacted to ensure a smooth surface on which to install the CC. Anchor trenches were then prepared at the crest and toe of the slopes, with the contractor taking care to ensure the excavation of the anchor trenches did not disturb or damage the lining below the top soil.

Bulk rolls of the specified CC5™ were mounted on a spreader beam and suspended from a boom truck at the crest of the slopes for easy deployment. The material was unrolled down the slope, laid vertically with subsequent layers overlapping the last by 100mm. The leading and trailing edges of each length of CC material were captured within the anchor trenches and secured to the substrate using ground pegs at 0.5m intervals. The material below each overlap was hydrated and the upper layer replaced prior to jointing of the overlaps using stainless steel screws applied in a zig zag pattern at 50mm centres. Once each section was completed, the material was hydrated using a water tank and hose with sprinkler head attachment and the anchor trenches backfilled using marl. Where CC terminated against concrete sleepers, stainless steel strips and bolts were used to prevent ingress below the material and ensure a neat termination detail.

A total of 23,700m<sup>2</sup> of CC5™ material were installed by contractor FOQSCO. A team of ten carried out the works over 24 days, with around ten hours worked per day in hot, dry conditions.
