BANK EROSION PROTECTION C

In February 2020, Concrete Canvas® GCCM* was specified for a project in Ras Al Khair, Saudi Arabia, where an erosion prevention measure was required for embankment side walls.

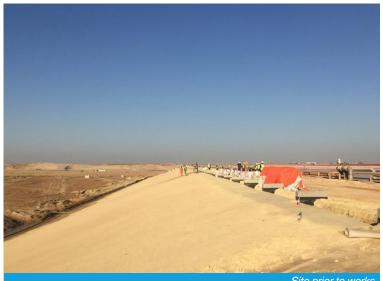
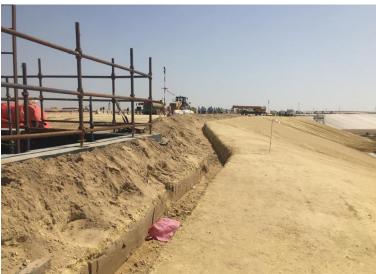
Site prior to works

Prior to the installation, the slope was graded and compacted to ensure a smooth surface on which to install the CC. Anchor trenches were then prepared at the crest and toe of the slopes, with the contractor taking care to ensure the excavation of the anchor trenches did not disturb or damage the lining below the top soil.

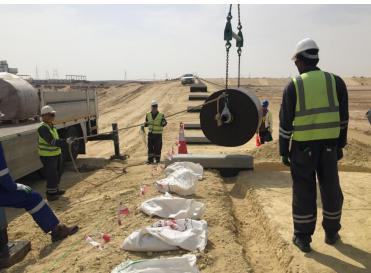
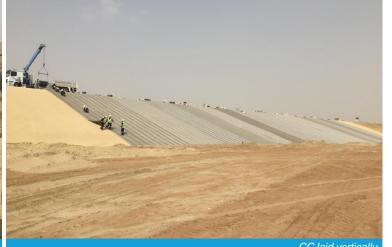
Steel bars and bolts used for CC to concrete terminations

Bulk rolls of the specified CC5™ were mounted on a spreader beam and suspended from a boom truck at the crest of the slopes for easy deployment. The material was unrolled down the slope, laid vertically with subsequent layers overlapping the last by 100mm. The leading and trailing edges of each length of CC material were captured within the anchor trenches and secured to the substrate using ground pegs at 0.5m intervals. The material below each overlap was hydrated and the upper layer replaced prior to jointing of the overlaps using stainless steel screws applied in a zig zag pattern at 50mm centres. Once each section was completed, the material was hydrated using a water tank and hose with sprinkler head attachment and the anchor trenches backfilled using marl. Where CC terminated against concrete sleepers, stainless steel strips and bolts were used to prevent ingress below the material and ensure a neat termination detail.
