CC5™ Bulk Rolls

Mackay, Queensland,
Australia

CC5™ was used to
repair two sections of
a bund where previous
repairs had failed.

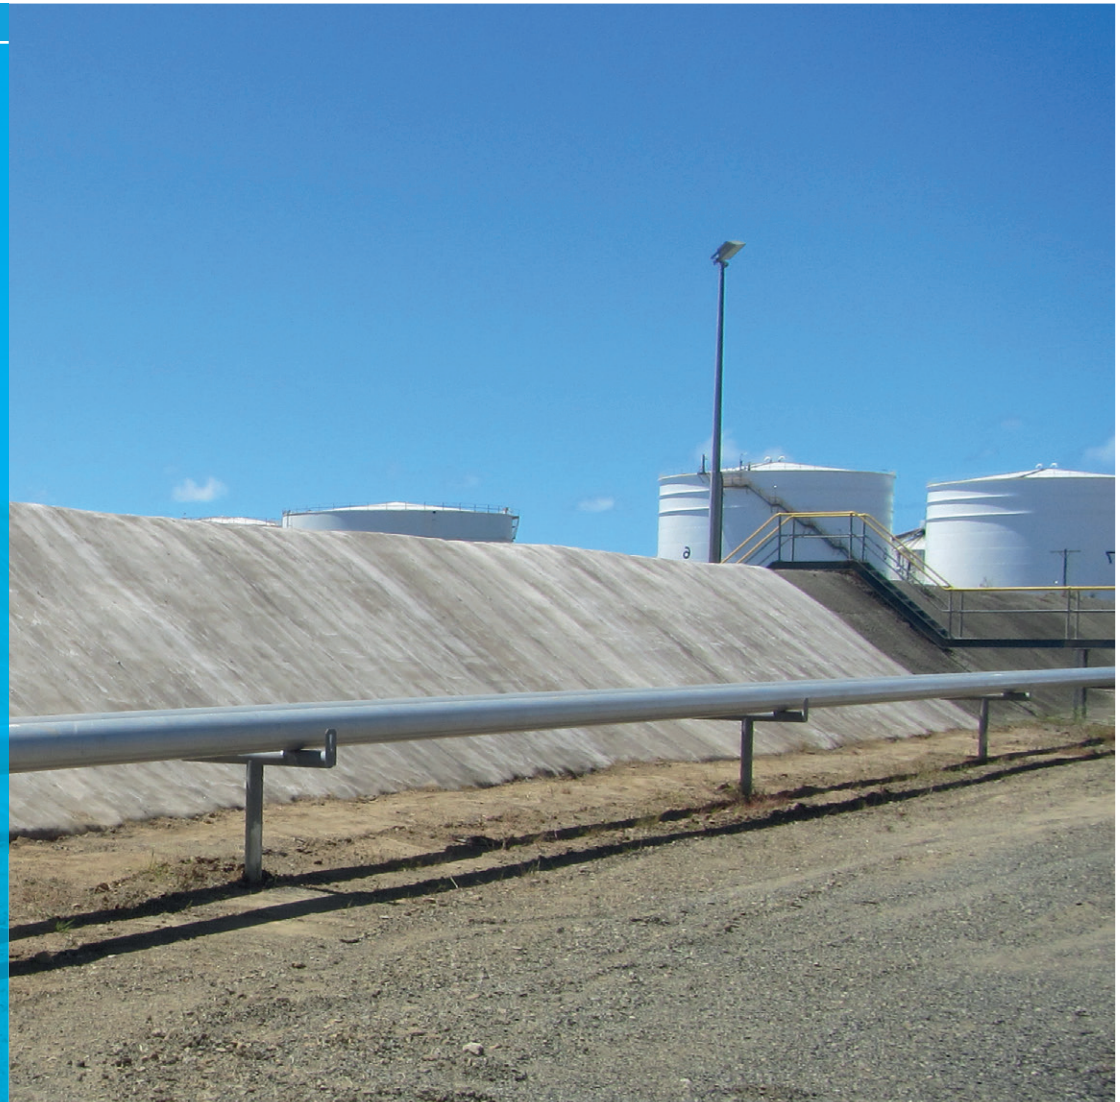
Completed installation

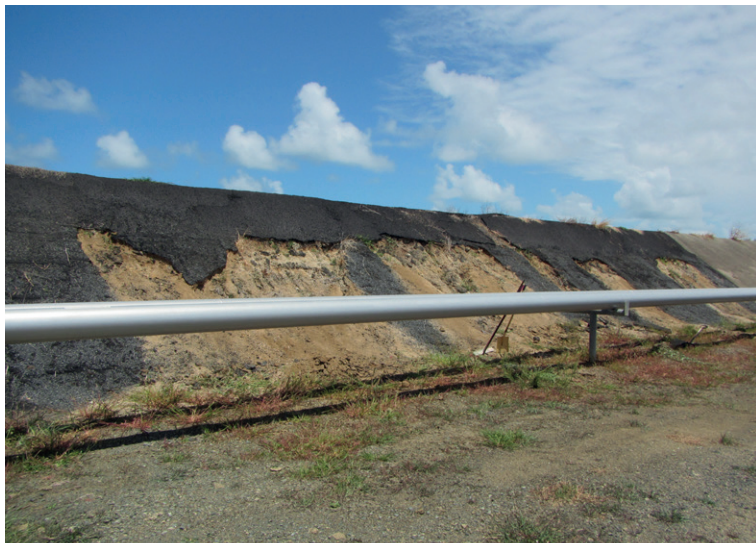
Failed repair

In December 2015, Concrete Canvas® GCCM* (CC) was used to repair two sections of bund at a petrochemical storage facility in Mackay, Queensland, Australia. Previous attempts to repair the bund using shotcrete and bitumen had failed, leading to a loss of integrity of the bund. CC was chosen as it would provide a durable, cost effective bund repair that would be easier to install. Installation was carried out as part of a joint venture between UGL and a major Oil and Gas company. The JV team provided Project, Engineering Maintenance and Asset Management services, with material provided by Burdens Australia.

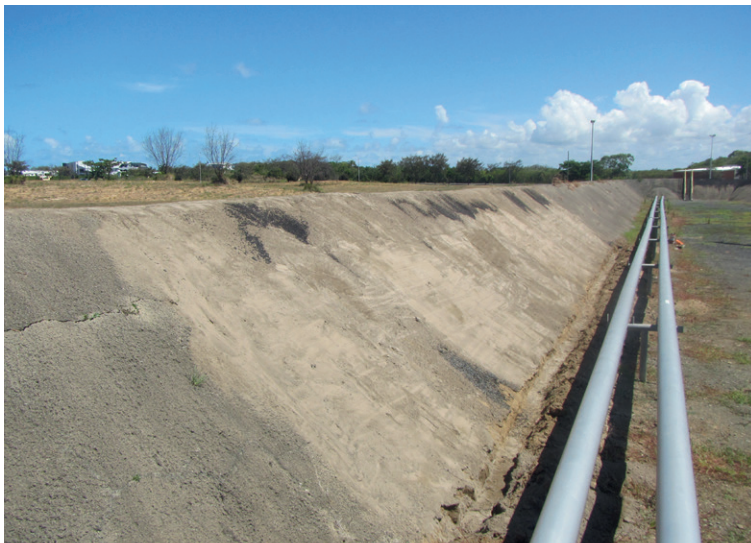
Bund preparation

Vegetation, loose rock and sediment were removed from the bund and any voids filled, to ensure intimate contact between the CC and the substrate. An anchor trench was dug around the inside perimeter of the berm. Bulk rolls of CC5™ were delivered to site and mounted onto a spreader beam hung from a crane. The CC was unrolled transversely across the berm, with subsequent layers overlapping the previous by 100mm. The overlaps were sealed with Sikaflex Tank and jointed with collated screws and concrete nails where necessary. Pegs were used to fix the CC into the anchor trench on the inside and to the ground on the outside of the berm. The anchor trench was backfilled to provide a neat termination. Hydration was achieved using a bowser and hose with spray nozzle attached.

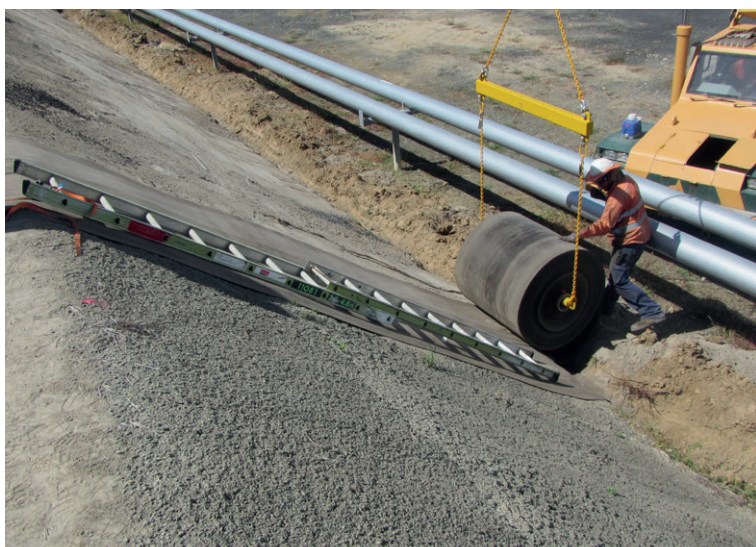
Unrolling CC

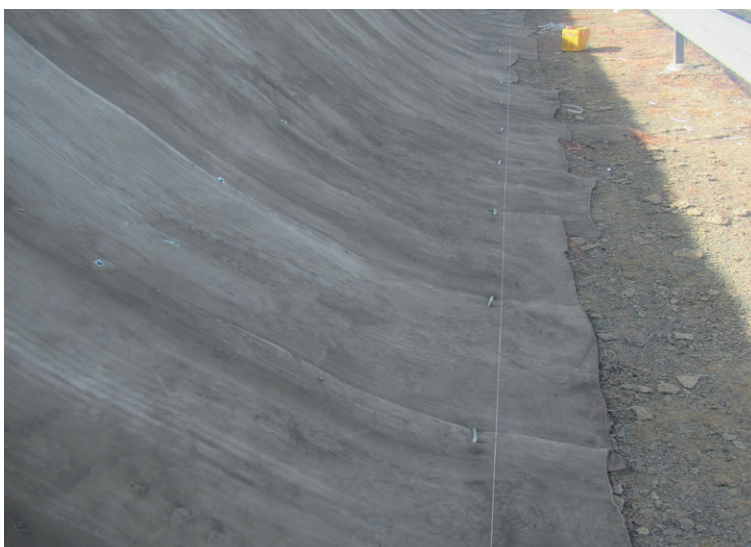
Pegging at toe of slope

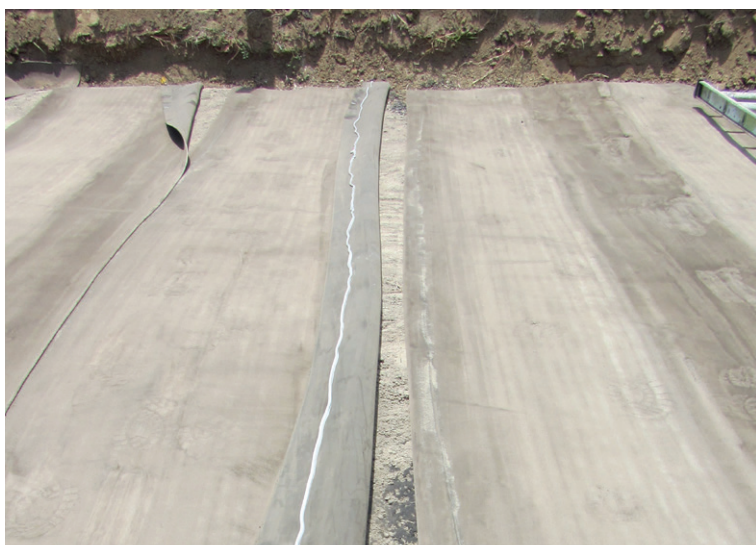
Sealant application

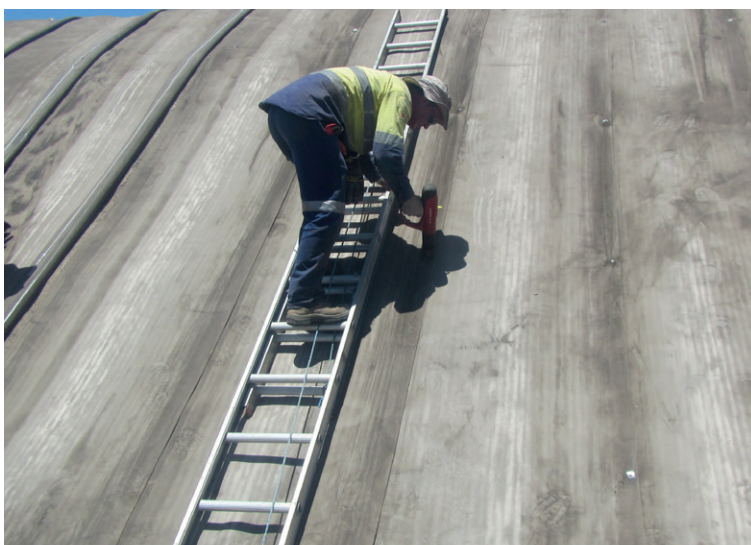
Screwing

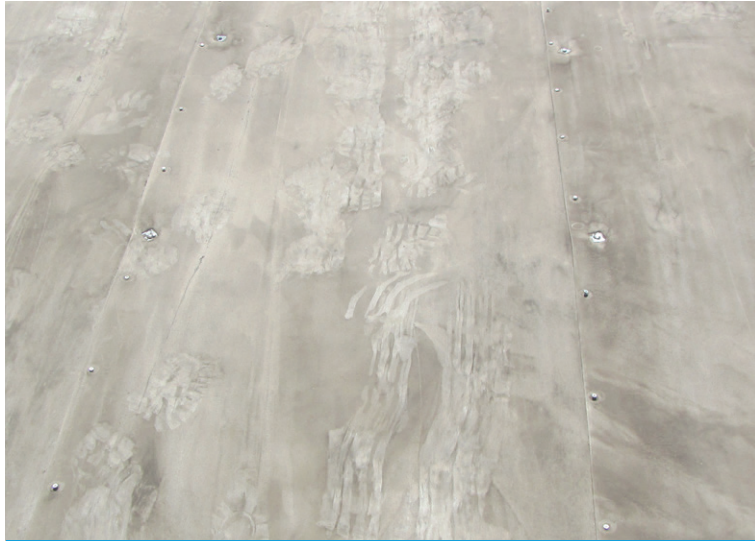
Screws and concrete nails

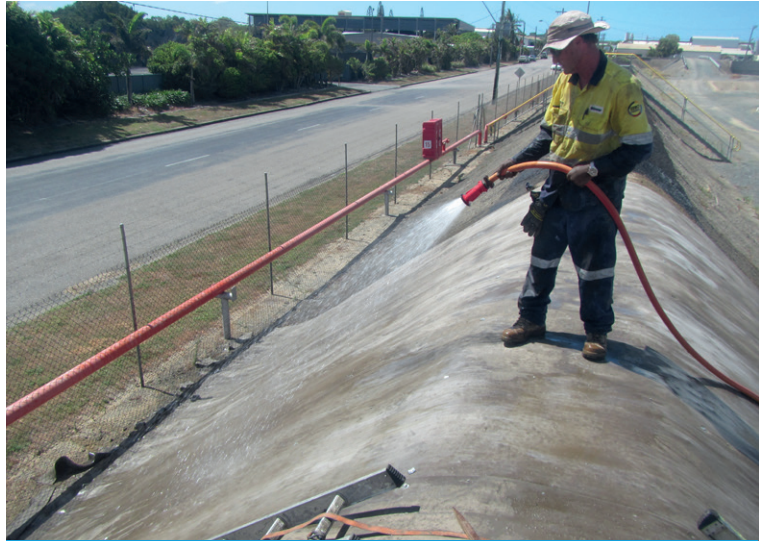
Hydration

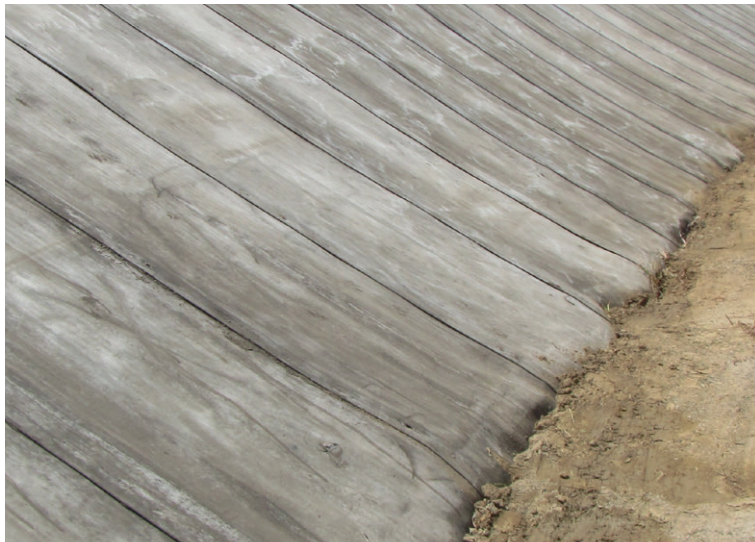
Backfilled anchor trenches

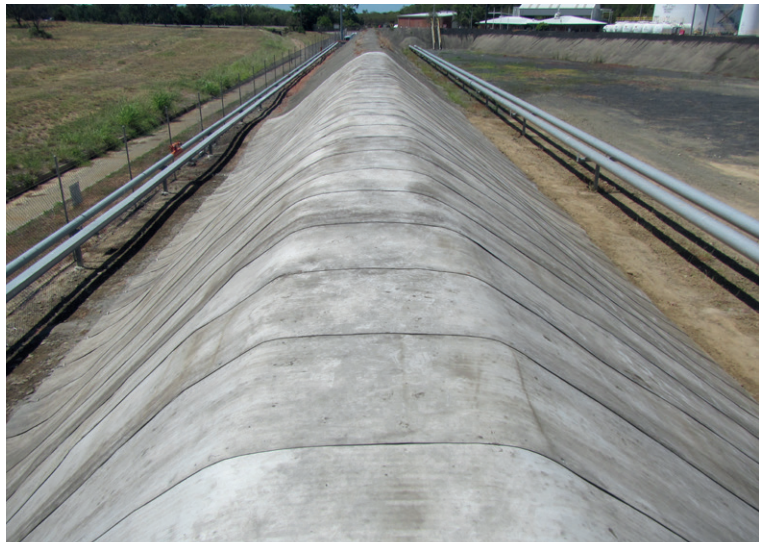
Completed installation

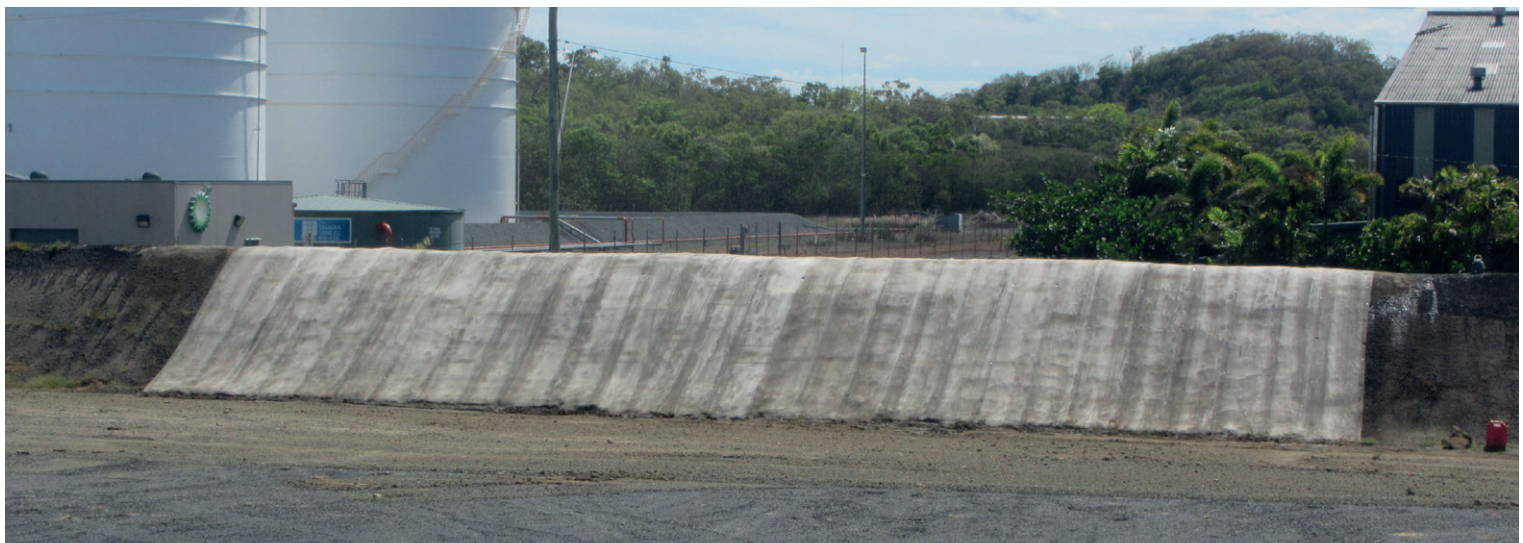
Finished project

1000m² of CC5™ were installed by 3 people in 3 days, compared to 2 weeks required for conventional bund repair methods. The client was very impressed with cost effectiveness of the installation and the contractor appreciated the speed and efficiency using CC.
