## BUND LINING

In May 2015, Concrete Canvas® GCCM\* (CC) was used to line a series of bunds at the Ungani oil field, located in the onshore Canning Superbasin, approximately 150 kilometres east of Broome, Western Australia. The existing bund was subject to weathering erosion causing it to lose integrity and fail to maintain the minimum height required to comply with AS 1940-2004: The storage and handling of flammable and combustible liquids Australian Standard.

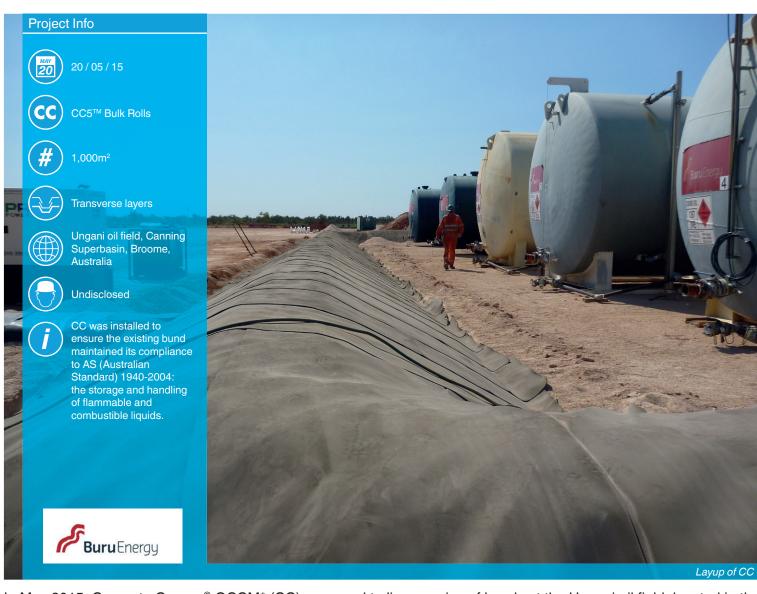
Anchor trenches were cut into either side of the bund before a standard HDPE liner was installed. 5mm thick CC (CC5™) was then unrolled transversely across the bund, with each layer overlapping the previous by 100mm. An adhesive sealant and screws were used to join the material, before hydration using a bowser and pressure hose with spray nozzle. The anchor trenches were backfilled to prevent water ingress under the CC and provide a neat termination.

In total, 1000sqm of CC5™ was installed in just 2 days by 3 people, instead of the 5 allowed for the install. Additionally the client estimated that using CC provided a cost saving of over 30%. The client was very impressed with the product and have already identified a number of sites within their network where they intend to use CC.
