Project Info

CC5™ Bulk Rolls

Far North Queensland,
Australia

CC5™ was specified
to maintain the height
of a bund for licensing
purposes.

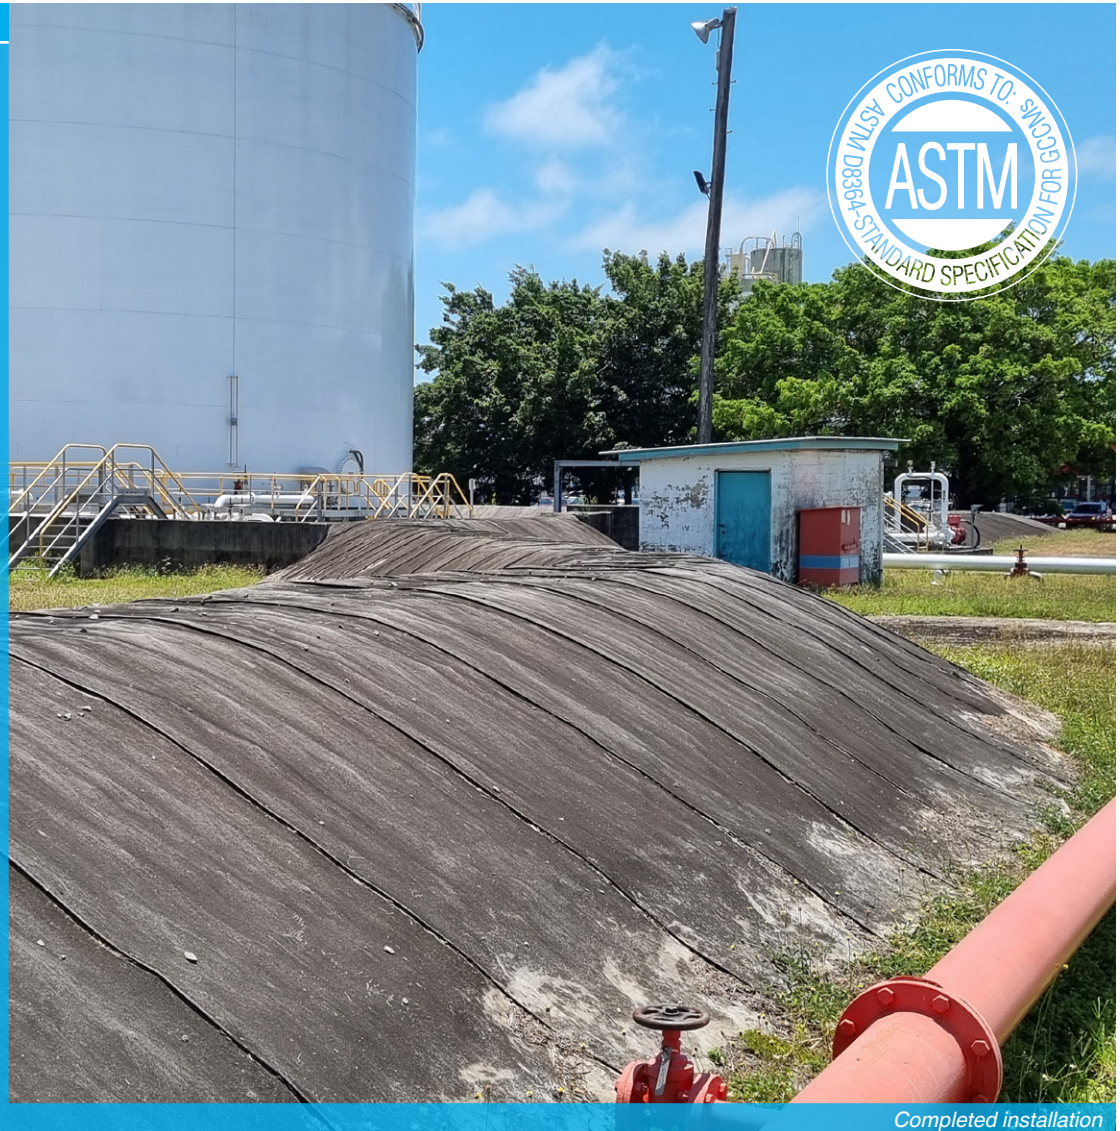
Completed installation

A total of 3,000's m² of CC5™ was installed in 8 days, by a team of 4 labourers and 1 excavator, all working 8 to 10hr days. The project was very successful, as previously the vegetation had to be maintained by a crew of 3 labourers up to once a week: using petrol-powered grass trimmers around hydrocarbon storage tanks. With the installation of CC the maintenance cost has now been reduced to zero and has protected the against weathering erosion, providing clear leak detection visibility, and preventing damage from burrowing animals.
