BUND LINING

In March 2019, Concrete Canvas® GCCM* (CC) was used to provide erosion protection and weed suppression to an existing bund at a major petroleum facility in Ireland. The existing bunds surrounded a series of tank farms storing hydrocarbons as part of the larger offshore facility.

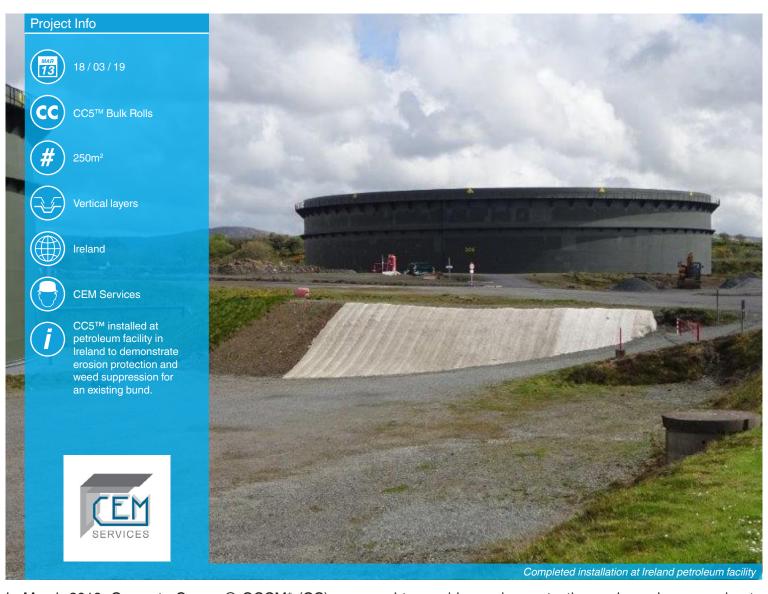
Vegetation was removed from the bund prior to works and any sharp rocks or protrusions were removed from the substrate to ensure a uniform profile. The bulk rolls of CC5™ were dispensed from a spreader beam mounted from a large crane located at the crest of the bund. Each bulk roll was positioned at the toe of the bund and secured within the 150mm anchor trench by the installation crew using 250mm galvanised pegs. The CC was then unrolled back up the bund where it was cut to length using utility knives and secured into the crest anchor trench with additional pegs.

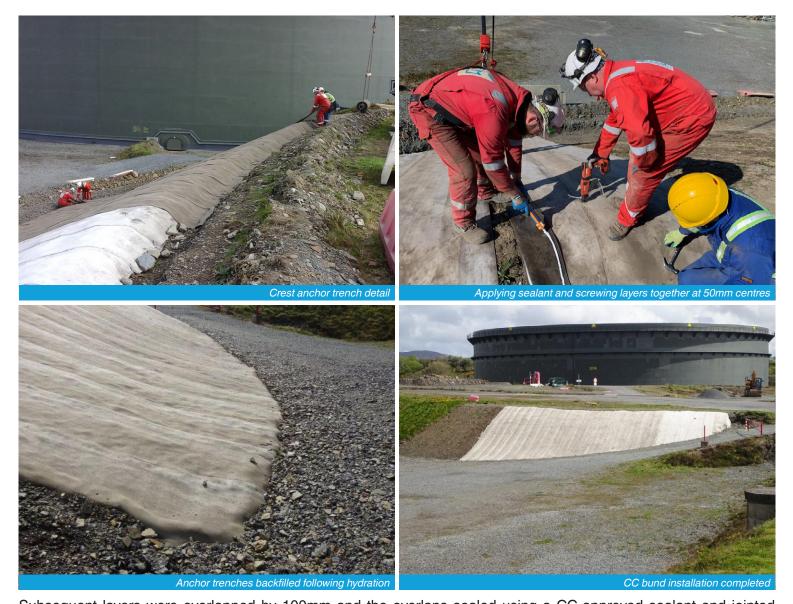
Subsequent layers were overlapped by 100mm and the overlaps sealed using a CC-approved sealant and jointed with stainless steel screws at 50mm intervals using an autofed screwdriver. The sealant created an impermeable joint whilst the screws provided a mechanical bond between overlapped CC layers. Hydration was achieved at the end of the working day using a bowser and pressure hose with spray nozzle attached, after which the anchor trenches were backfilled to prevent water ingress under the CC and provide a neat termination. The installation crew safely navigated the bund area during the installation by utilising a fall restraint system.

In total 250m² of CC5[™] was installed in less than 2 days with a crew of 4 people from CEM Services and will provide long-term erosion protection and weed suppression for the client while providing additional levels of containment and fire protection for the bund area.
