## BUND LINING

In January 2016, Concrete Canvas® (CC) GCCM\* was trialled as an erosion prevention method for a pipe protection berm for a gas pipeline in Abu Dhabi, UAE. The bund was at risk of weathering erosion which could have led to the exposure of the gas transport pipe beneath, risking infrastructure and environmental damage. Other conventional methods, such as Bitumen, can quickly degrade under high levels of UV exposure and can have a huge environmental impact. In addition there is risk of wildlife damage, to which CC would be much more resistant. The works were carried out by M/s OQC for M/s GASCO.

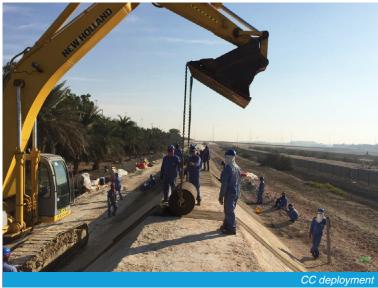
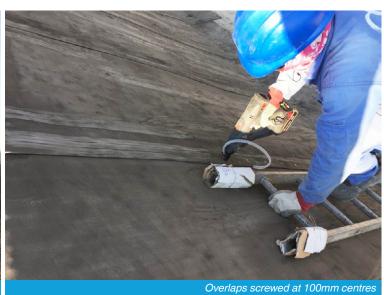
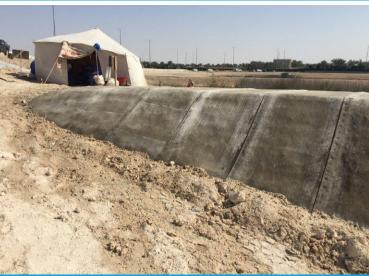
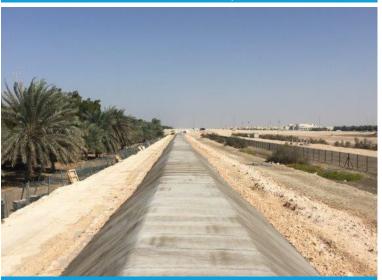
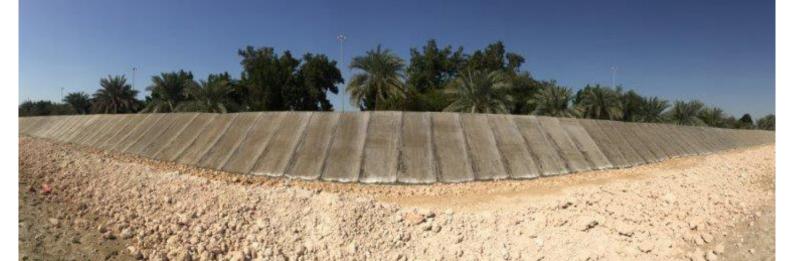
The bund was compacted using the bucket of an excavator before bulk rolls of CC5™ were delivered to site. The rolls were mounted onto a spreader beam and hung from plant equipment before being deployed transversely across the berm, with each layer overlapping the previous by 100mm. Sealant was used to increase the impermeability of the overlap and collated screws were inserted at 100mm centres to joint the material. A 3000 gallon water truck was used to hydrate the material. Due to the high temperatures and arid climate, hydration was undertaken hourly.
