CC5™ and CC8™ Bulk Rolls

Undisclosed, Oman

CC8 and CC13 were used to line and prevent erosion of a water lagoon bund, line a drainage channel and create holding pits for excess water.

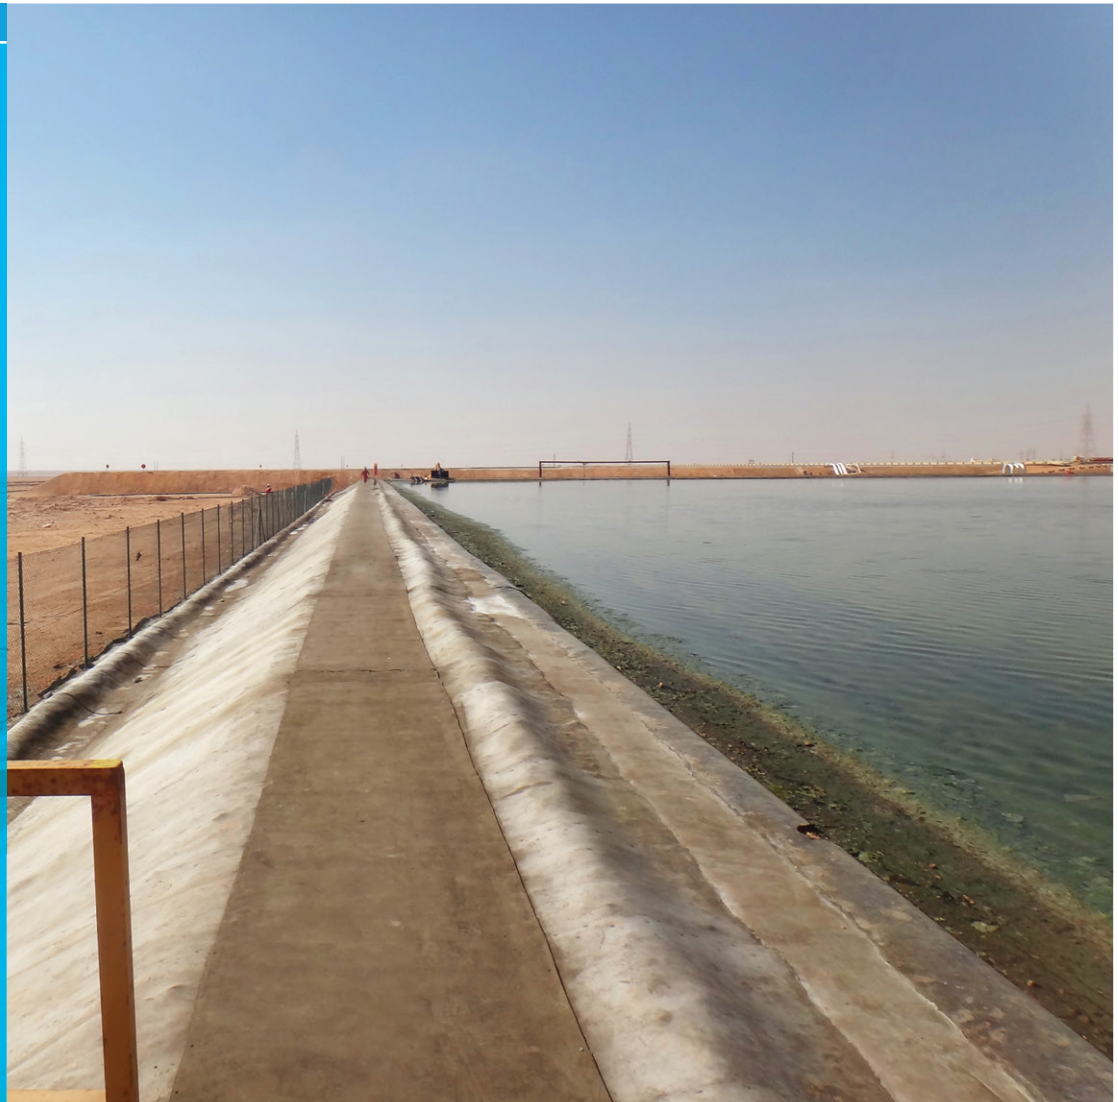
Completed installation in Oman

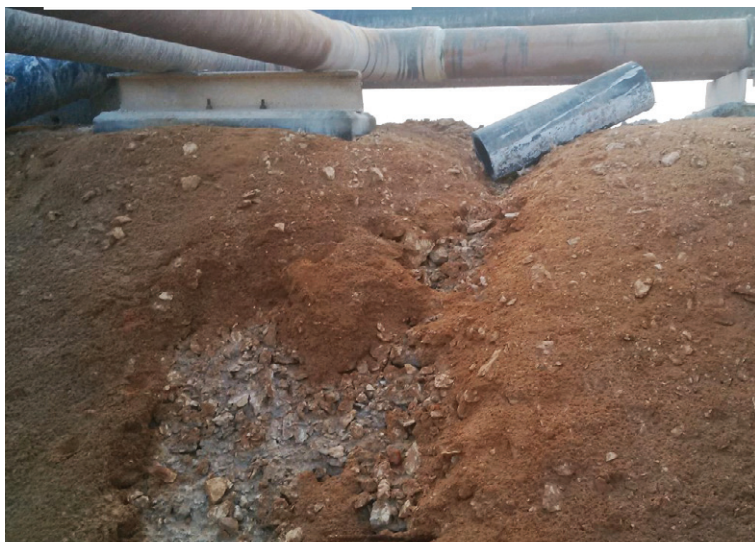
The bund was severely eroded in some areas prior to works

The bund wall was graded and erosion damage repaired to ensure there would be no voids under the CC. On the north side of the lagoon the bund was raised by 500mm to repair extreme erosion and increase the lagoon capacity. A drainage channel was constructed at the base of the bund by creating a small berm, and an anchor trench was cut into the top of the berm.

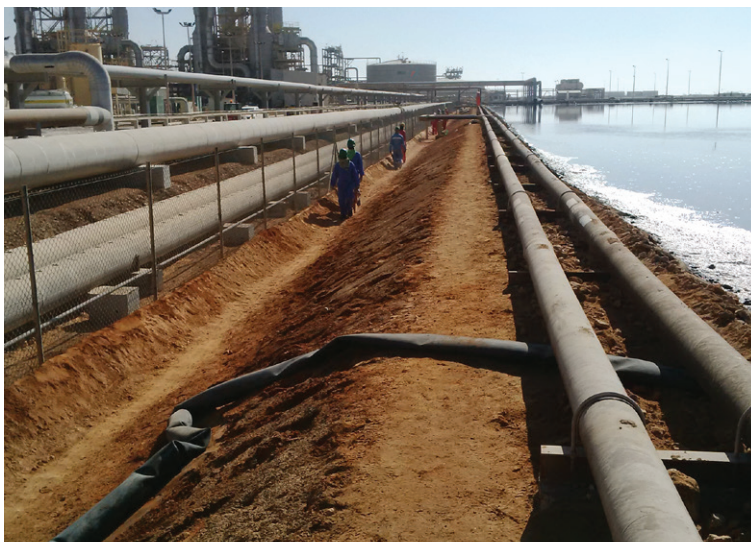
Pipework on the northside of the lagoon prevented plant access

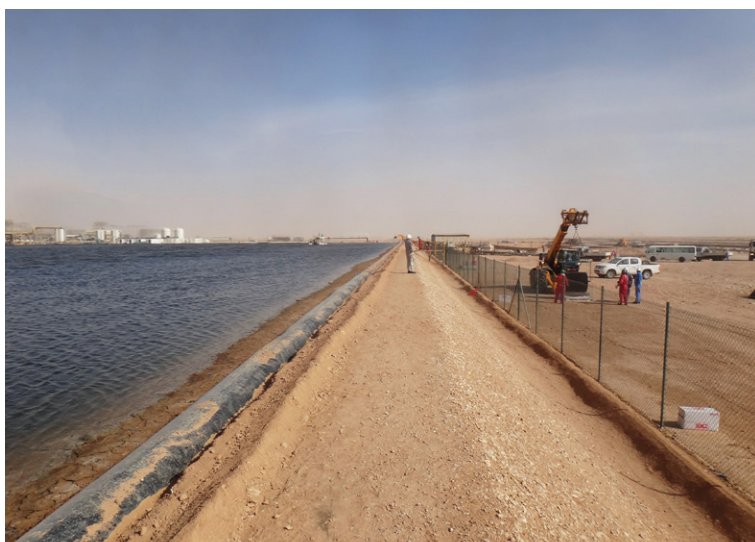
The bund was graded prior to installation

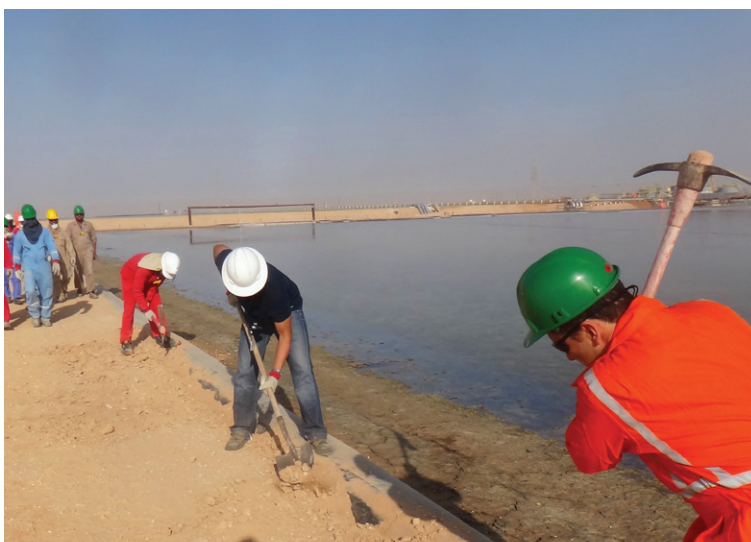
An anchor trench was created prior to installation

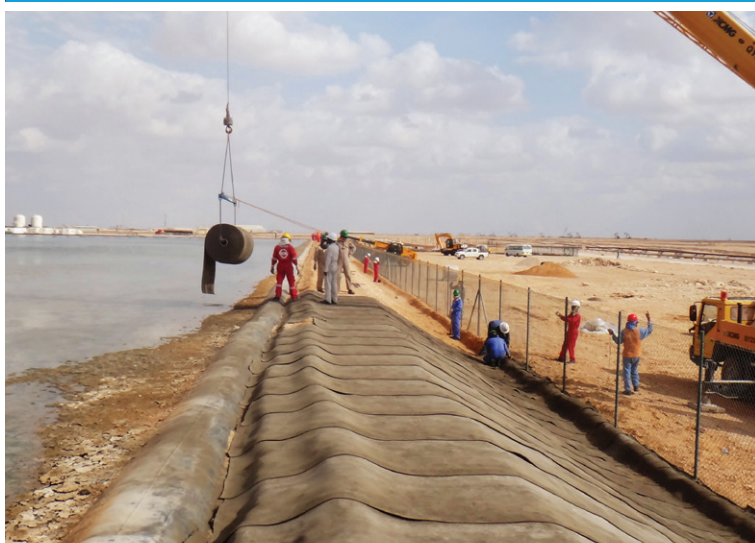
Bulk rolls were mounted on a spreader beam for easy dispensing

29 bulk rolls of CC8™ and 42 bulk rolls of CC5™ were delivered to site. Where weather and access allowed, the bulk rolls were mounted onto a spreader beam hung from a telescopic handler and unrolled down the berm and cut to length with a utility knife. On days where the wind was too strong or in locations where there was no plant access, the CC was unrolled on the flat and cut to specific profile lengths then transported to the berm by hand. The leading edge of the CC was placed into an anchor trench, unrolled down the berm and across the drainage channel at the toe. Each layer of CC was overlapped by 100mm, and overlaps were then sealed and jointed with an offset double row of screws applied at 200mm centres with an auto-fed screw driver. Following installation, hydration was given using a 45,000L water truck and hose. At 5 locations around the berm, water collection pits were created to collect the water carried by the drainage channel; these were lined with transverse layers of CC. Where pipes couldn't be lifted, smaller sections of CC were cut to size and fitted around the pipes, with sealant used to create an impermeable joint.

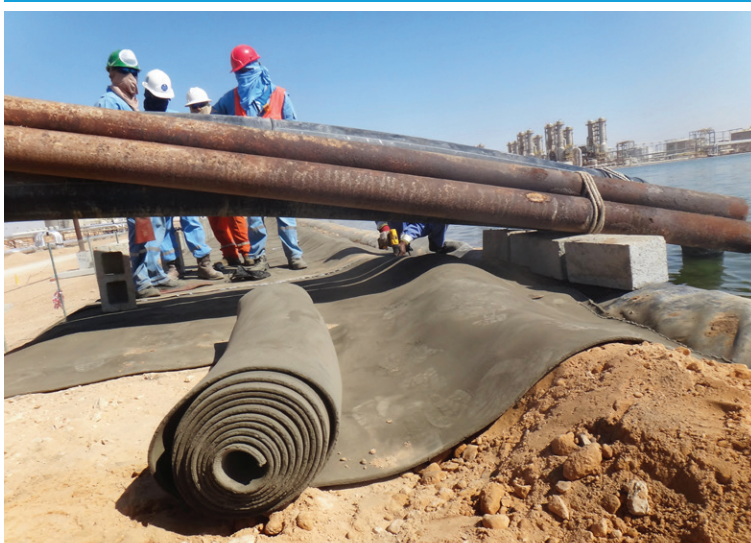
A pre-cut piece of CC being laid under existing pipework

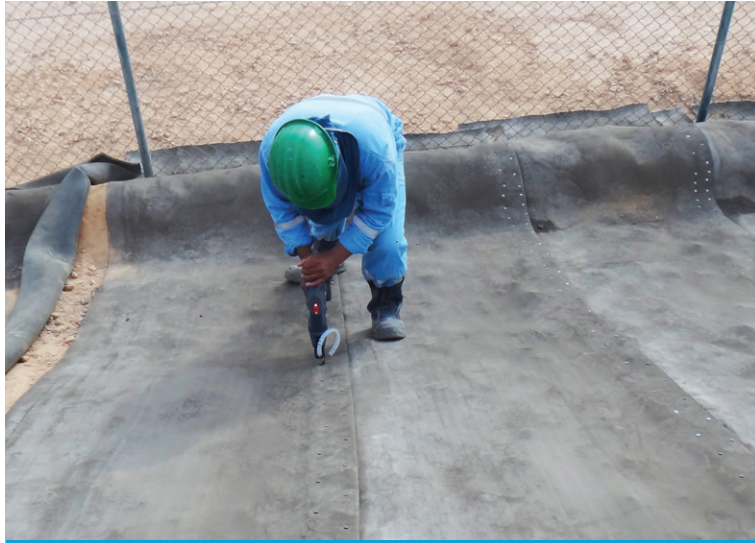
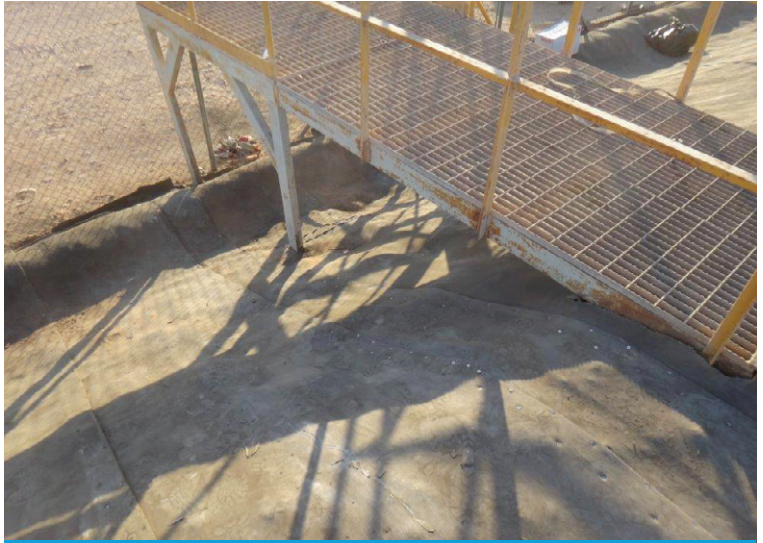
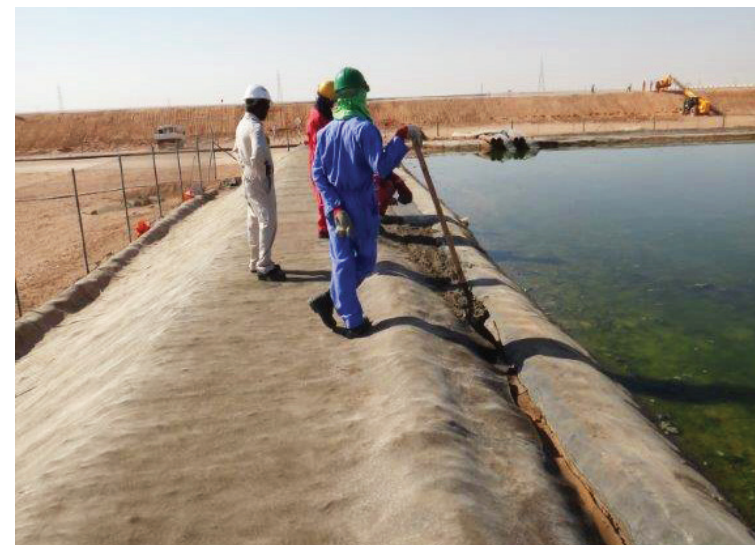
The CC was jointed with screws

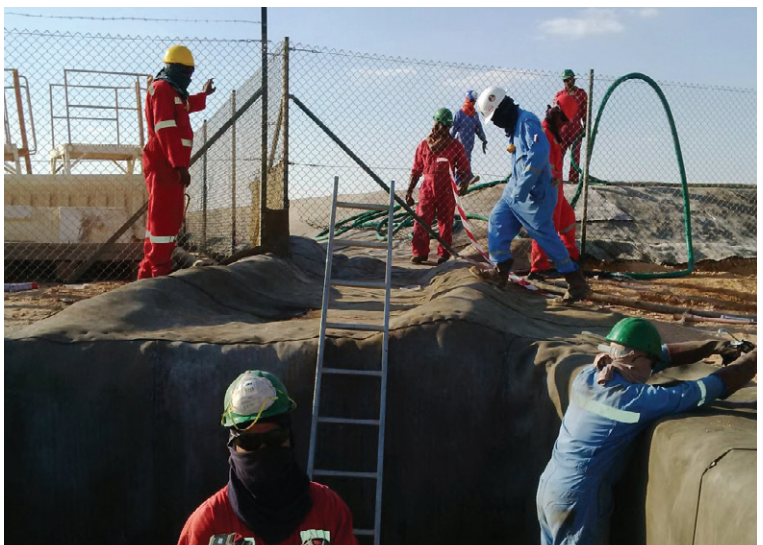
The CC was cut to shape accomodate existing infrastructure

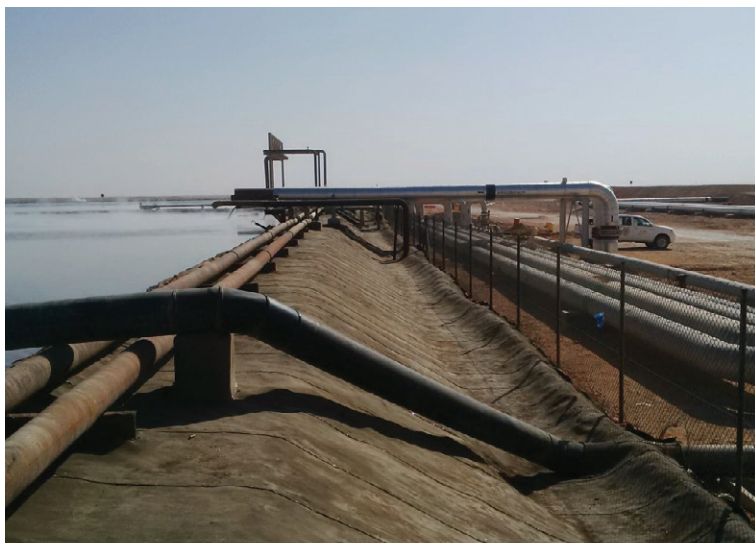
The CC edges were buried in pre-dug anchor trenches

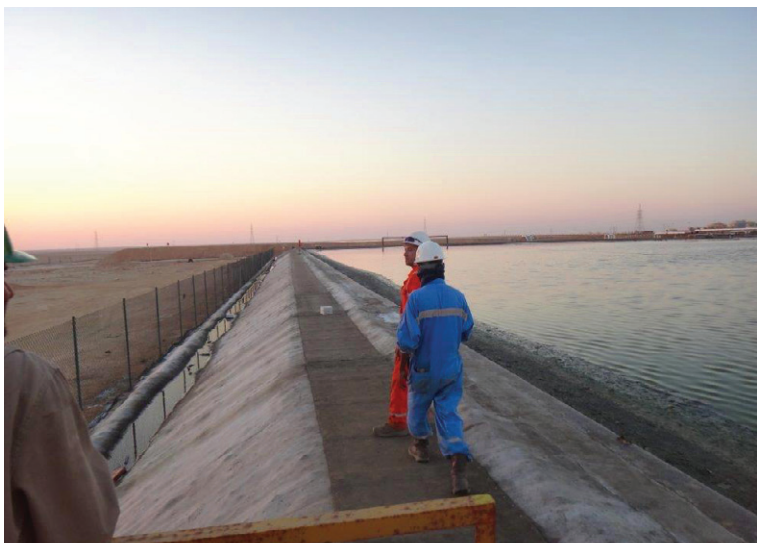
Five water collection pits were created

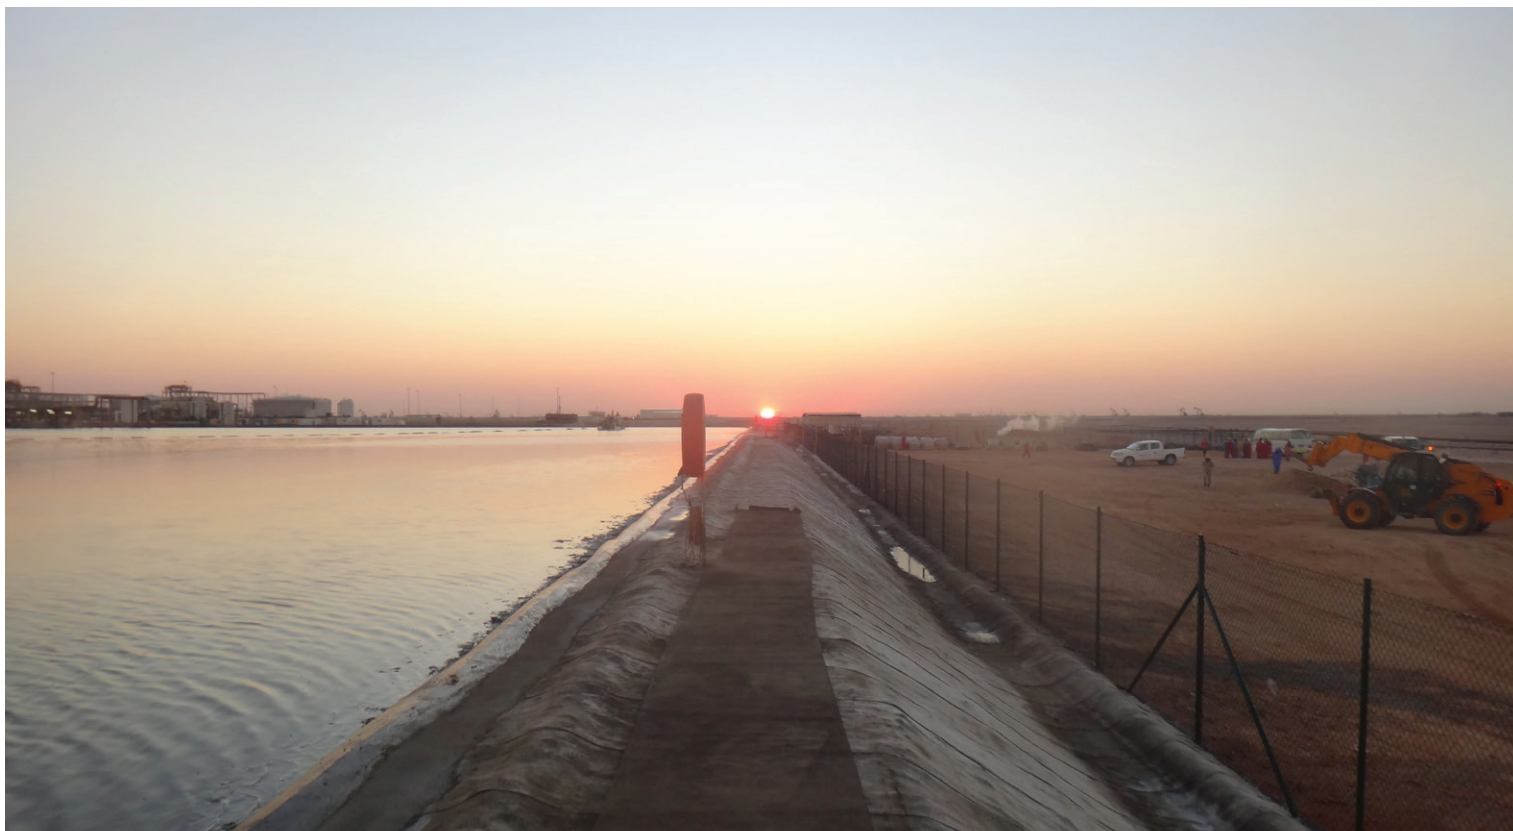
*Completed installation*

A total of 12,000m² of CC were installed at rates of up to 1500m²/day. The installation was carried out over 14 days by a team of 14 people, in high temperatures and difficult environmental conditions. The installation has directly led to CC being specified on two further projects.
