CC5™ Bulk Rolls

Mount Vernon
Washington, USA

Western Refinery
Service (WRS)

CC5™ was used as a
hard armour capping
for a secondary
containment berm

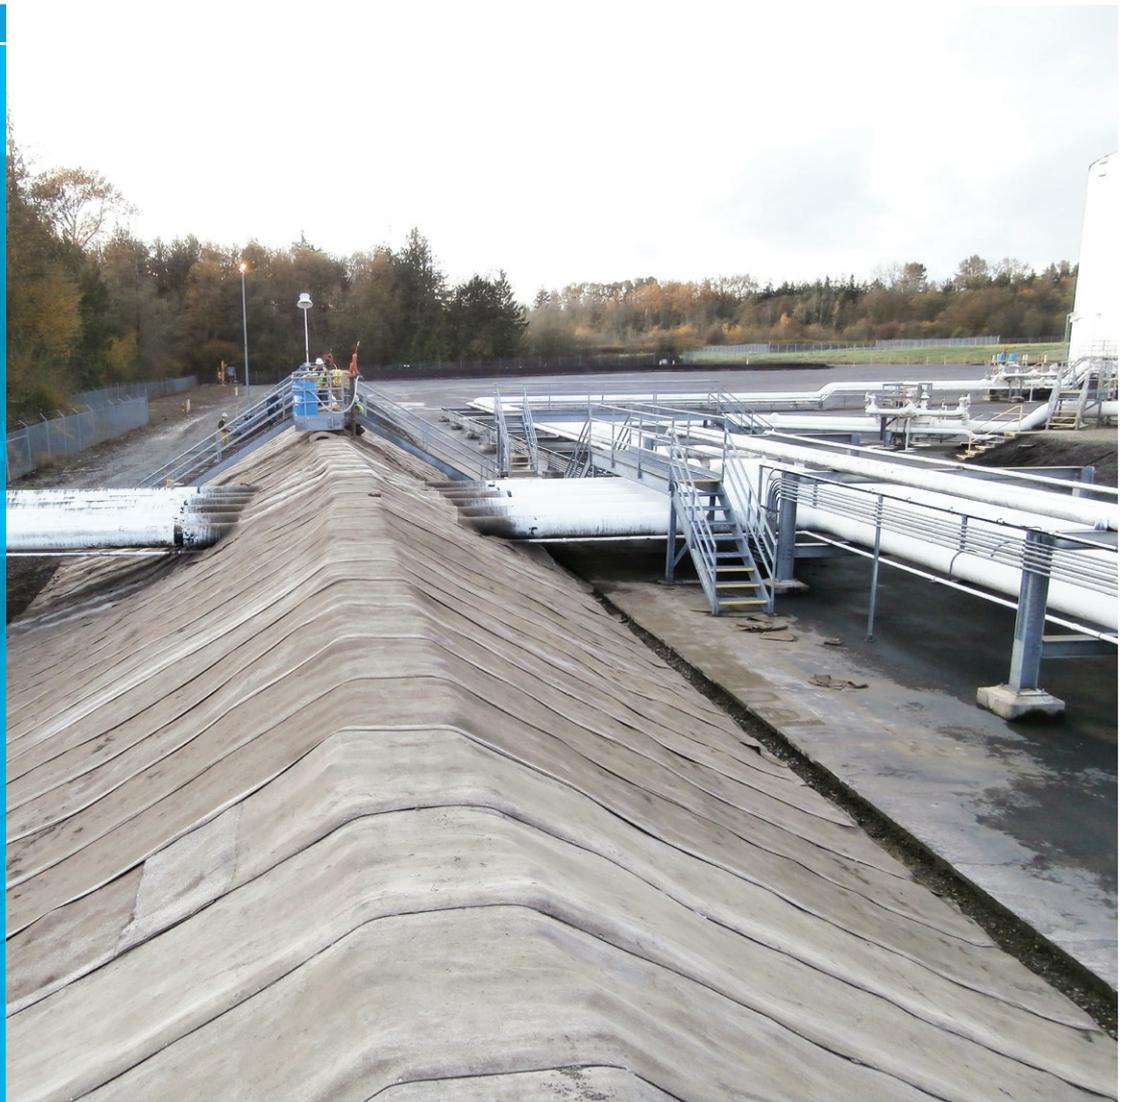
Completed section of bund

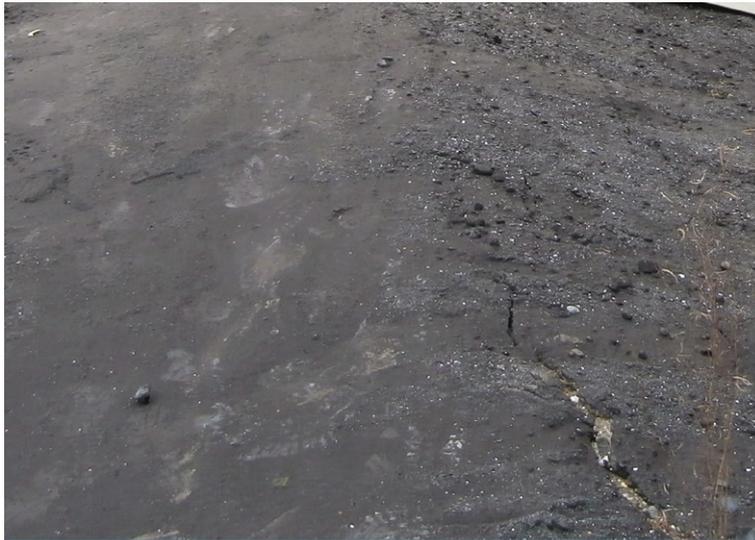
Cracked asphalt

Industry safety protocols state that berms must maintain a minimum height in order to provide effective secondary containment. Previously, asphalt had been used to protect the berm, however this incurred high maintenance costs due to re-coating every 5-7 years to repair cracking, as well as patch repair work throughout the year. CC has a 50 year life-span and requires little to no maintenance, promising significant cost savings. Additionally, CC offers hydrocarbon resistance to BS:14414, as well as UV resistance and weed suppression characteristics which suppress growth, reduce maintenance costs, and prevent the fire hazards that vegetation can pose.

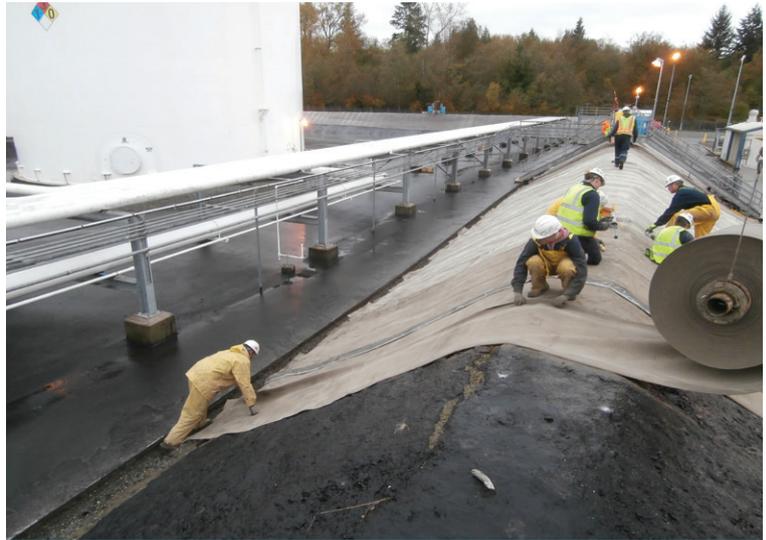
Spooling the CC down the bund

Bulk rolls of CC5™ were placed at the crest of the berm and unrolled down one side, and then the other. This process was repeated along the berm, with a 100mm overlap created between layers, which was sealed with Sika 1-A sealant, and screwed using 20mm self tapping screws at 300mm intervals. On the inside of the bund, the CC edges were placed into an anchor trench and captured with concrete paving. On the outer edges, masonry bolts were used to fix the CC to the existing concrete infrastructure.

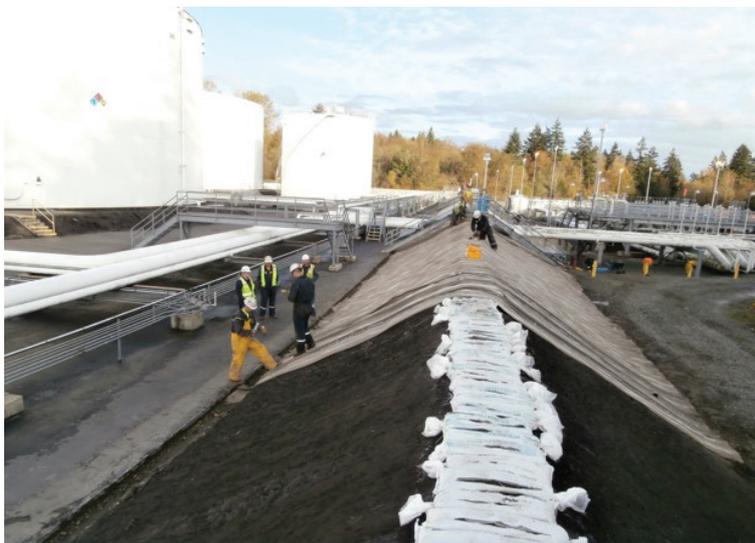
Using sandbags to increase the height of the berm

In areas where the bund had eroded to the extent it no longer met the height requirements, sandbags were used to fill any voids before the CC was deployed. Infrastructure such as pipework was easily accommodated due to the flexibility of CC; holes were cut for the pipes, and where needed, an extra layer of CC was fitted around them and sealed. The CC was hydrated using a high volume mounted hose attached to a water hydrant.

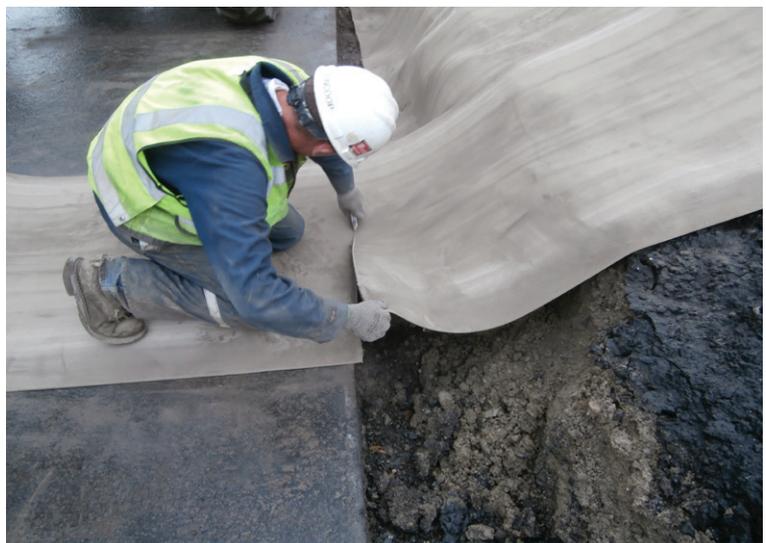
Cutting the CC to length with a utility knife

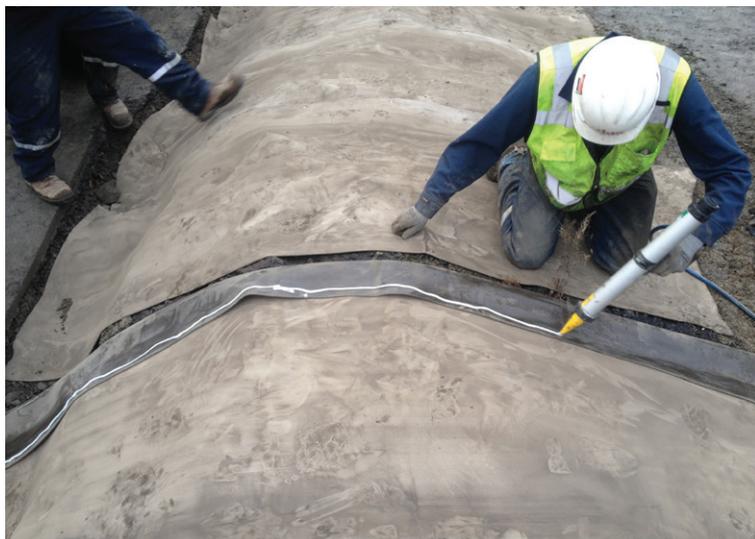
Sealing the overlap with Sika 1-A sealant

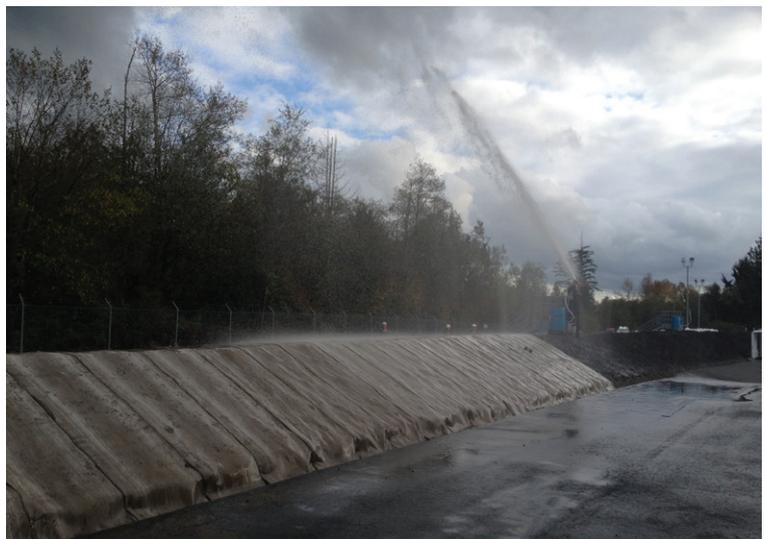
Hydration from the water mains

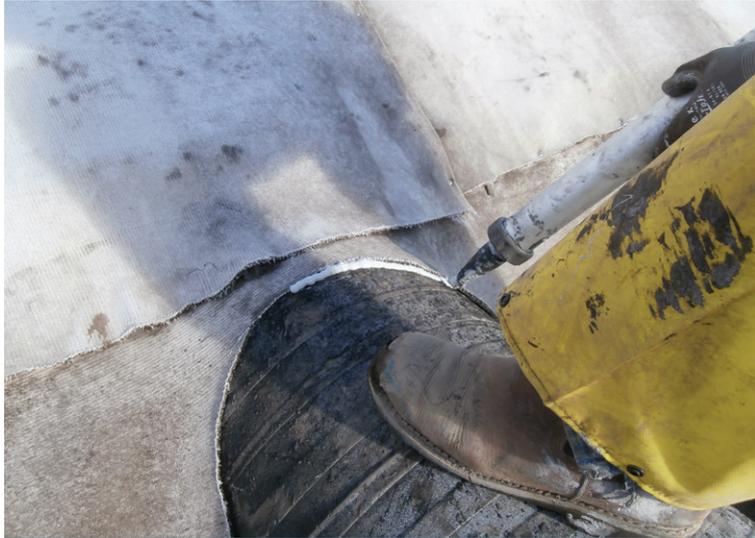
Sealing around piping

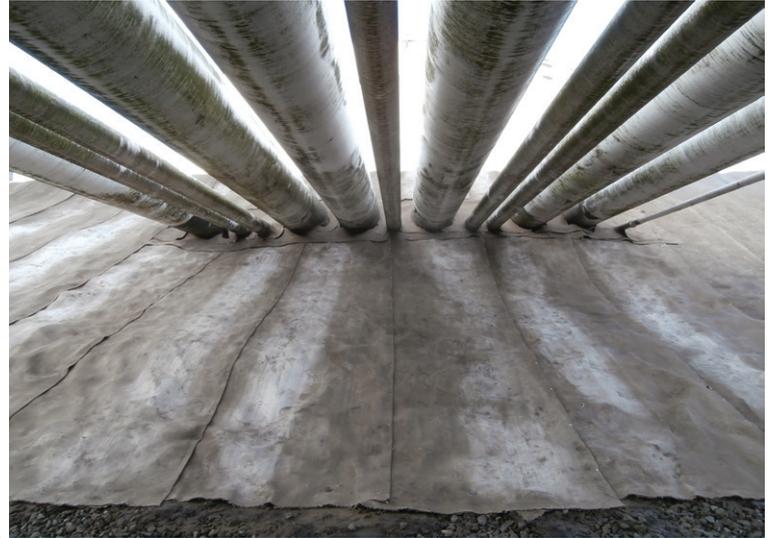
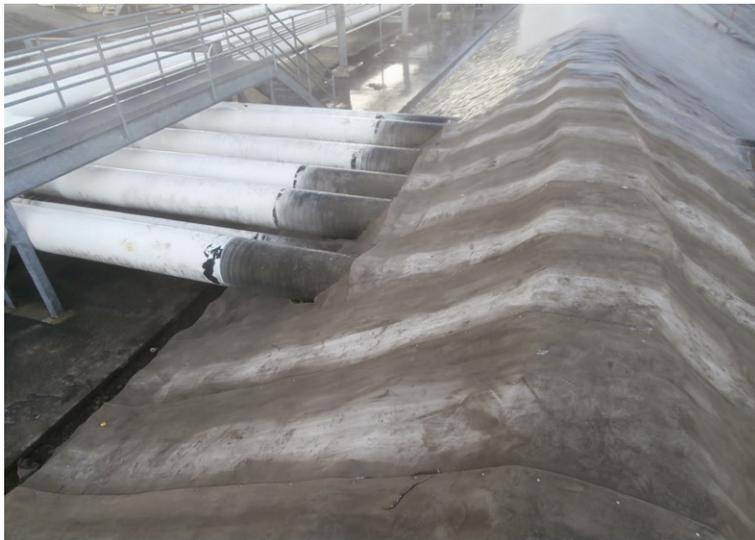
Piping detail

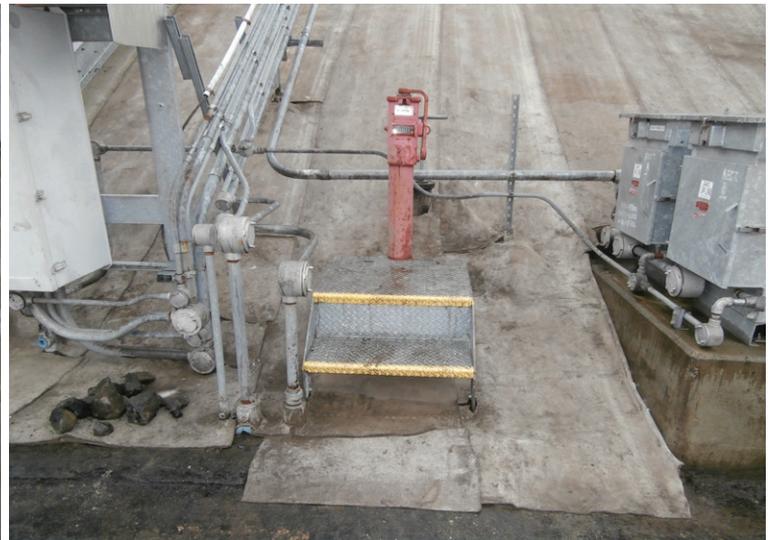
CC accomodating infrastructure

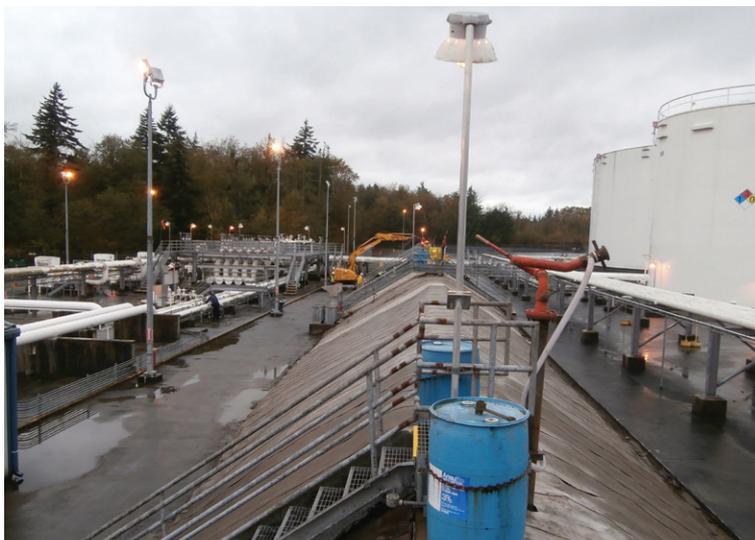
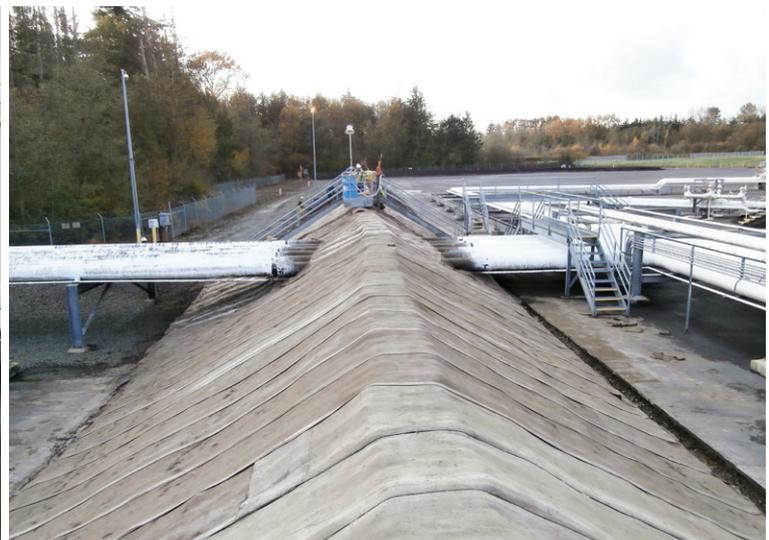
The finished installation

5,200m² of CC5™ were installed by a team of 8 in just 7 days. The completion of this project has resulted in drastically reduced maintenance costs, improved impermeability and improved fire resistance of the berm. Infrastructure, corner details and pipe protrusions were simple to accommodate resulting in an easy and rapid install. The client has said they are “very happy” with the outcome of the project and they are looking to install CC on other bunds in their vast oil and gas network.

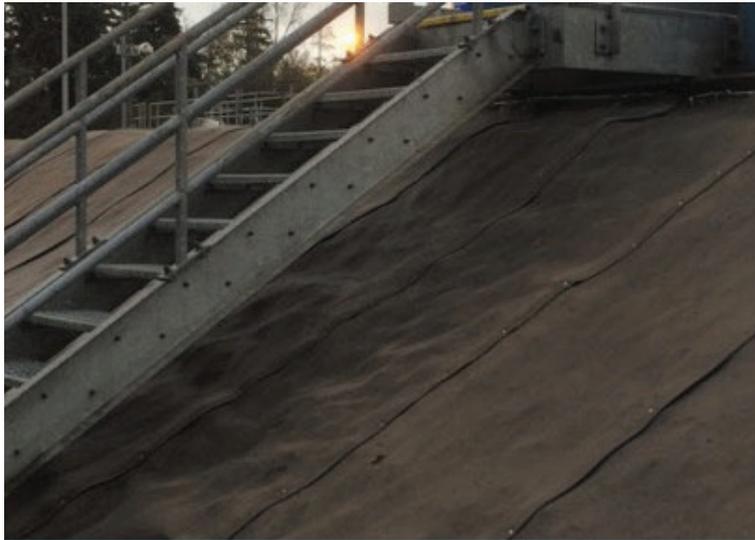
Stair detail
