# CONCRETE CANVAS®

## BUND LINING CASE STUDIES

## Project Info

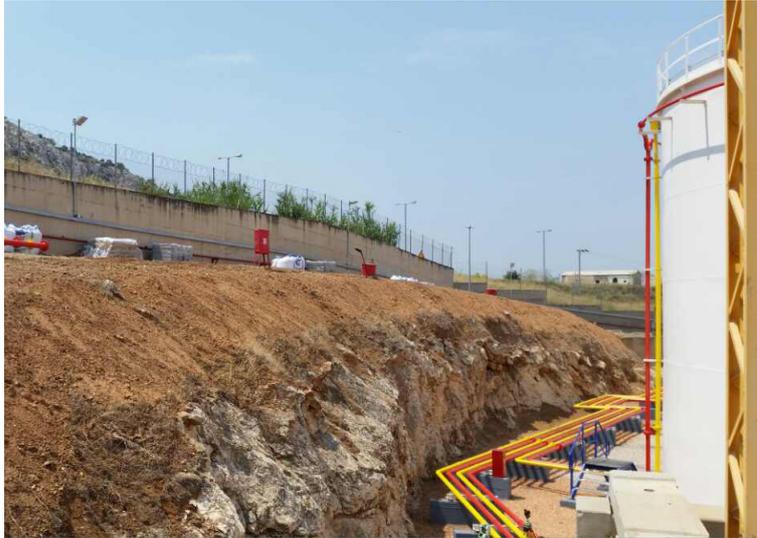
*The existing bunds had been affected by weathering erosion*

The existing bunds of the petroleum tank farm were subject to weathering and erosion affecting the ground's integrity and stability. The client required a long-term, durable and cost-effective solution to combat the issues. In addition, Athens is subject to extremely hot weather in summer months, with temperatures often hitting highs of 48°C, which meant the heavily vegetated bunds posed a fire hazard. As a result, a weed suppression solution was also required to prevent fires. The chosen solution also had to be easily installed without interfering with the existing complex pipe infrastructure.

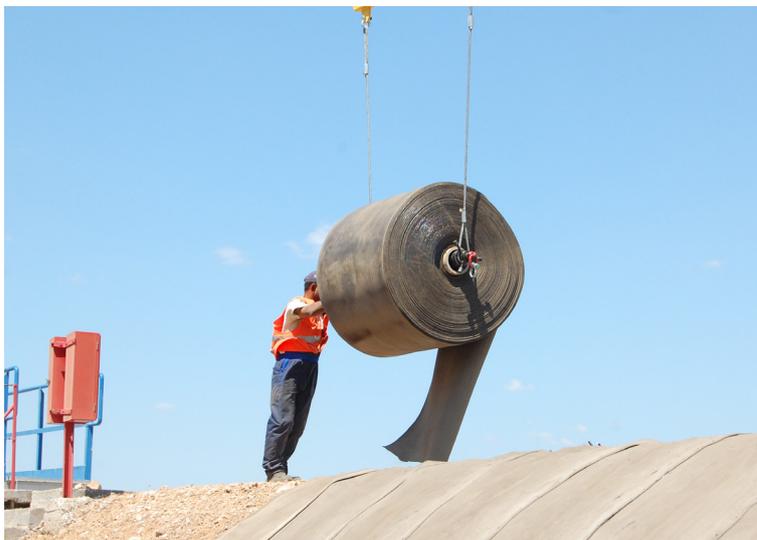
*The CC was mounted onto a spreader beam and crane for easy deployment*

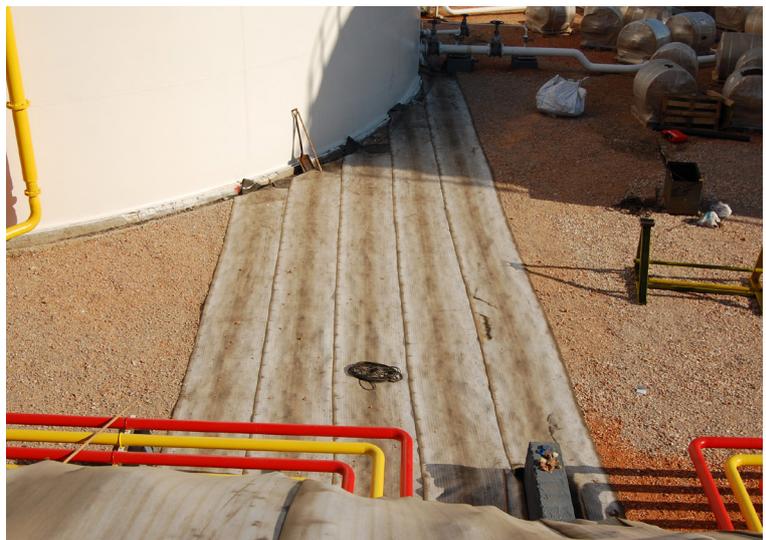
*CC was unrolled down the slope and along the tank farm floor*

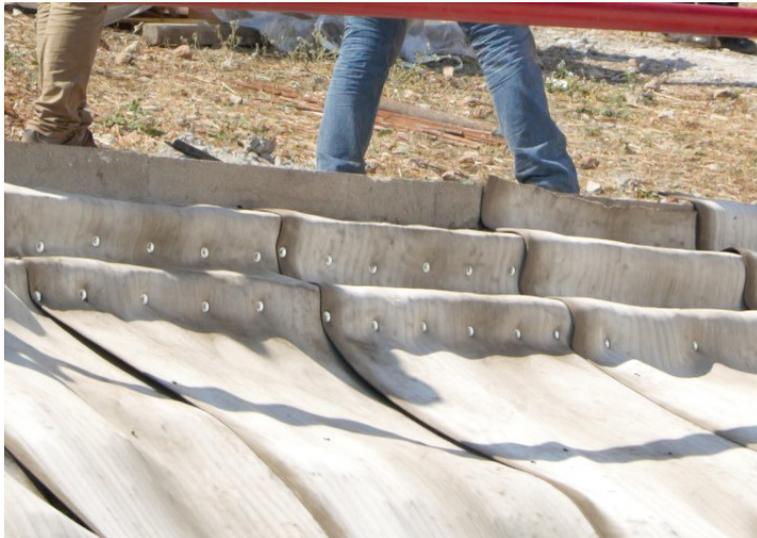
CC was fixed to a concrete slab at the crest of the slope with masonry nails

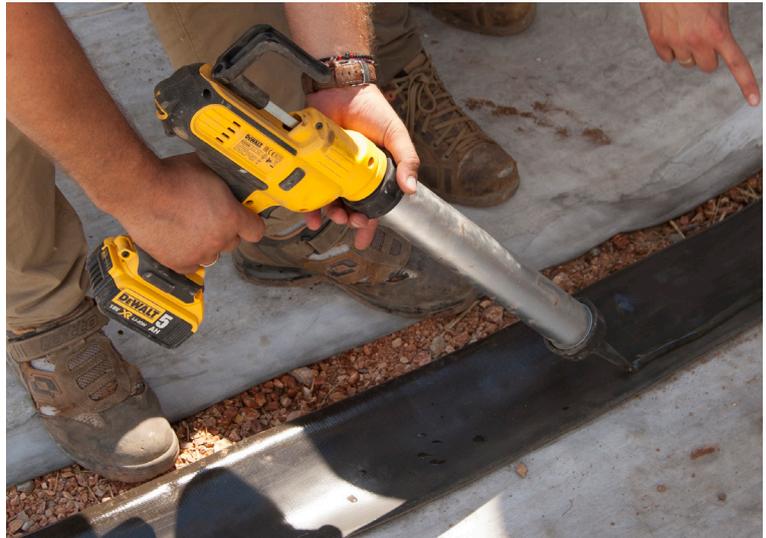
Overlaps were sealed using Everbuild Clearfix adhesive sealant

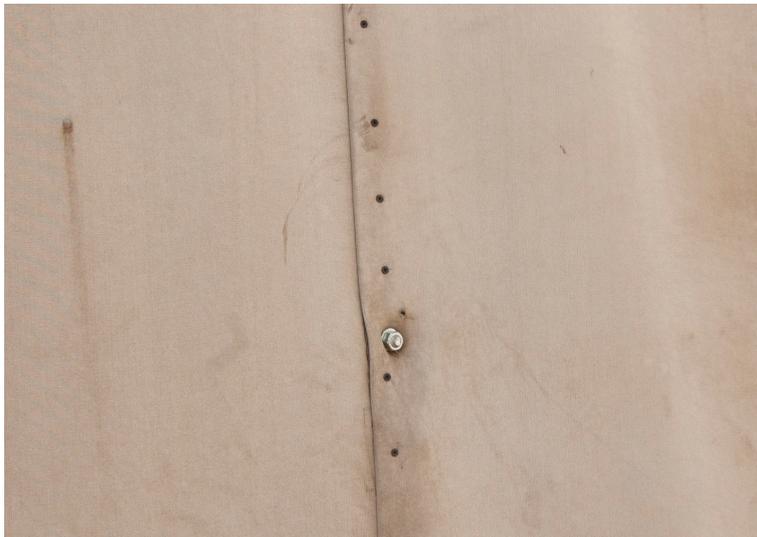
The CC was fixed and jointed using screws and anchor bolts

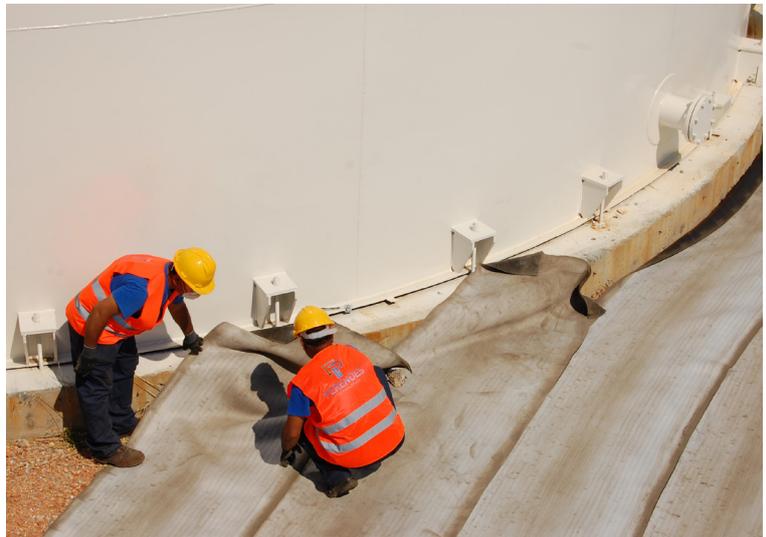
CC was cut using hand tools to negotiate storage tanks

Infrastructure such as the petroleum storage tanks and pipework were easily accommodated due to the drape characteristics and flexibility of CC. The CC around the walls of the storage tanks, corners and other complex shapes from protruding infrastructure, was cut using hand tools, and where needed, an extra layer of CC was fitted around the item, then sealed. Once the installation was complete, the CC was hydrated using hoses attached to fire pipes. This was repeated three times due to the high temperatures to ensure adequate hydration.

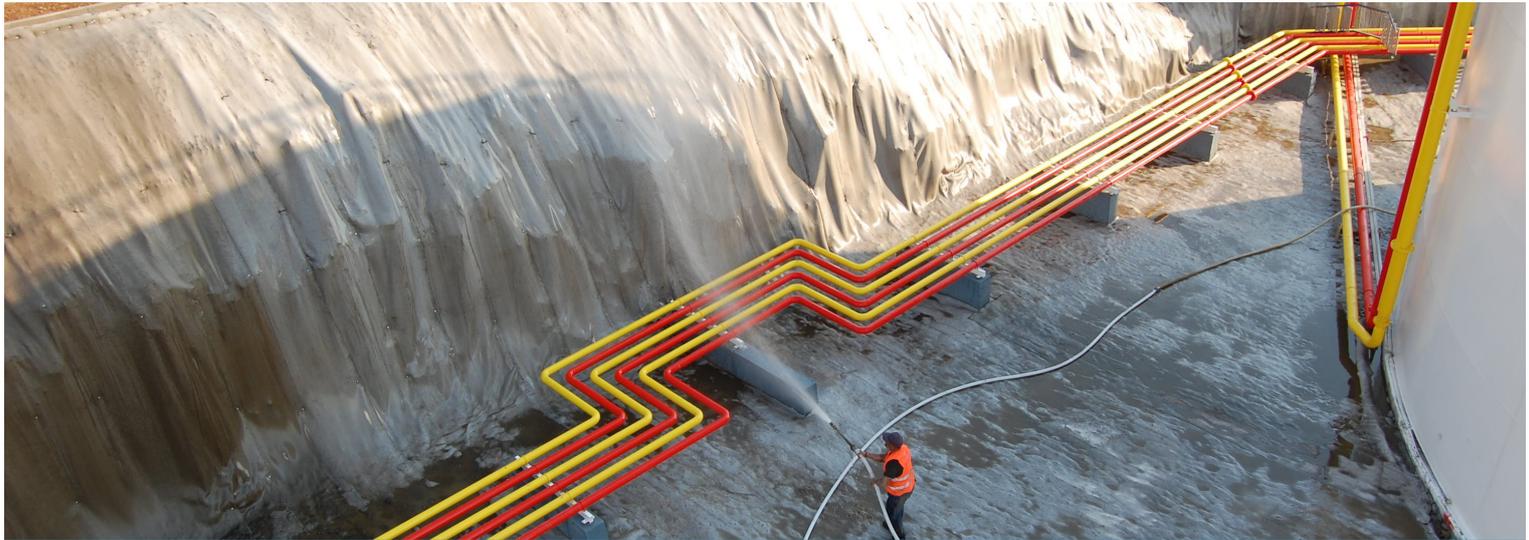
*The CC was hydrated using a hose attached to fire pipes*

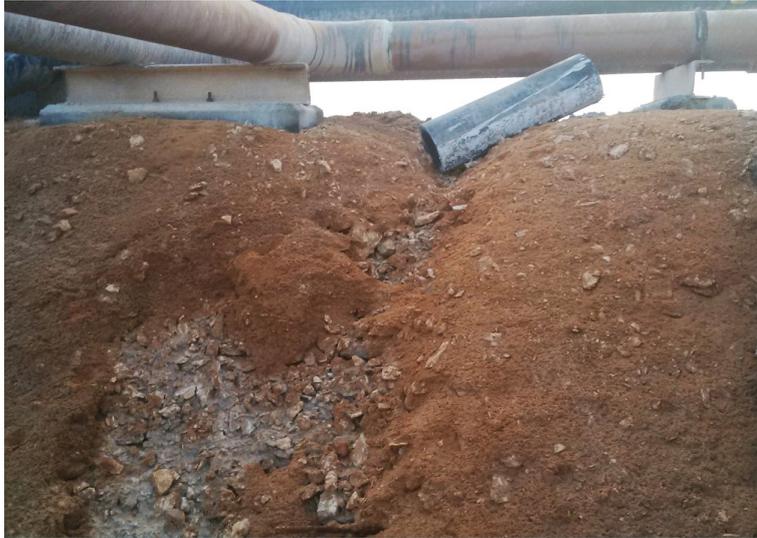
The bund was severely eroded in some areas prior to works

The bund was subject to periodic severe erosion, when the water lagoon would flood and send water cascading down the sides of the bund. The water then posed a flooding risk to the production area. As a result there was also a requirement to create drainage channels on the outside toe of the bund to direct any water overflow to holding pits, also lined with CC. Shotcrete was considered, but it would have taken considerably longer to install with much more complex logistics. There were also numerous pieces of existing infrastructure such as pipework which would have made a shotcrete installation challenging.

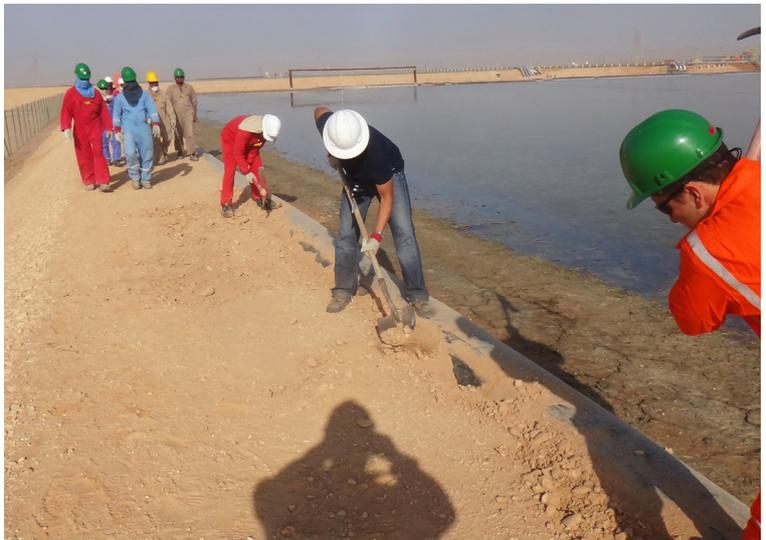
An anchor trench was created prior to installation

The bund wall was graded and erosion damage repaired to avoid voids forming under the CC. On the north side of the lagoon, the bund was raised by 500mm to repair extreme erosion and increase the lagoon capacity. A drainage channel was constructed at the base of the bund by creating a small berm, and an anchor trench was cut into the top of the berm.

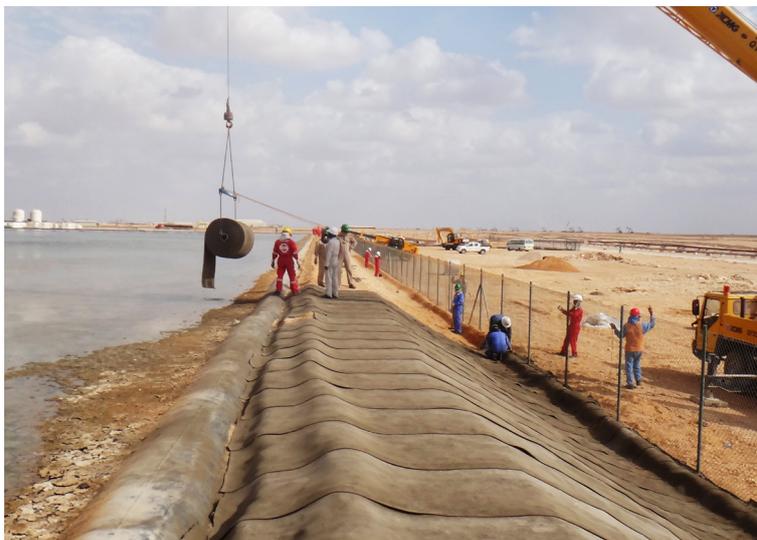
Bulk rolls were mounted on a spreader beam for easy dispensing

29 bulk rolls of CC8™ and 42 bulk rolls of CC5™ were delivered to site. Where weather and access allowed, the bulk rolls were mounted onto a spreader beam hung from a telescopic handler and unrolled down the berm and cut to length with a utility knife. On days where the wind was too strong, or where access was limited, the CC was unrolled on the flat and cut to profile lengths then transported to the berm by hand. The leading edge of the CC was placed into an anchor trench, unrolled down the berm and across the drainage channel at the toe. Each layer of CC was overlapped by 100mm, sealed and jointed with an offset double row of screws applied at 200mm centres with an auto-fed screw driver. Following installation, hydration was given using a 45,000L water truck and hose. At 5 locations around the berm, water collection pits were created to collect the water carried by the drainage channel; these were lined with transverse layers of CC. Where pipes couldn't be lifted, smaller sections of CC were cut to size and fitted around the pipes, with sealant used to create an impermeable joint.

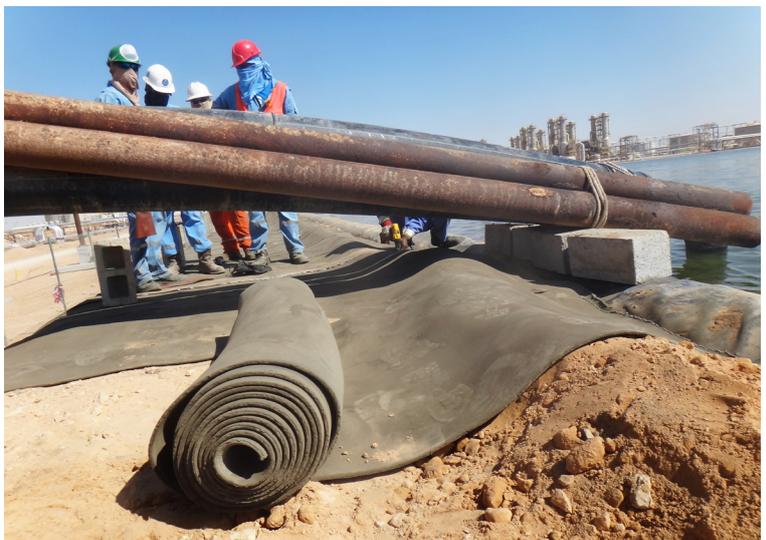
A pre-cut piece of CC being laid under existing pipework

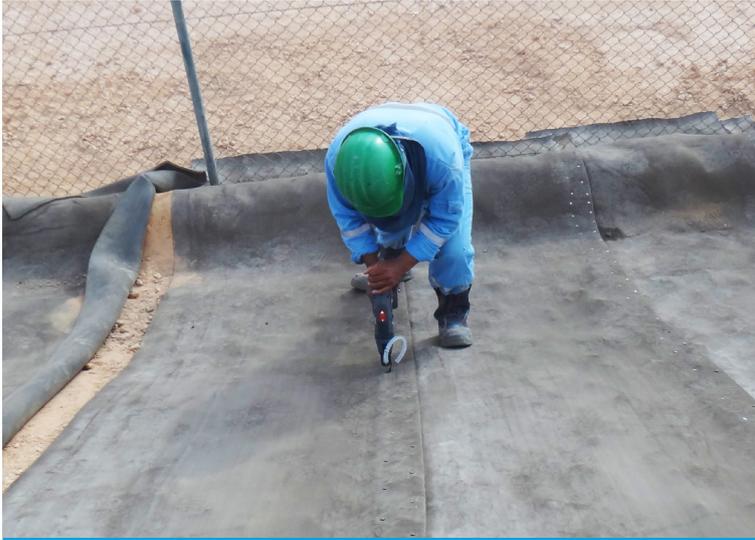
Fixing overlaps with screws

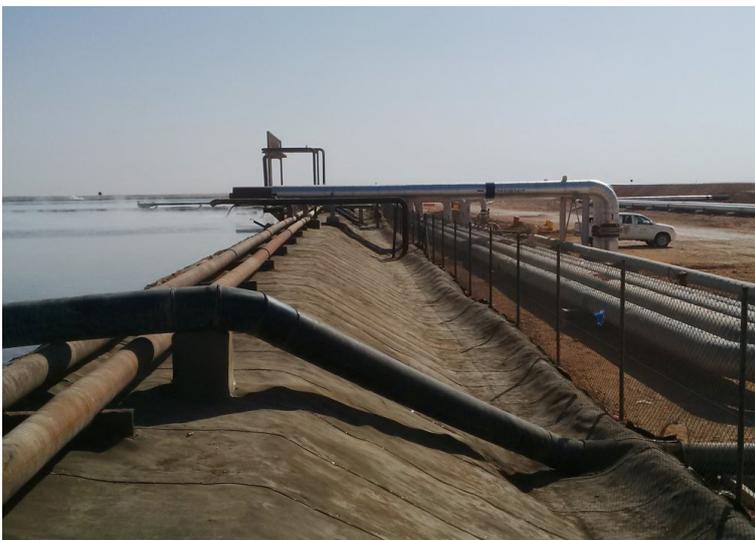
The CC edges were buried in pre-dug anchor trenches

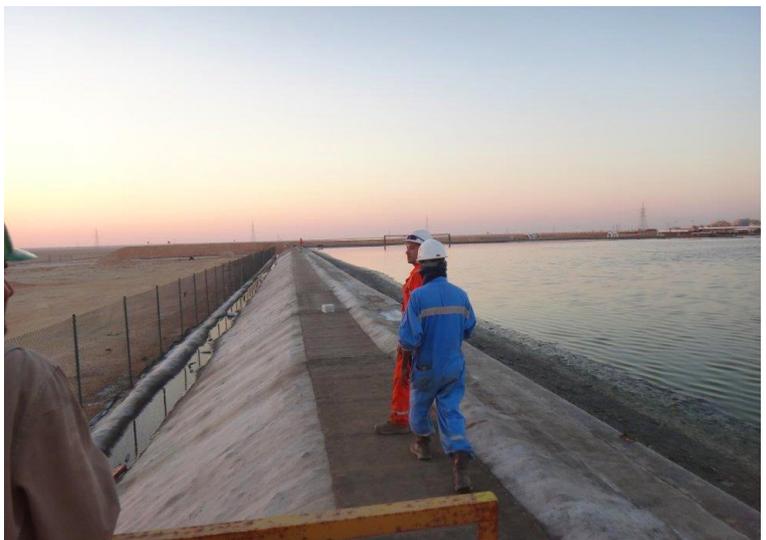
Five water collection pits were created

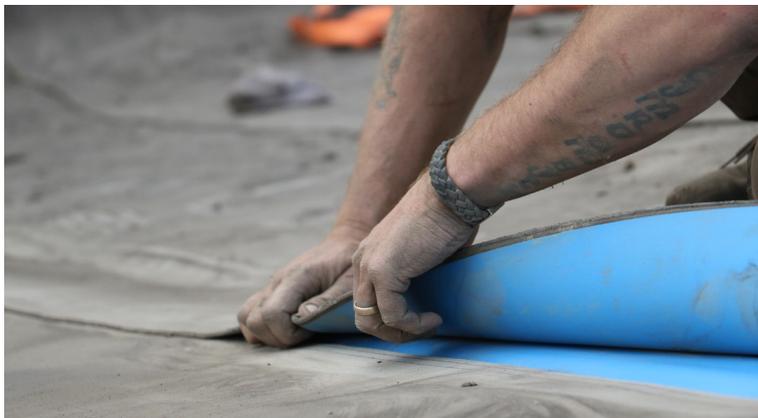
CC Hydro™ is marked with two guidelines, 15mm and 30mm from the edge of the material. When overlapping layers for thermal welding, the upper most layer should line up with the 30mm guideline. This provides the necessary clearance between the thermal weld strip and CC Hydro™ to allow pressure testing.

Alignment

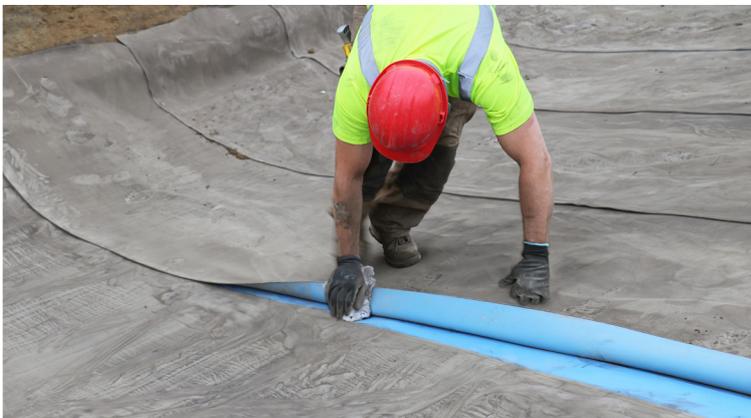
The two geomembrane faces should be wiped down prior to welding to remove any dirt or moisture, to ensure an optimum weld.

Cleaning the geomembrane faces to be welded

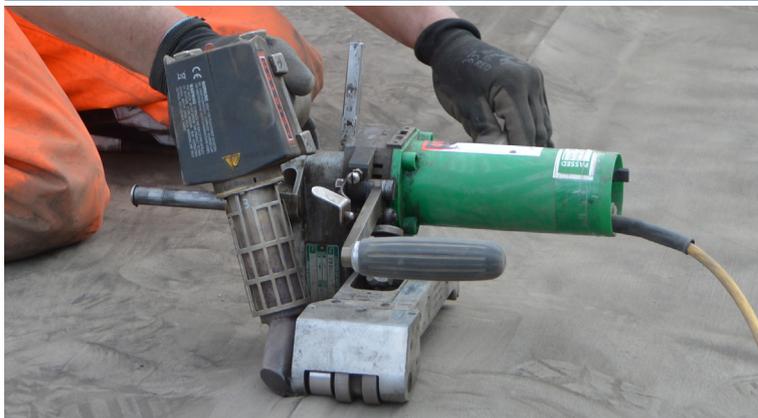
Welding on this project was performed by TWI (UK Thermal Welding Institute) certified operators using Leister Twinny T and S models. The welding machines were individually calibrated at the beginning of each days phase of work to adjust to ambient temperature. Cut sample sections were also regularly welded and pull tested to destruction to check the integrity of the weld channels.

Welding

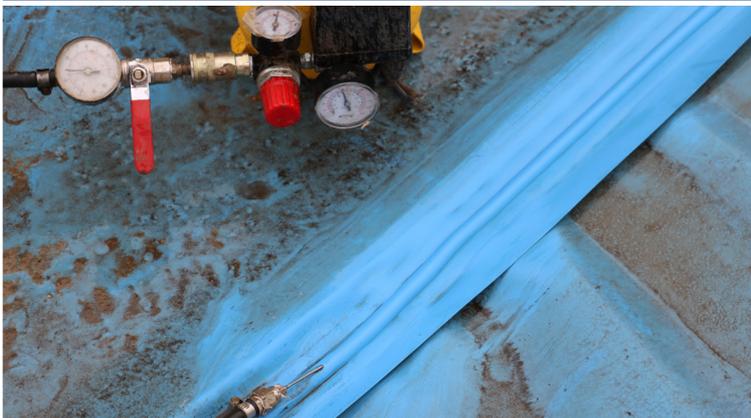
As per industry standards, regular pressure testing of welded seams was performed over the course of installation. In this instance, channel welds were clamped at the crest and toe of the CC Hydro™ layers, before pressurising to 2bar. A successful weld was determined if the pressure didn't decrease by greater than 10% over a five minute interval.

Testing

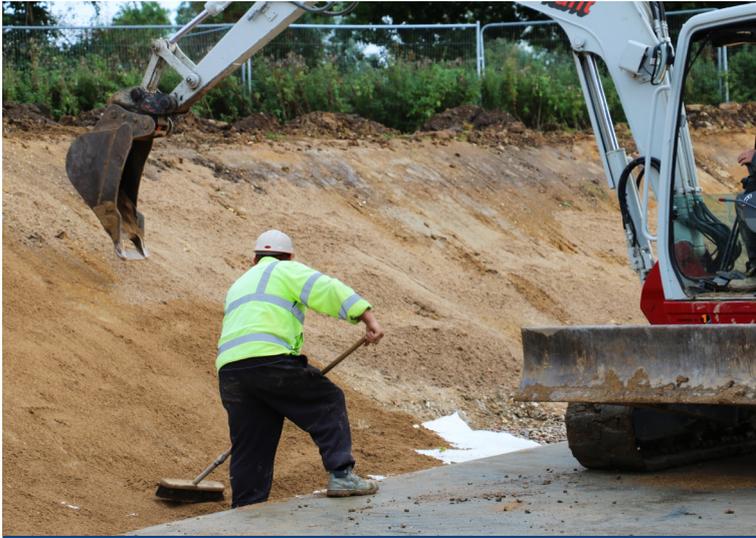
Ground preparation

Prior to works, the berm was graded, loose rock removed and a sand blinding layer applied to fill voids, ensuring intimate contact between the material and substrate. Bulk rolls of CCH5™ were delivered to site in staggered deliveries to minimise on-site storage and match the rate of installation.

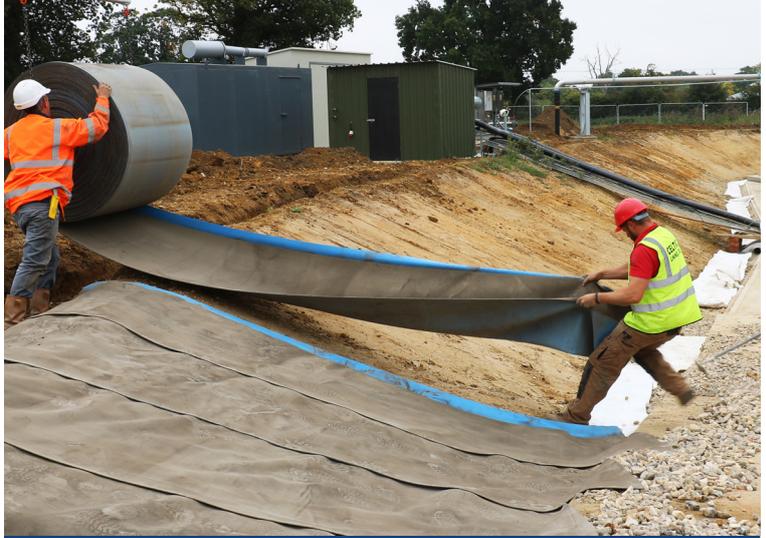
Unrolling the CC Hydro™

The CCH was mounted onto a spreader beam, mounted on a telehandler, and the material unrolled either up or down the berm face depending on access. The material was cut to length to reduce wastage, and the leading edge tucked into an anchor trench at the crest and fixed using ground pegs. The toe edges were lapped onto a cut step in the poured concrete base and formed an interior drainage channel. The overlapping layers of the CCH were thermally welded, and joints then inspected and pressure tested. At the end of each day, the crest anchor trench was backfilled and the CCH hydrated, before the last, exposed length of CCH was covered in tarpaulin to protect it ahead of installation and welding the next day.

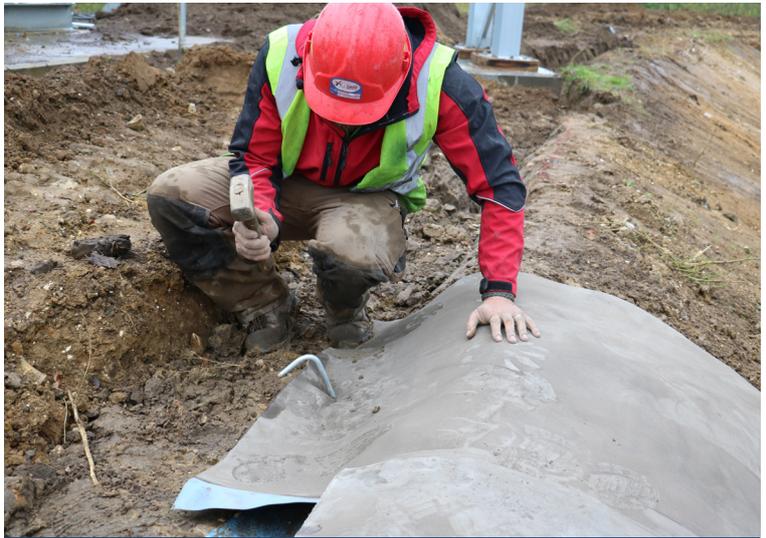
Fixing into the anchor trench

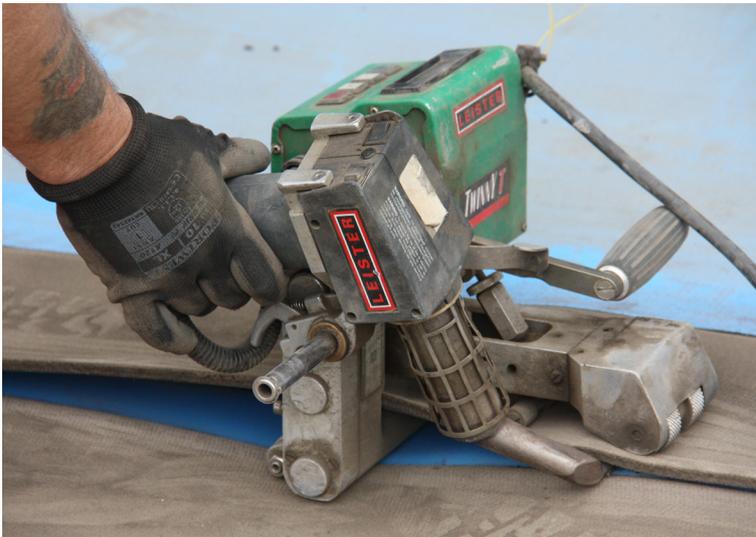
Setting up a thermal welder

CC Hydro™ can be thermally bonded using similar welding and solvent methods to standard plastic liners and geomembranes to provide testable joints with the same level of impermeability as the material itself. For this installation, thermal welding with a twin track air channel was specified to allow the onsite testing of joints for quality control purposes. Welding rates of CC Hydro™ can vary from 3-6m/minute subject to site conditions and CQA requirements.

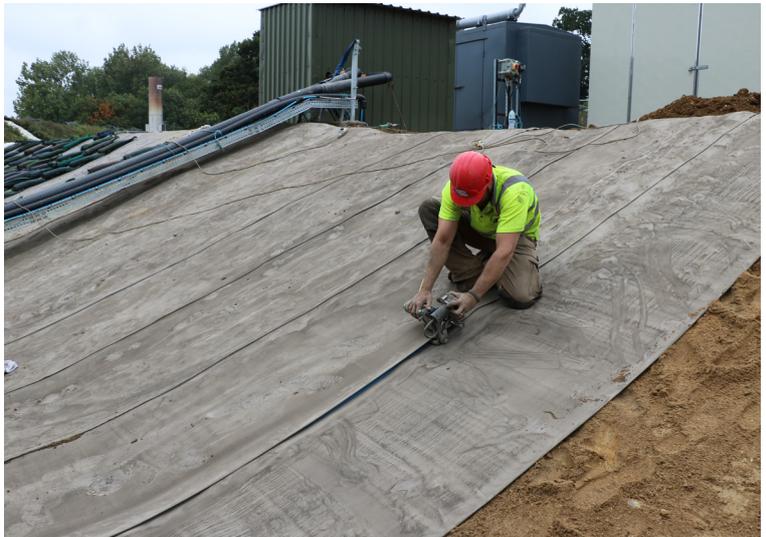
Welding

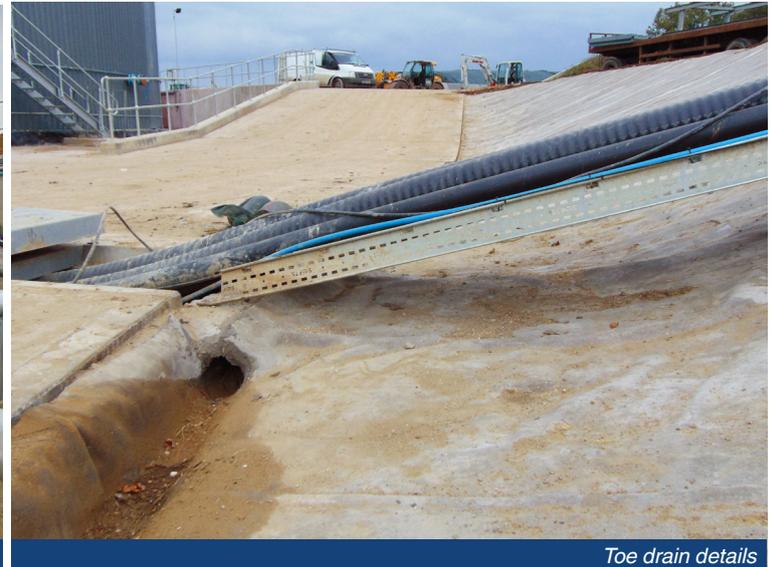
Toe drain details
