CC8™ Batched Rolls

A66(W) County Durham,  
UK

CC8™ was used to  
prevent undercutting of  
the A66 Highway.

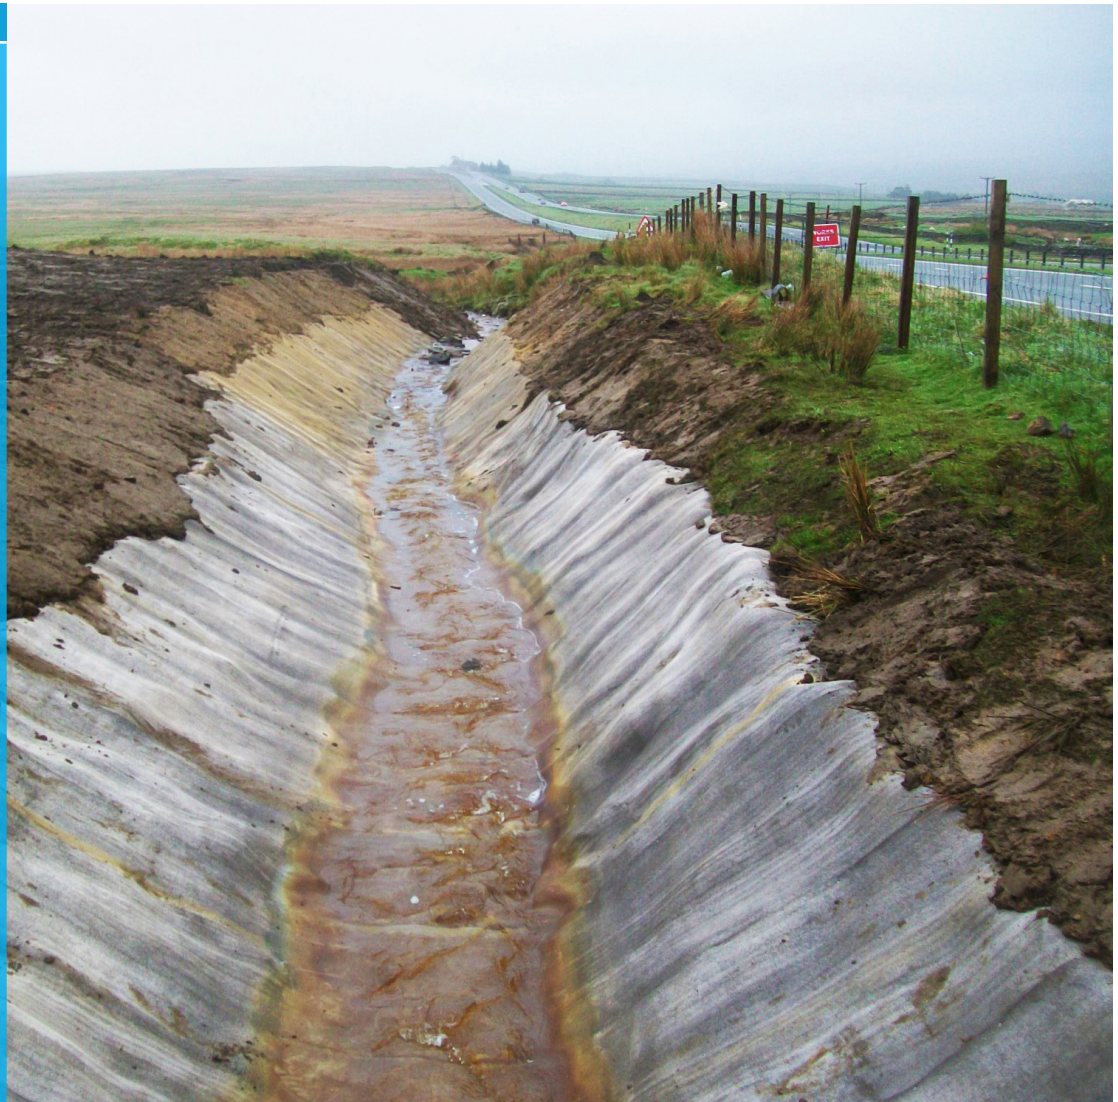
Completed installation

A total of 150m<sup>2</sup> of CC8™ were installed by 6 people in just 2 days in a live water course, despite torrential rain.

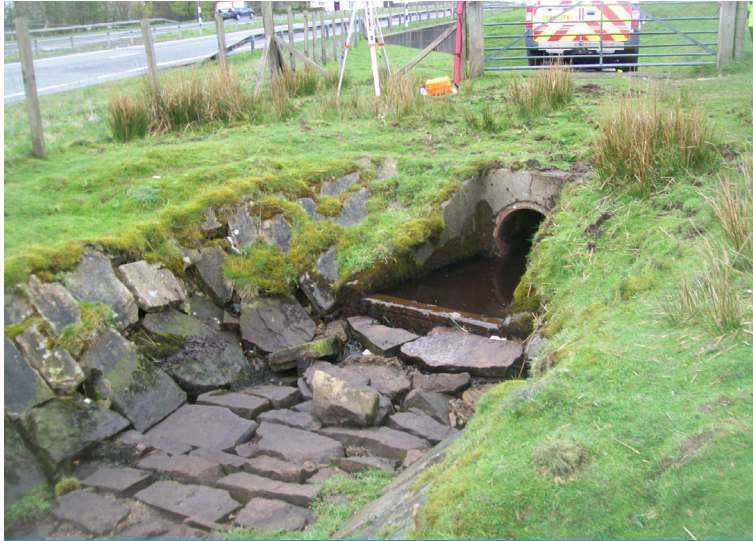
Site before works began

During a site inspection, it was found that it would not be possible to stop or divert the water due to weather conditions, so a solution that could be installed in a live water course was paramount. At the top of the channel there was a termination of a culvert which also needed to be accommodated. The works were carried out by A-one+ Integrated Highway Services (Area 14).

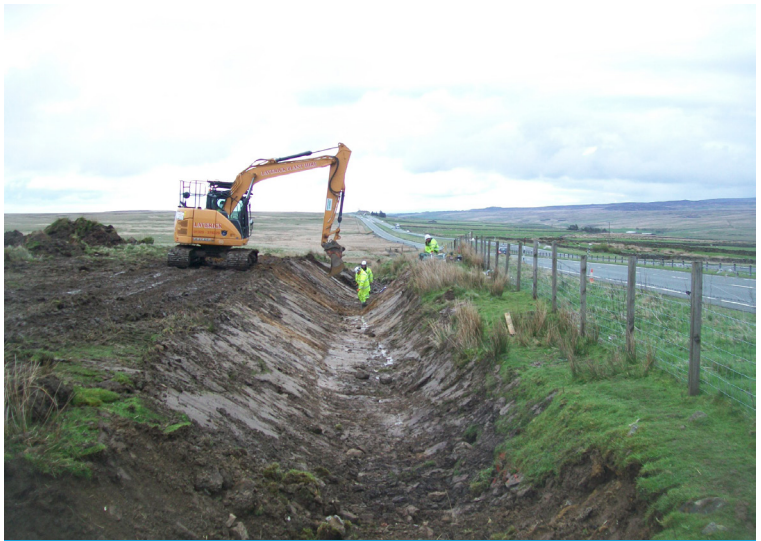
Grading channel profile

An excavator was used to re-profile the channel and culvert before 30 batched rolls of CC8™ were delivered to site. The excavator located the batched rolls at sections of the channel as required before they were unrolled by hand into position. The CC was laid progressively upstream, and pegged at the edges whilst allowing the live water course to flow under the material. Once CC had been installed along the length of the channel, a concrete sandbag headwall was built on top of the last CC layer. This would allow the water from the culvert to flow over the CC as intended. The overlaps were mechanically jointed with screws at 200mm centres, but the joints weren't sealed so as to create natural weep paths allowing water ingress into the channel and preventing the build-up of hydrostatic pressure behind the CC. Post hydration, the channel anchor trenches along the crest were backfilled to secure the CC in place and to provide a neat finish.

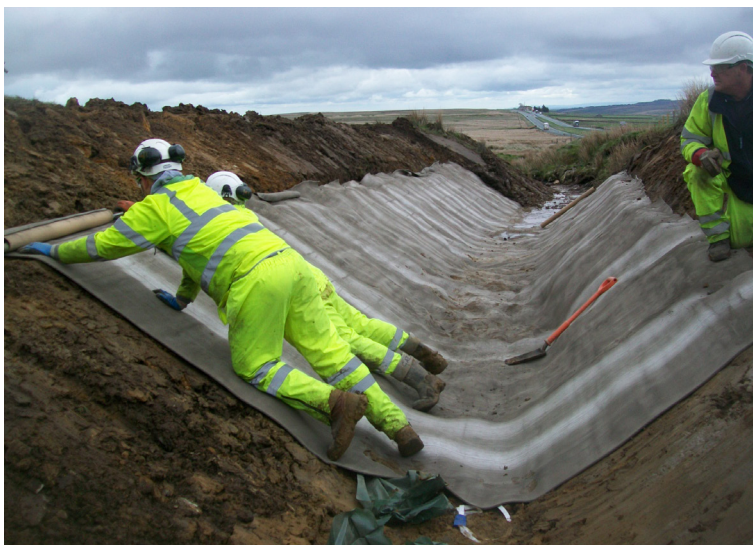
Batched CC8™ being unrolled

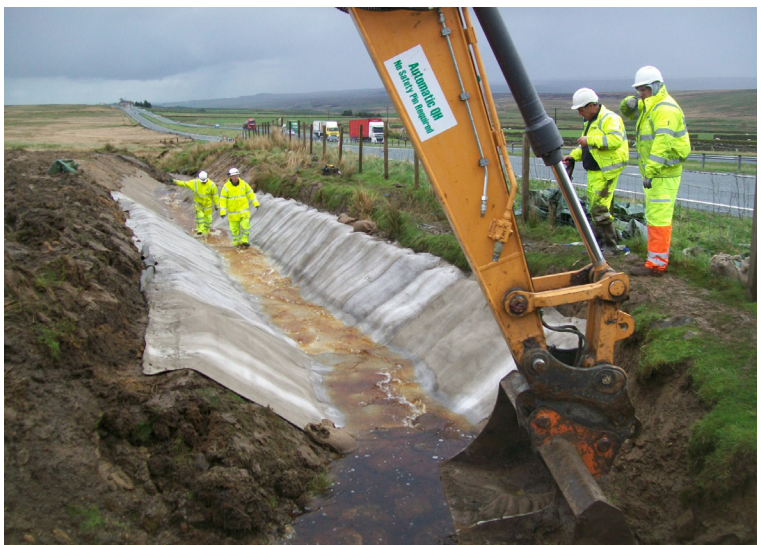
Allowing live water course to hydrate CC

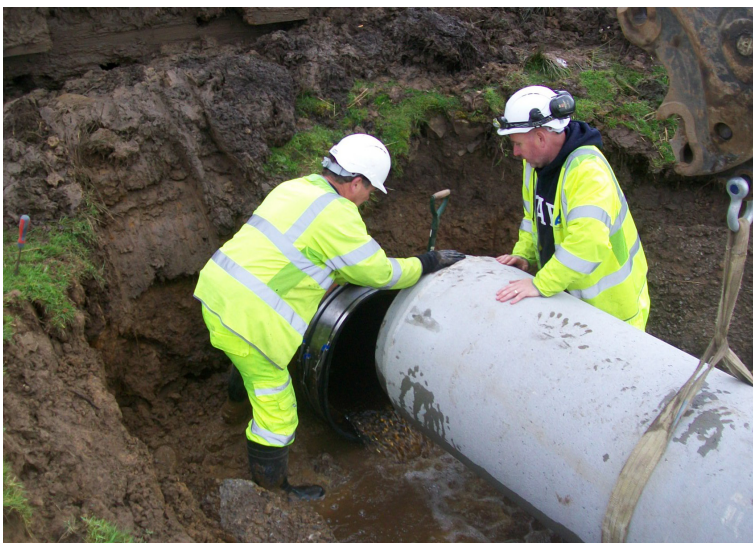
Connecting new pipe to culvert

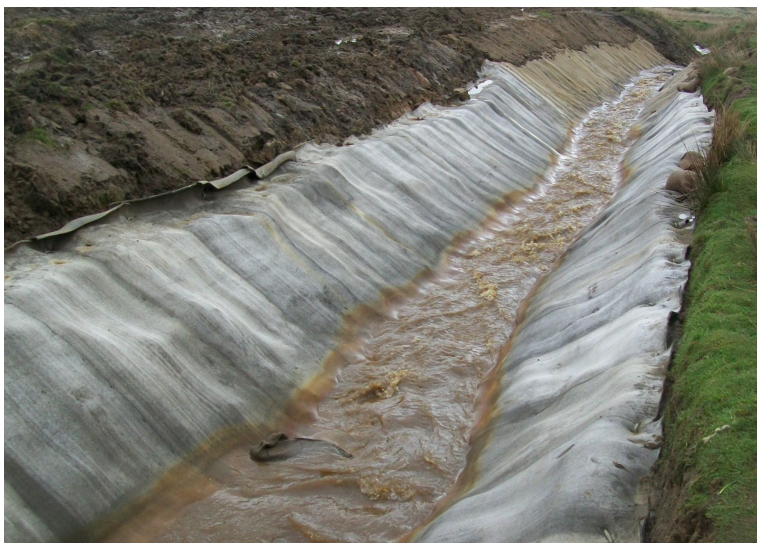
CC laid, prior to backfilling of anchor trenches

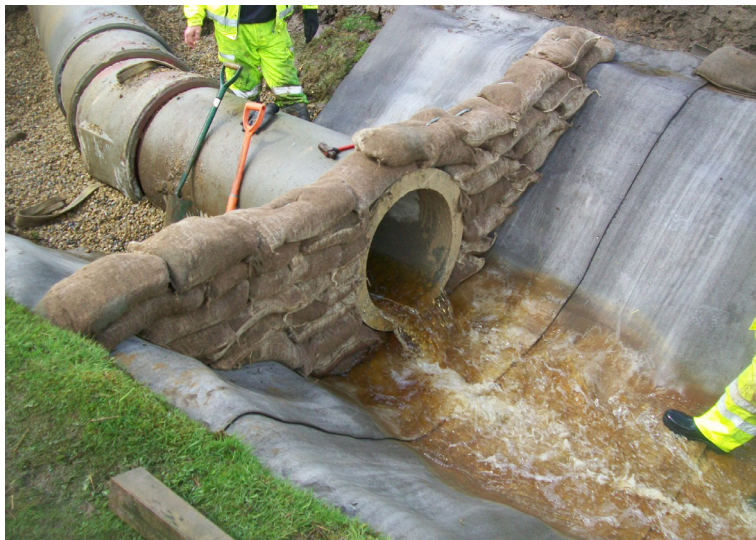
New culvert pipe in place

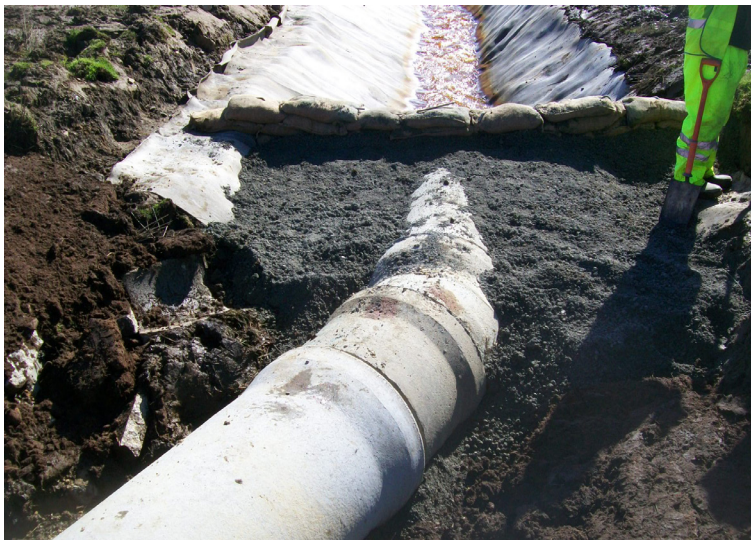
Burying culvert pipe following construction of sandbag wall

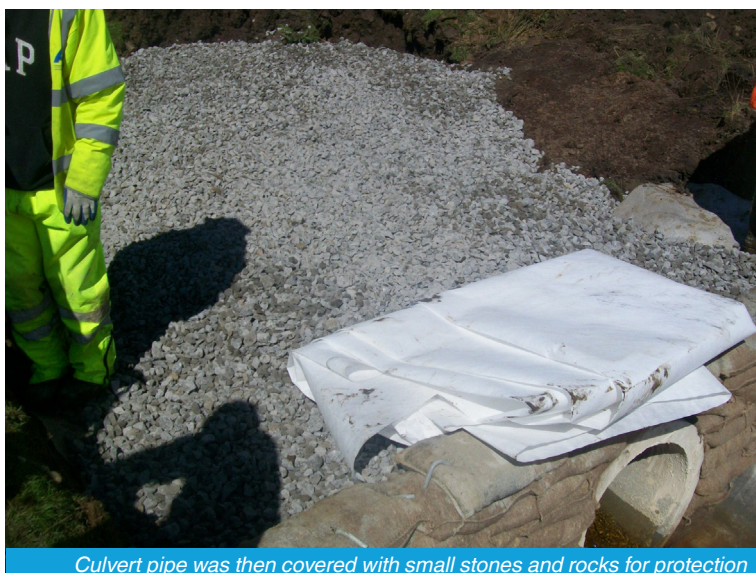
Culvert pipe was then covered with small stones and rocks for protection

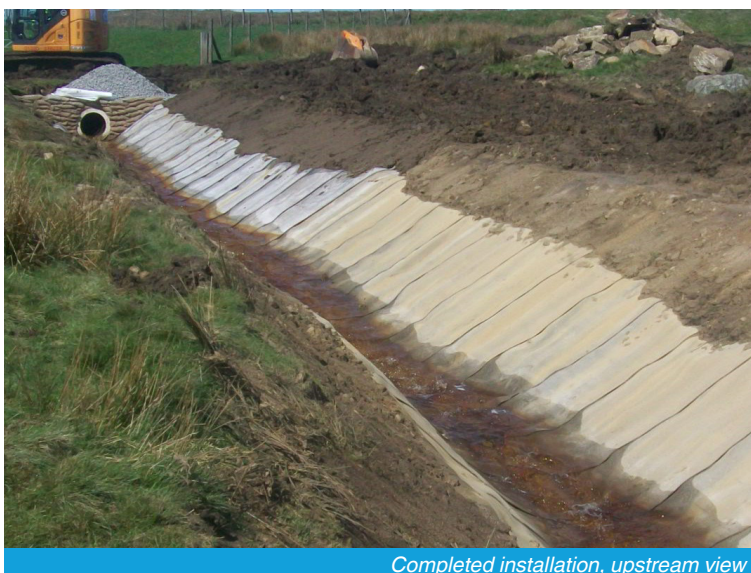
Completed installation, upstream view
