CC8™ Bulk Rolls

Albania, La Guajira, Colombia

CC8 used to line ditches at a mine, to provide drainage and prevent erosion

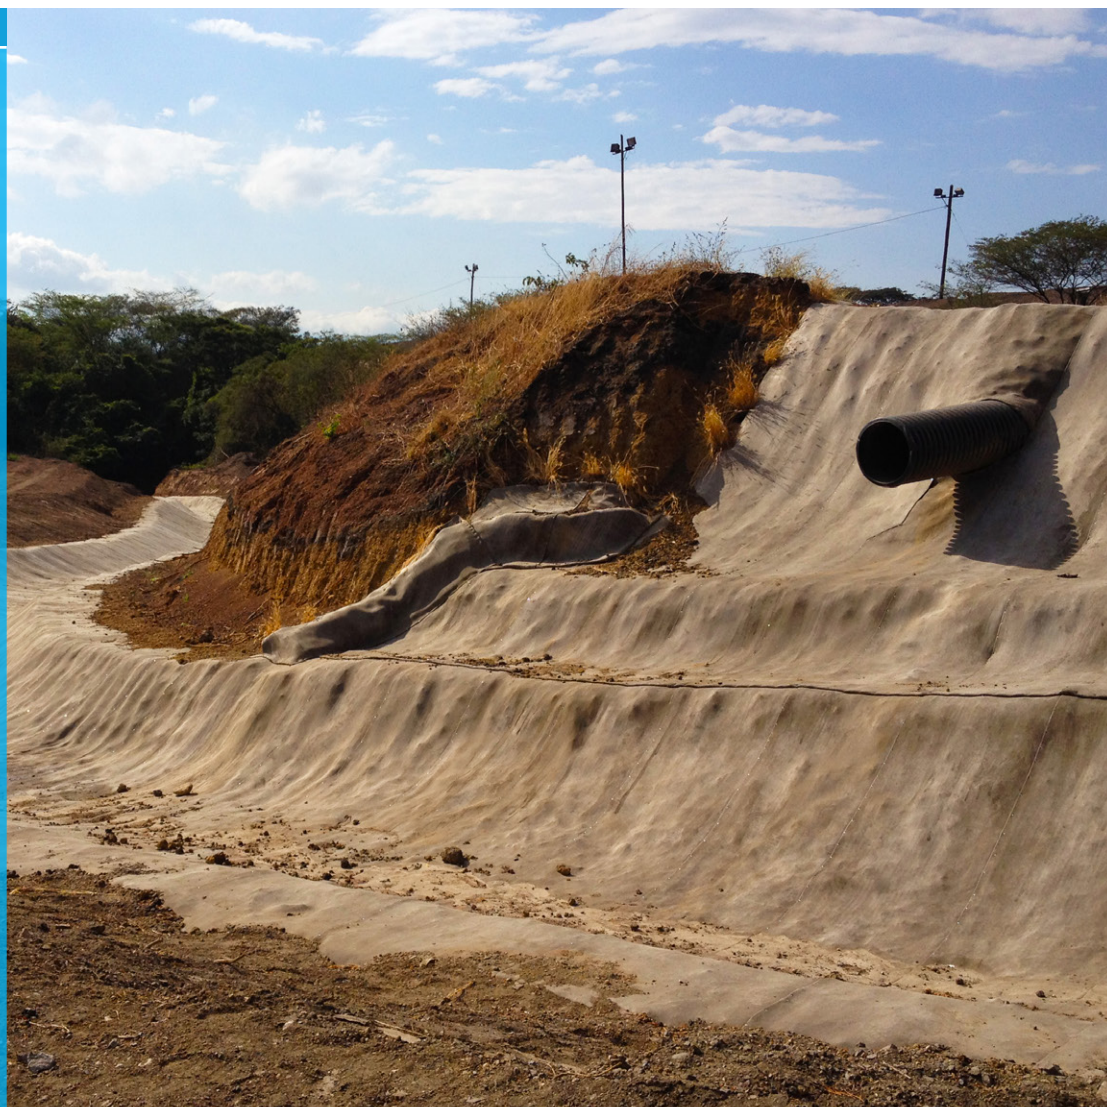
Completed section of ditch

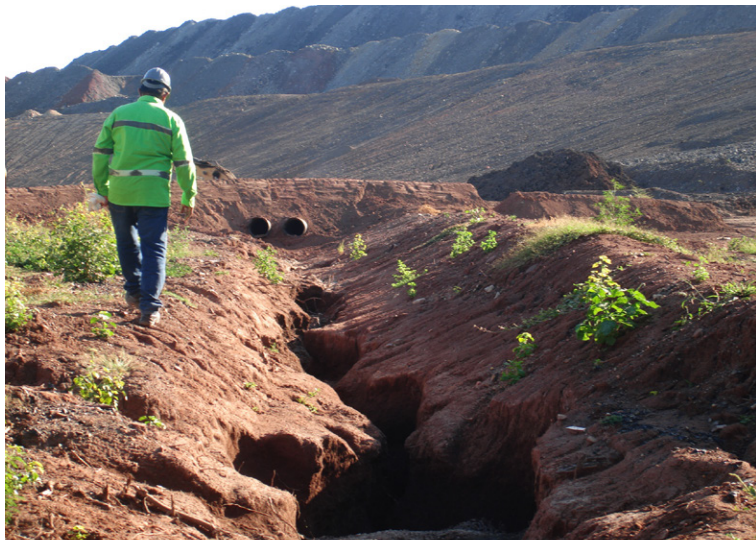
Severe vertical erosion and vegetation growth

The original ditches were carved from the substrate with no extra lining and had varying lengths and profiles. As no lining had been incorporated the original ditches suffered from extreme erosion and were causing damage to the local environment, the National Authority for Environmental Permits (ANLA) required the urgent installation of a protective lining to prevent any further damage to the surrounding environment. Problems included cracking, undercutting and root growing vegetation and debris restricting water flow and exacerbating the issues of erosion.

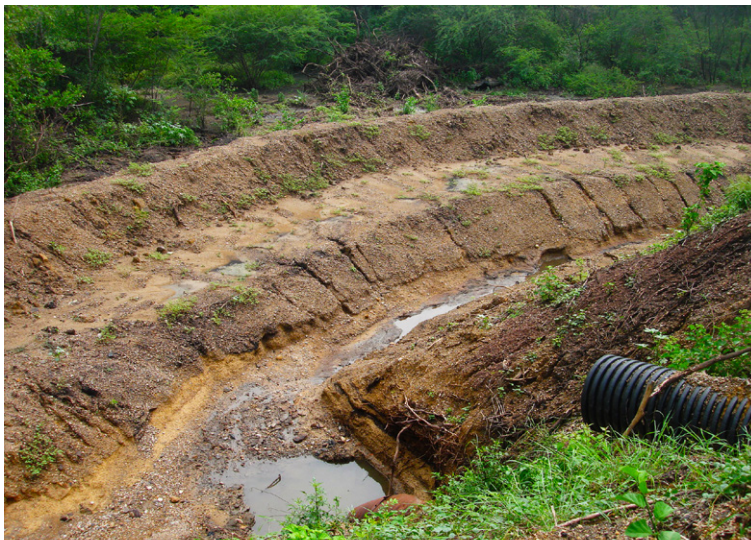
Slope and ditch erosion, cracking and vegetation

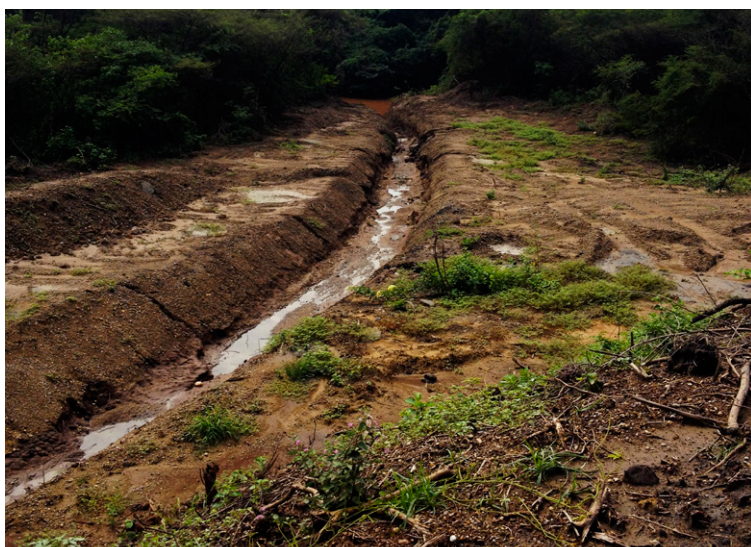
Cracking and undercutting of ditch walls

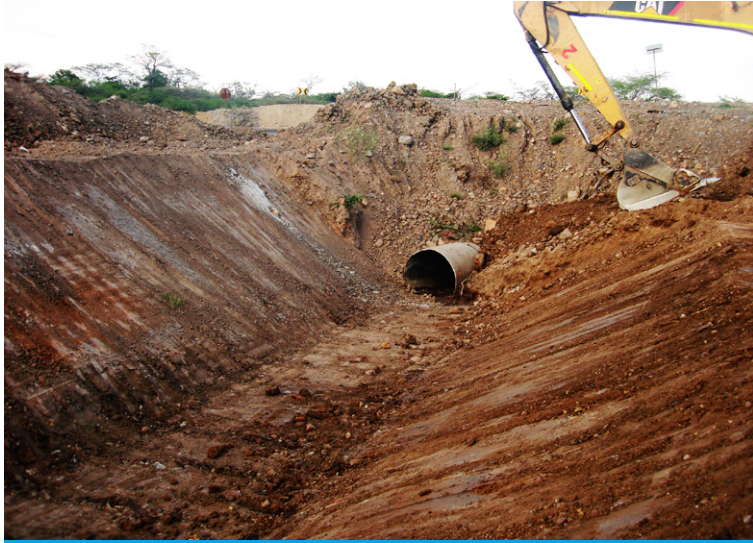
The ditches were cleared of debris and graded

Prior to installation, the ditches were cleared of vegetation, loose soil and rock to ensure intimate contact with the substrate, before being graded to 45°. For the transverse layups, bulk rolls of CC8™ were delivered to site and cut to specific lengths to reduce wastage, these were then positioned and fixed in place using 13mm x 400mm ground pegs. Adjacent layers of CC were overlapped by 100mm in the direction of water flow and jointed using 3mm x 20mm zinc screws at intervals of 200mm. For longitudinal layups, a spreader beam and plant were used to unroll the CC along the length of the ditches. These were fixed in place using ground pegs every 1.5m and, again, jointed screws. Both layups were sealed with Sista FT 101 sealant along every overlap.

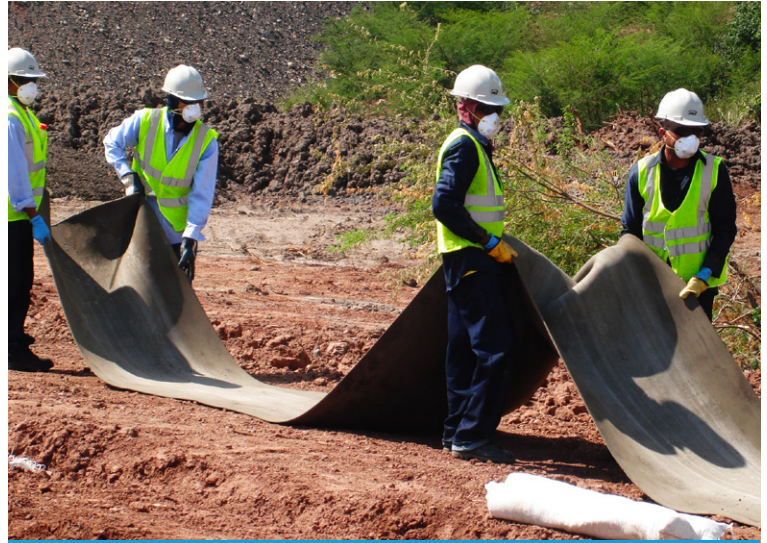
CC8 was cut to length and then positioned

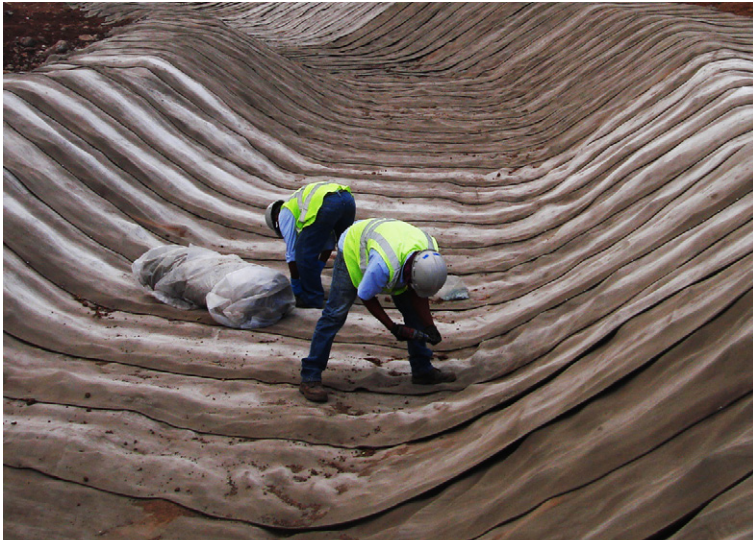
The overlaps were sealed and screwed

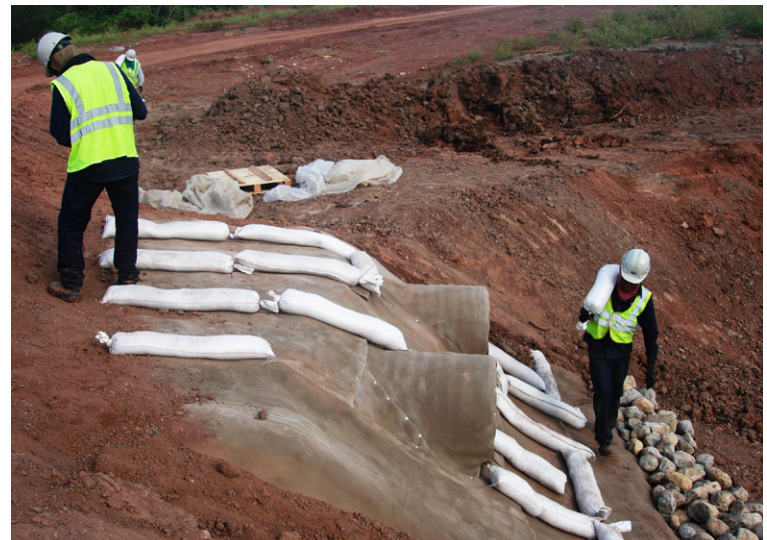
Sandbags were used to provide compression during setting

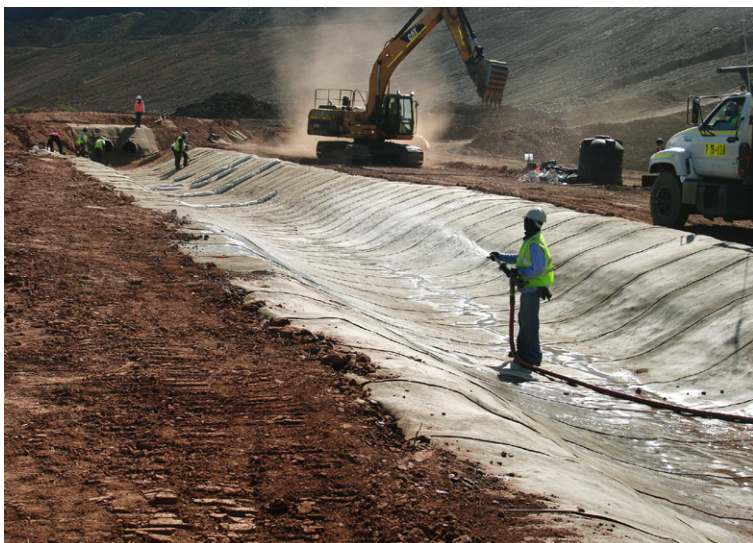
Hydration

The material was hydrated using a water truck and due to CC having a very low wash out rate and a low alkaline reserve, treatment of the run off from installation was not required.

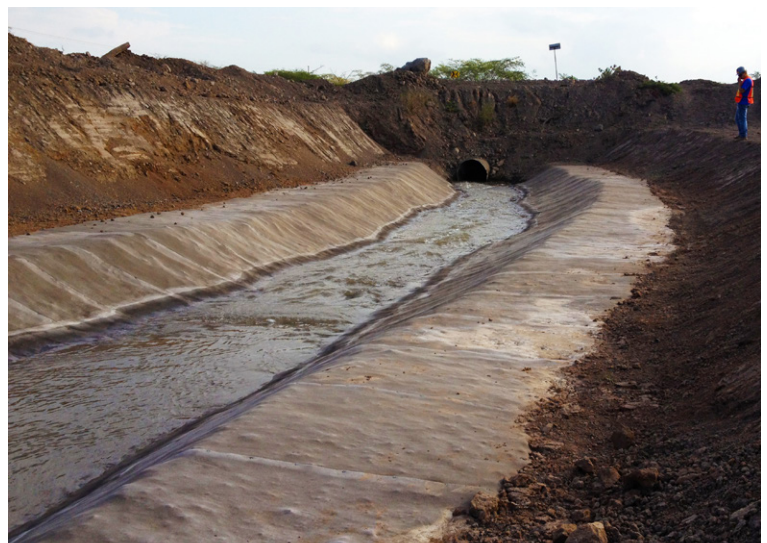
Finished ditch

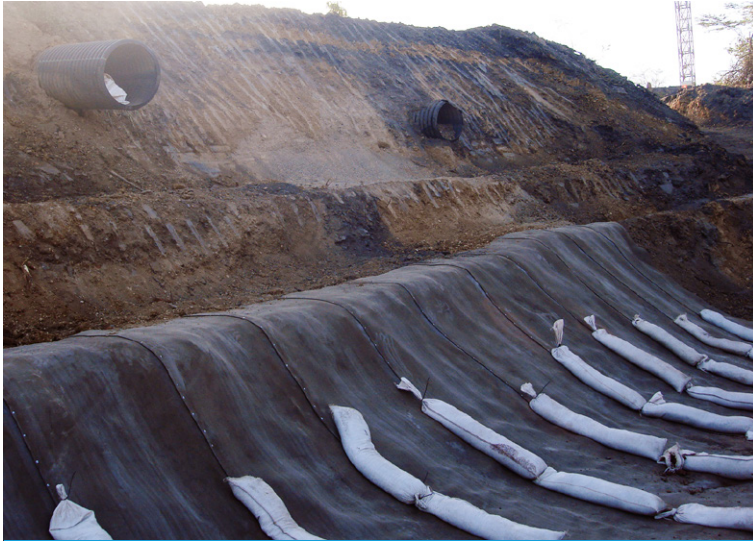
The ditch below the slope was lined with CC8

Slope protection was also needed in places, due to the existing pipe infrastructure and changes in elevation. CC allowed the slope protection and ditch lining to be installed almost seamlessly. Once the ditch was lined, further layers of CC8 were added, overlapping the CC used to line the ditch and extending up the slope, accommodating the existing pipe infrastructure. These layers were overlapped, sealed and screwed in place.

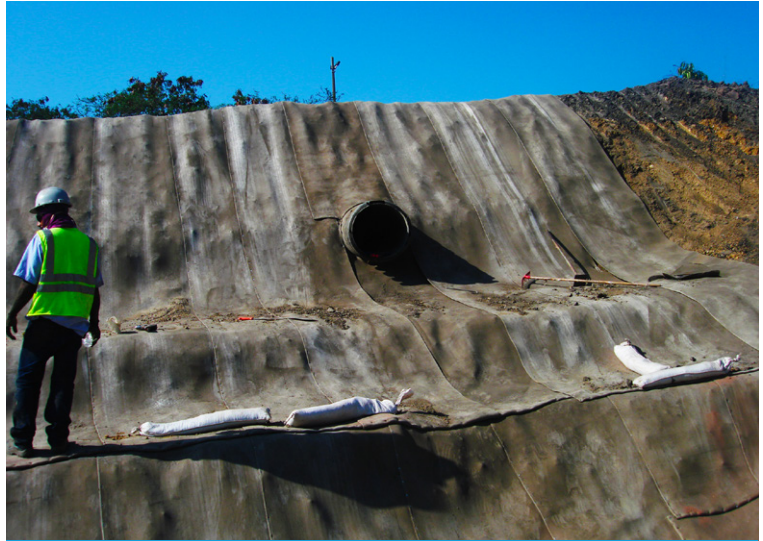
This was then overlapped with the CC8 being used for slope protection

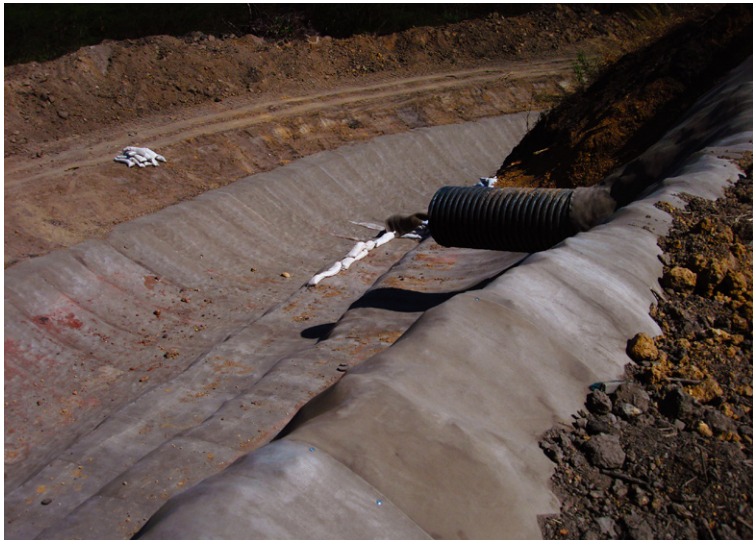
The CC8 was anchor trenched at the top of the slope

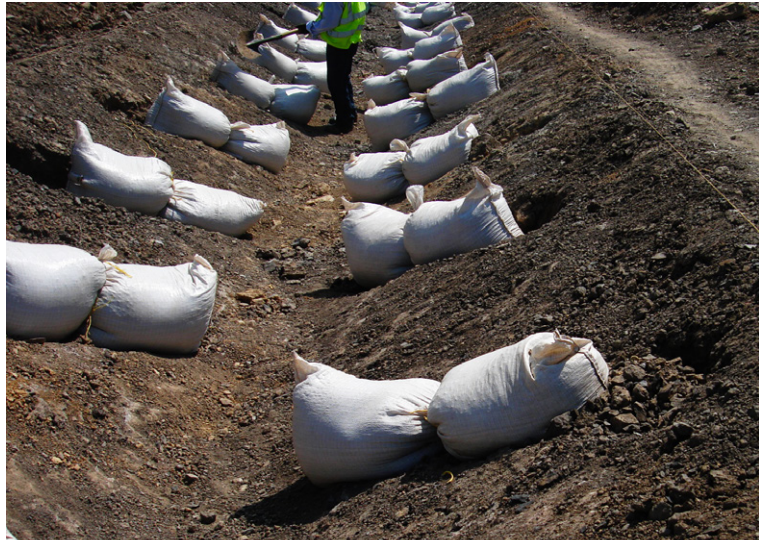
Placement was at 2m intervals (offset) to create a meandering route

Baffling was also needed in a steep ditch known as 'Caida Potreiro' to dissipate the water's energy, and prevent fast flowing water from undercutting the substrate. The ditch was graded to 45° before pairs of sandbags were offset at 2m intervals on either side at 45° angles to the direction of water flow, creating a meandering path to reduce the flow velocity. CC was then layered over them, fixed with ground pegs, and jointed with sealant and screws.

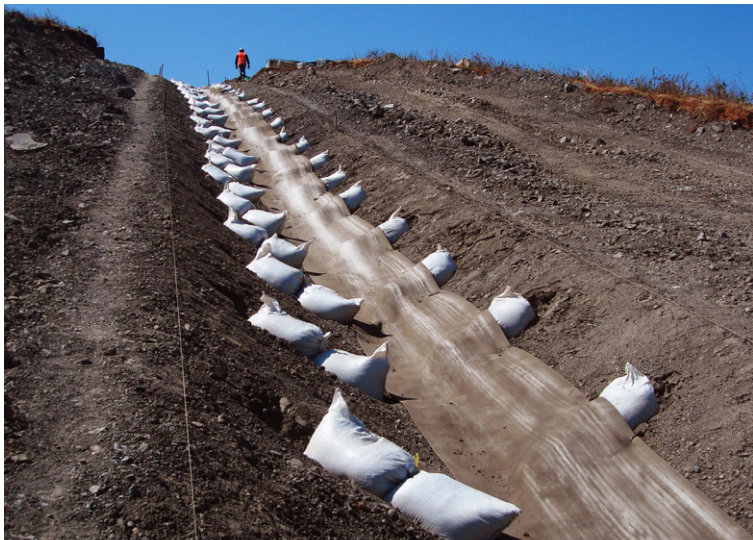
The ditch with one layer of CC8 in place

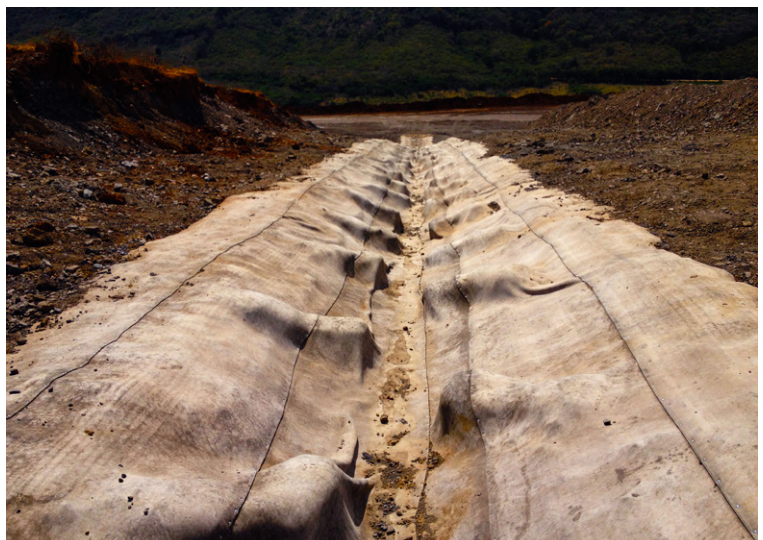
The finished ditch with baffling

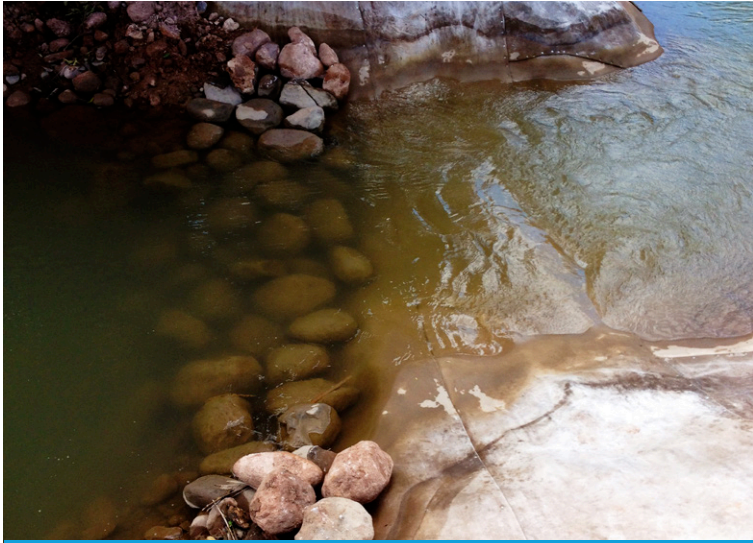
A stepped change in height

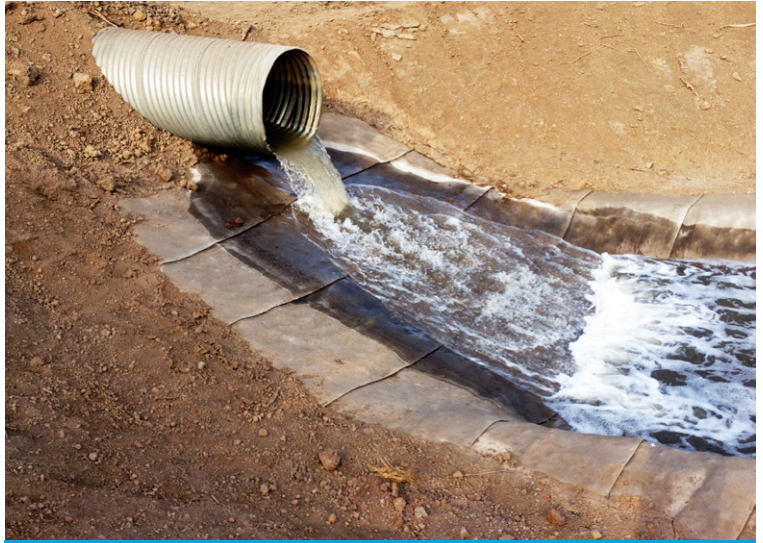
Existing pipe infrastructure detail

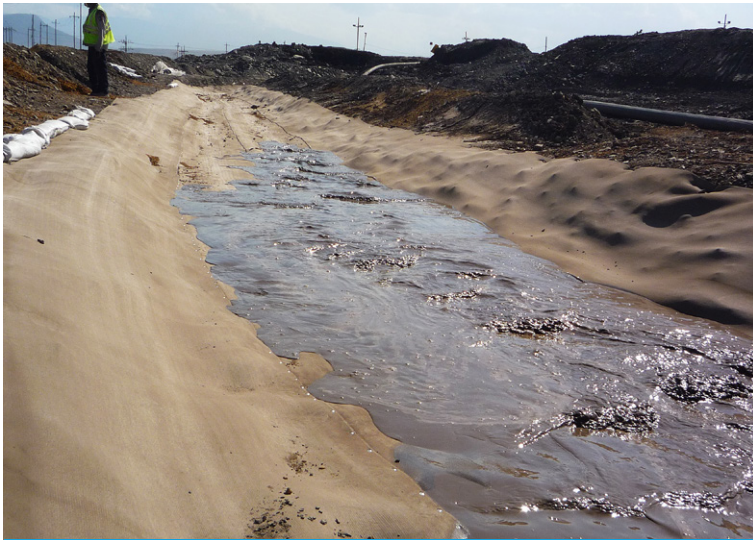
CC8 laid longitudinally

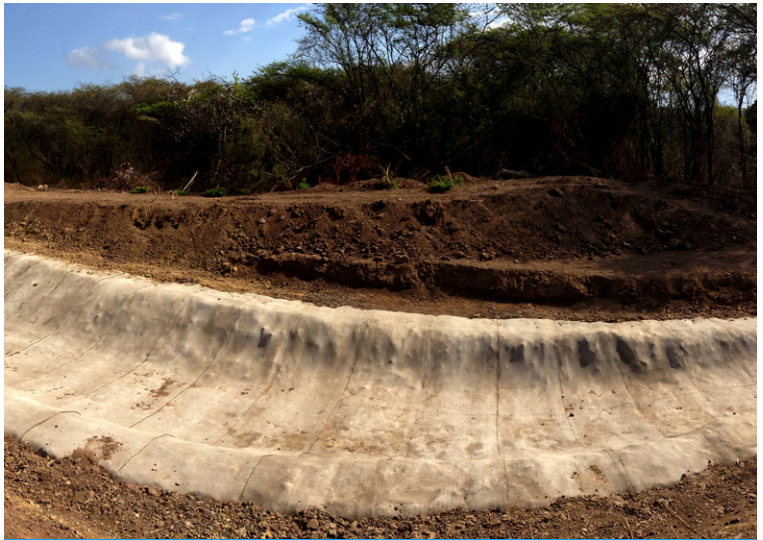
CC8 laid transversely and anchor trenched
