CC5™ and CC8™
Bulk Rolls

Bedwas Colliery,
South Wales, UK

CC5™ and CC8™ were
used to provide erosion
protection to dilapidated
sections of drainage
channel at a disused
mine.

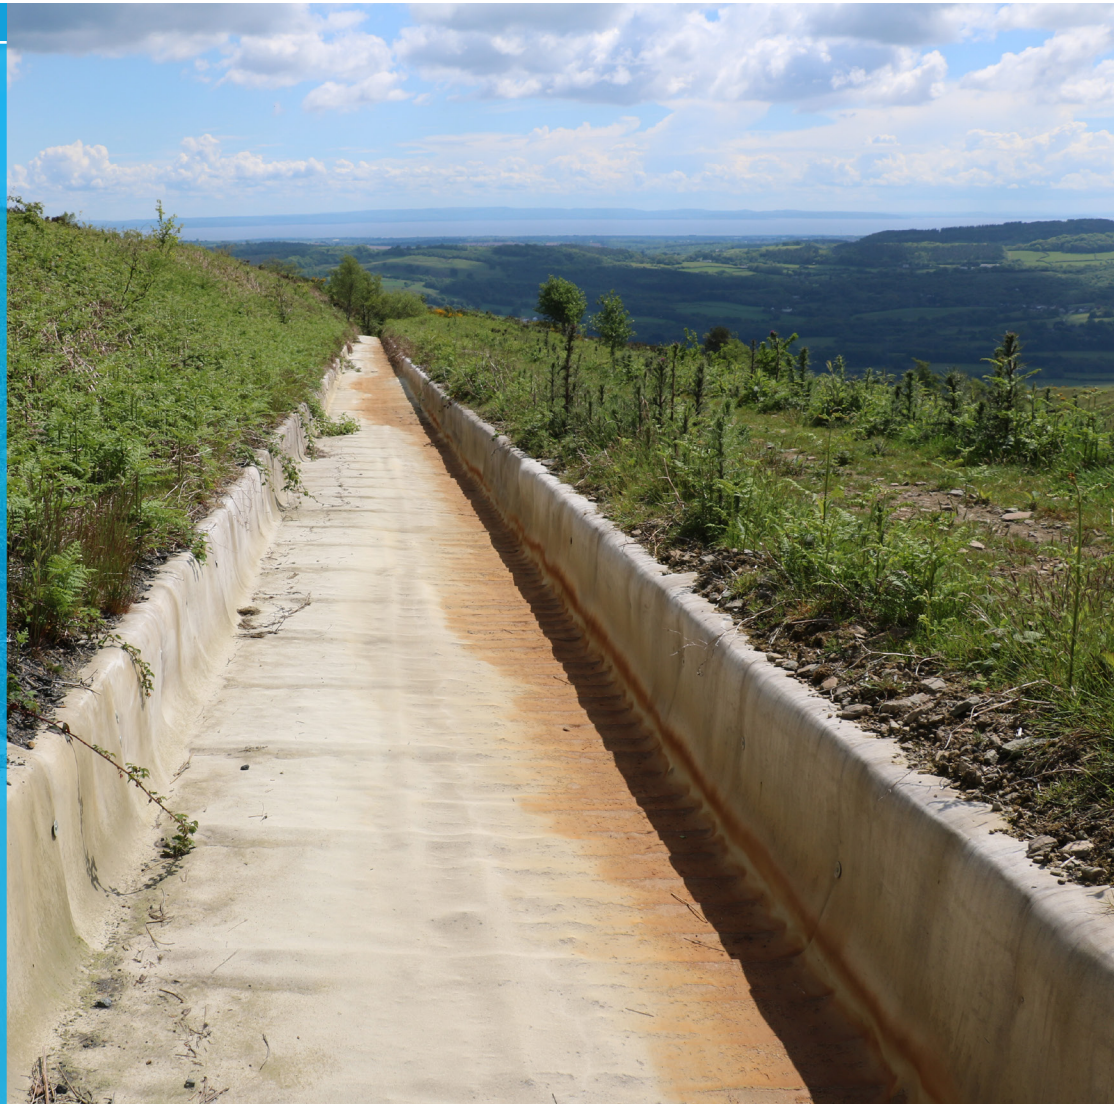
Completed section of CC lined drainage channel at Bedwas Colliery

The design specifications required CC8 lining longitudinally to the channel invert, followed by a CC5 lining transversely across the channel. This was carried out by the team, and the material positioned, fixed, jointed and hydrated as required to form the new concrete channel within the existing section.

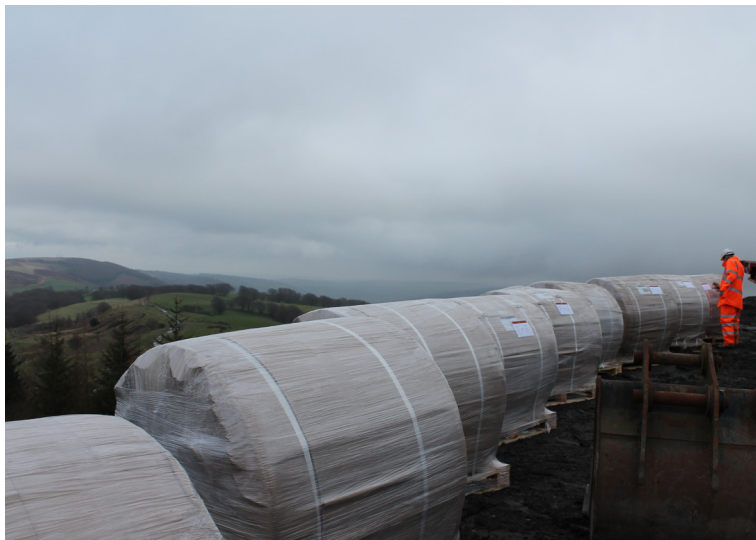
Bulk roll delivery

For speed of installation, CC bulk rolls were specified. However, this came with several challenges due to the hilltop location of the site and the steep access routes. In order to mitigate environmental impact, small access routes were created and most of the works were carried out from inside the existing channel. The up-slope side wall was replaced prior to lining and a fixing detail was put in place following a collaborative design process with CCBC, Walters, Concrete Canvas and Hilti.

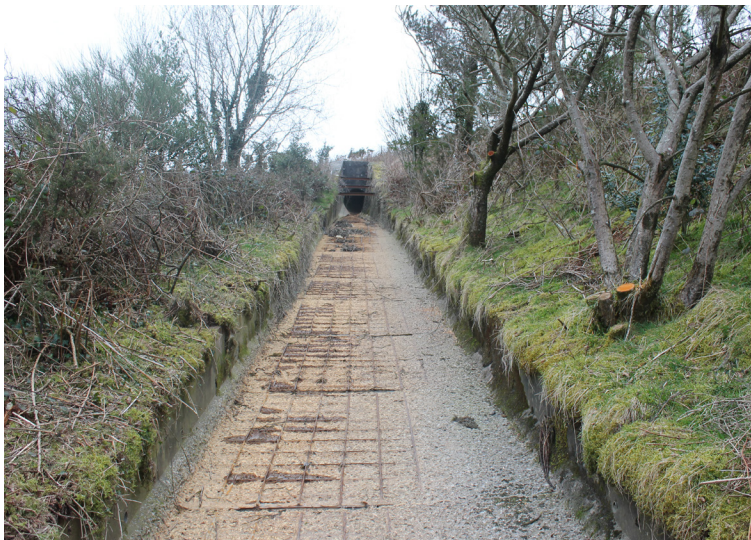
Due to the high flow of water through the existing tip drainage channels, heavy scouring had occurred, eroding the concrete and exposing the reinforcement below. Some sections had also experienced severe erosion to the side walls. Walters Group were appointed by CCBC to carry out the concrete repair works to a 340m section of drainage channel. The purpose of the works was to replace the existing side wall with a new wall case, inside the existing channel prior to lining. Two sections of drainage channels were then proposed for lining with CC, each approx. 1000 linear metres in length with varying profile widths.

Channel prior to works

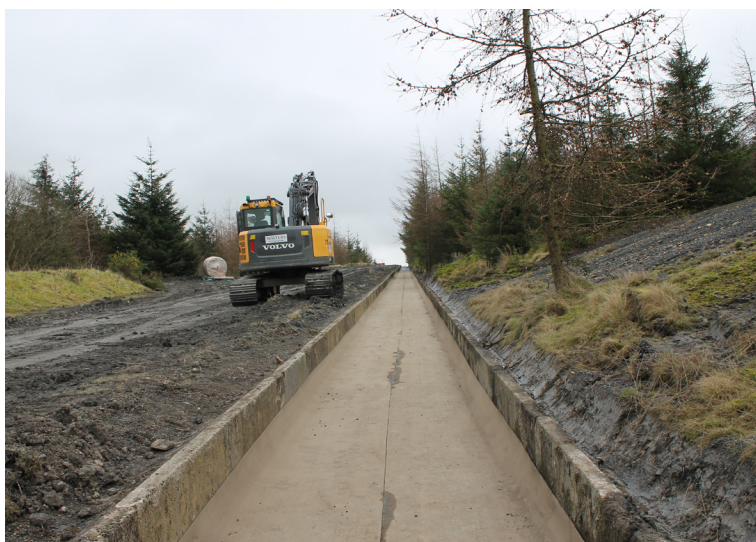
Original concrete section of channel

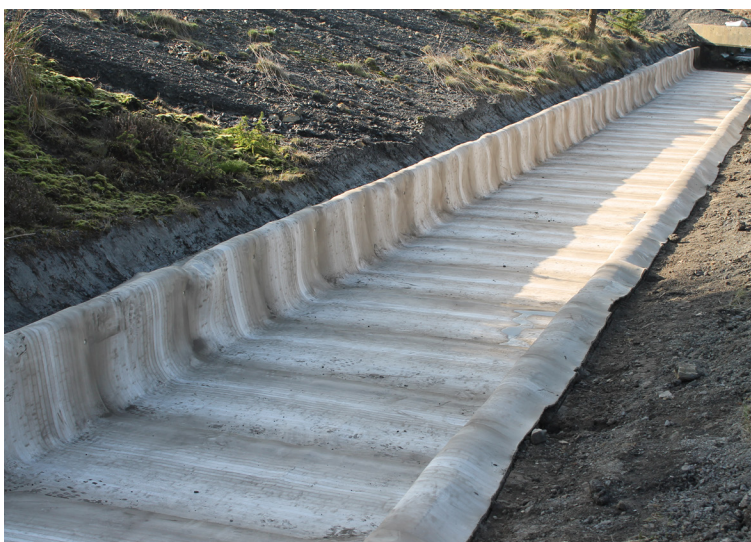
CC was laid transversely

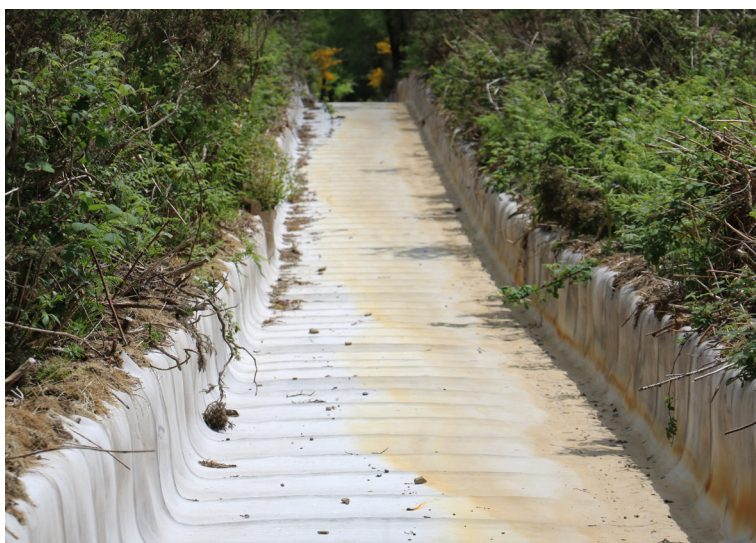
CC fixed to invert using shot-fired nails

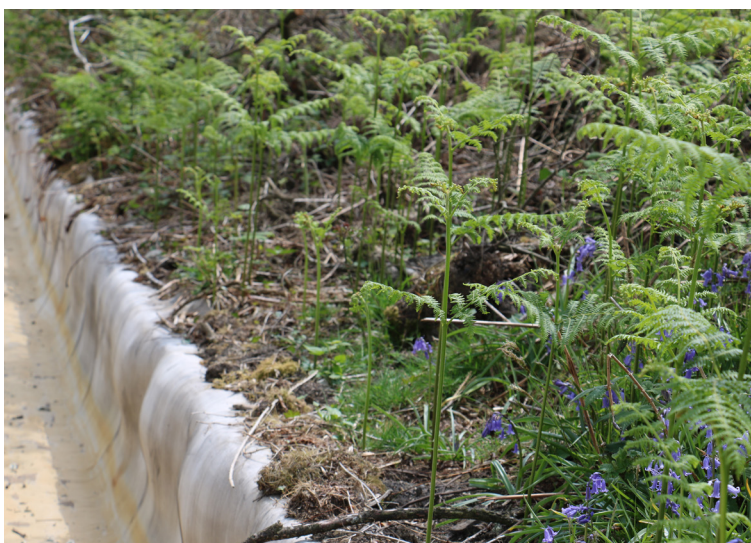
Back filled anchor trenched edge detail filled

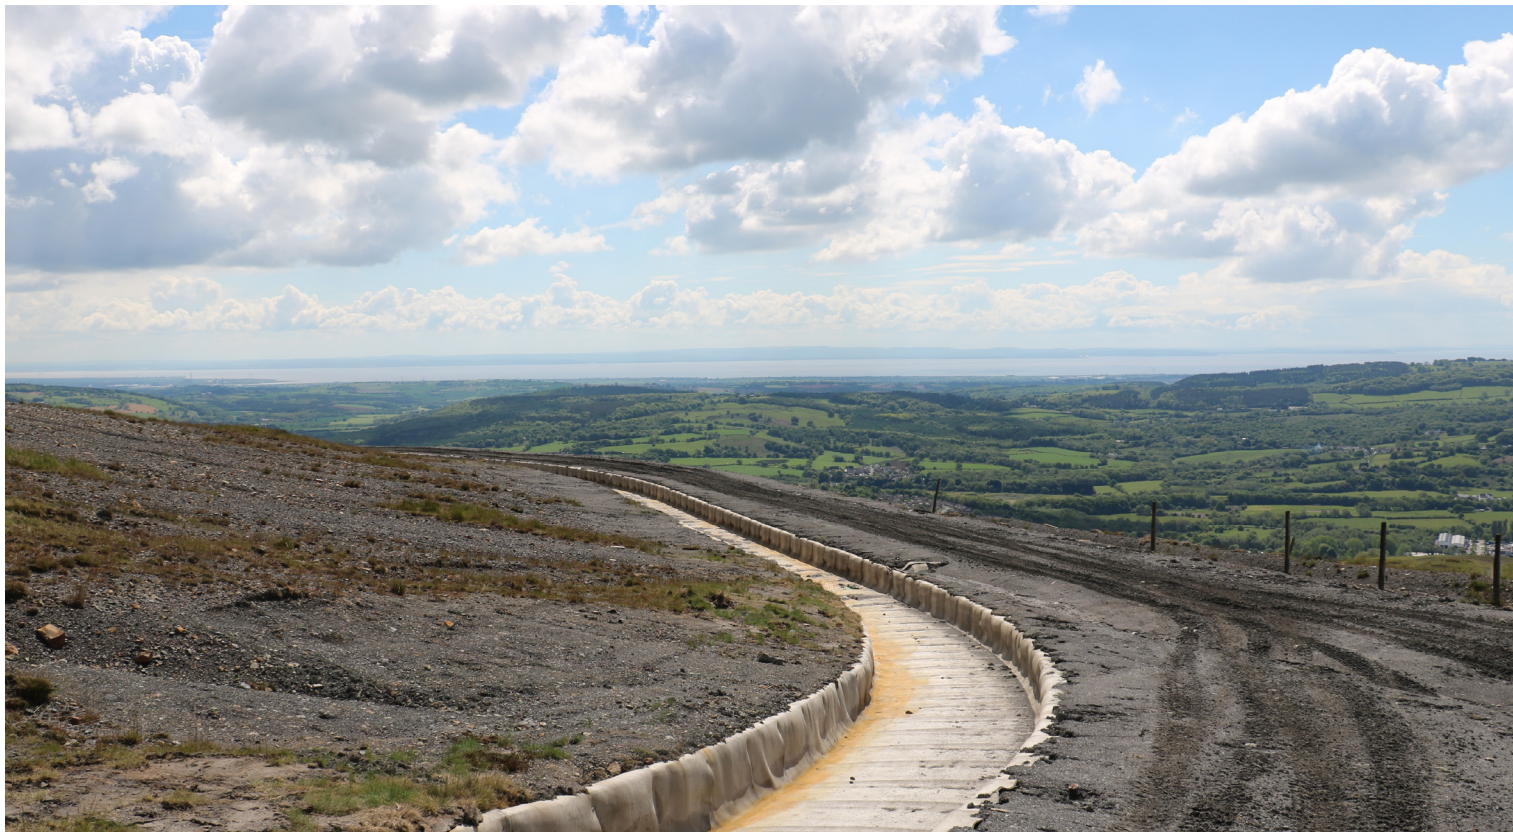
Completed remote access section
