CC8™ Bulk Rolls

Bower Quarry, Halkirk,
Caithness, Scotland

CC8™ used to line a series of crest drainage channels to prevent earthworks failure within the slope

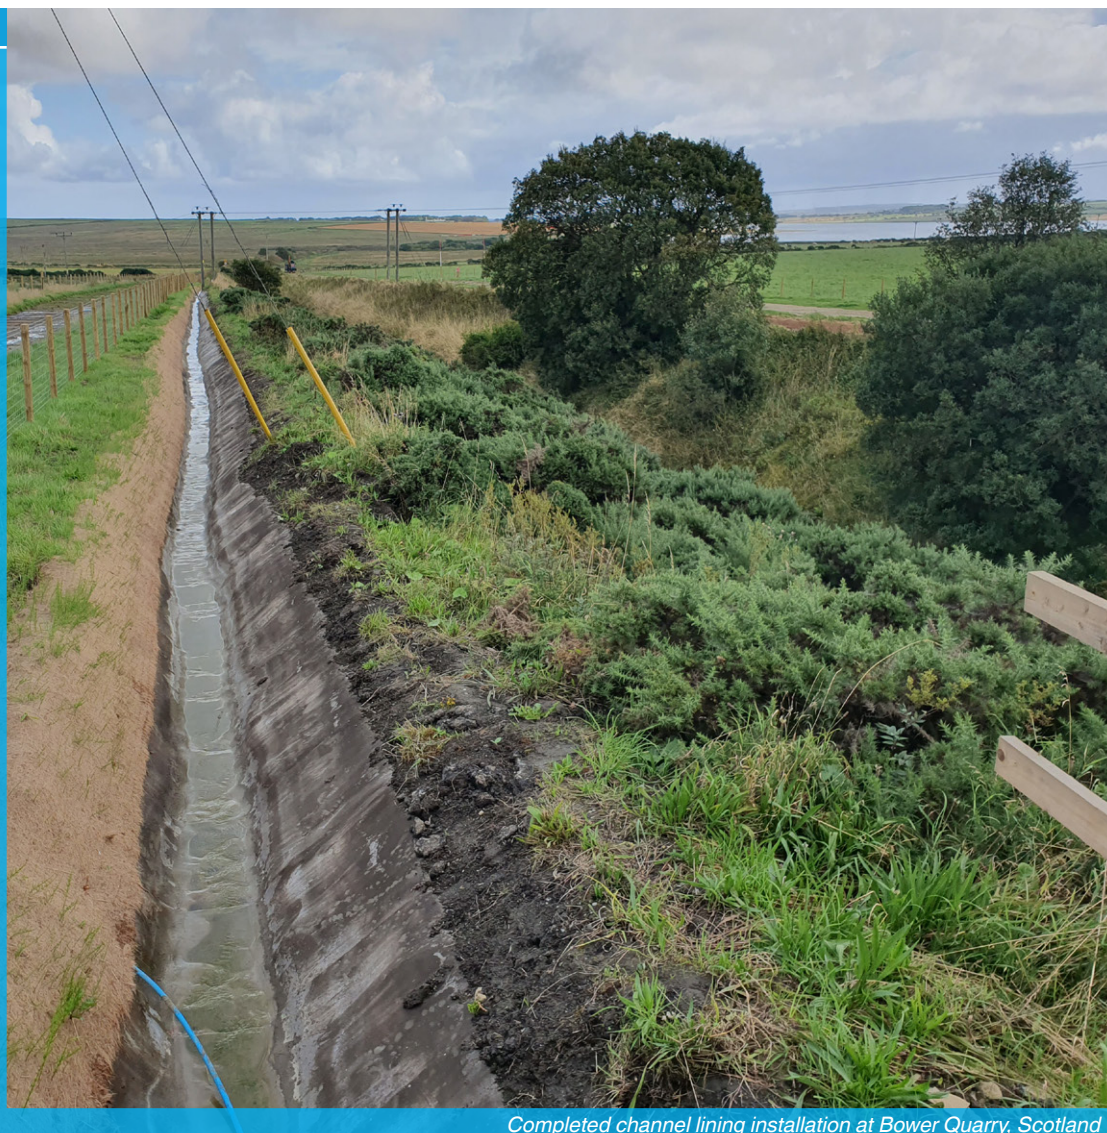
Completed channel lining installation at Bower Quarry, Scotland

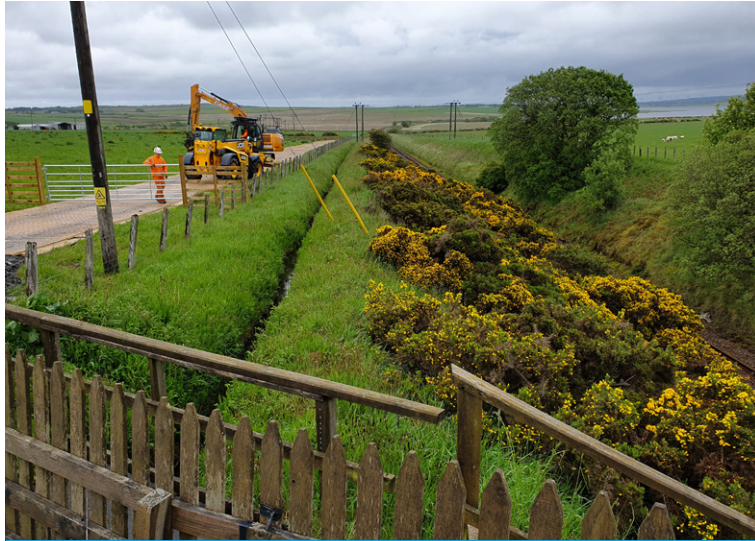
Unlined crest drainage channel

The cutting beside the Far North Railway Line in Halkirk was subjected to water ingress by surface runoff from the adjacent saturated agricultural field.

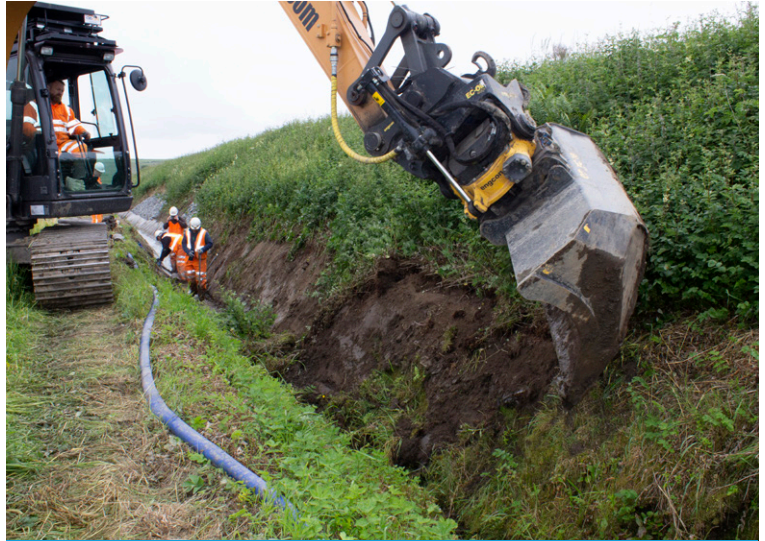
Channel excavation

Over 1000 linear metres of trapezoidal channel were excavated and measured 500m in depth, 600mm wide at the base with 45-degree side slopes. The works were carried out by QTS Group Ltd on behalf of Network Rail.

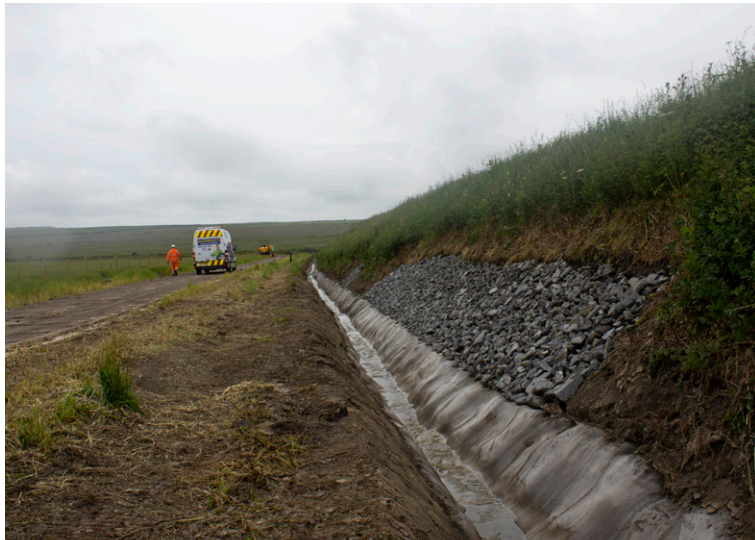
CC installed prior to erosion mat

BBA certified CC8™ material was specified for the project and delivered to site in bulk rolls. The bulk rolls were deployed using a spreader beam mounted on tracked plant machinery from the adjacent field. The material was unrolled into the channel transversely and cut to specific profile length. The CC8™ layers were overlapped by 100mm in the direction of water flow and were then screwed together at 200mm intervals using 30mm stainless screws.

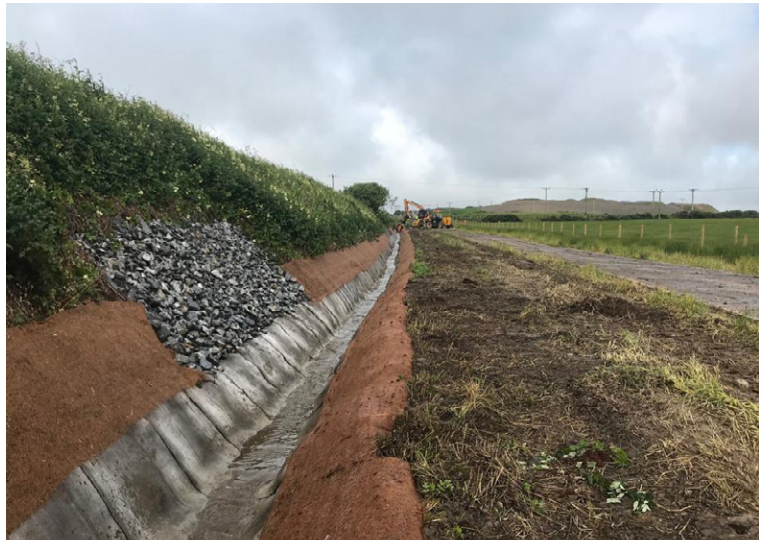
Erosion mat installed on field side

On the track side the material was terminated into a 150mm crest anchor trench and fixed to the substrate using 250mm ground pegs prior to being backfilled with material. The CC8™ material extended 300mm up the opposite side slope and anchored into the slope by 200mm using 250mm ground pegs. A permeable erosion mat was then installed from the crest of the field side slope and terminated 100mm below the CC8™ material, allowing surface runoff from the adjacent saturated field to migrate into the CC lined channel.

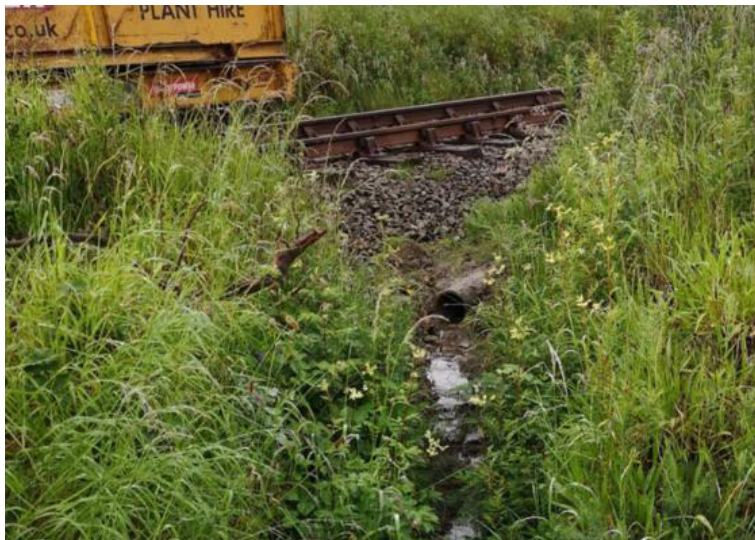
Unlined arterial drainage channel

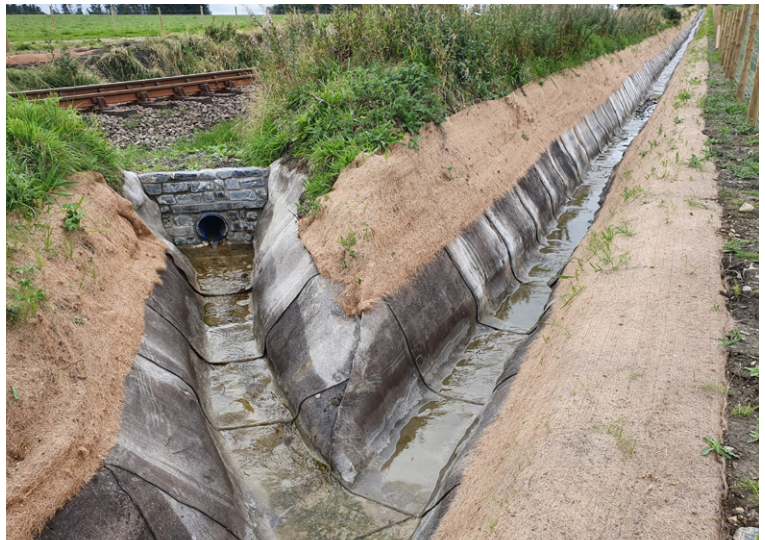
CC lined arterial drainage channel

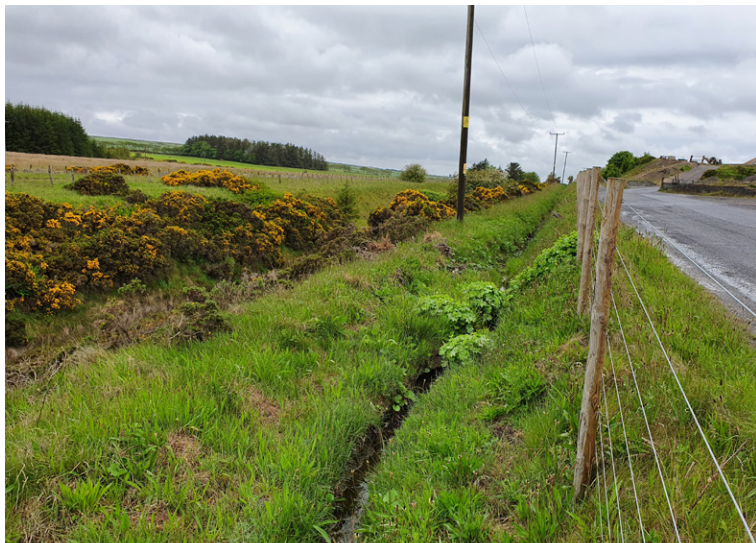
Unlined channel showing scour

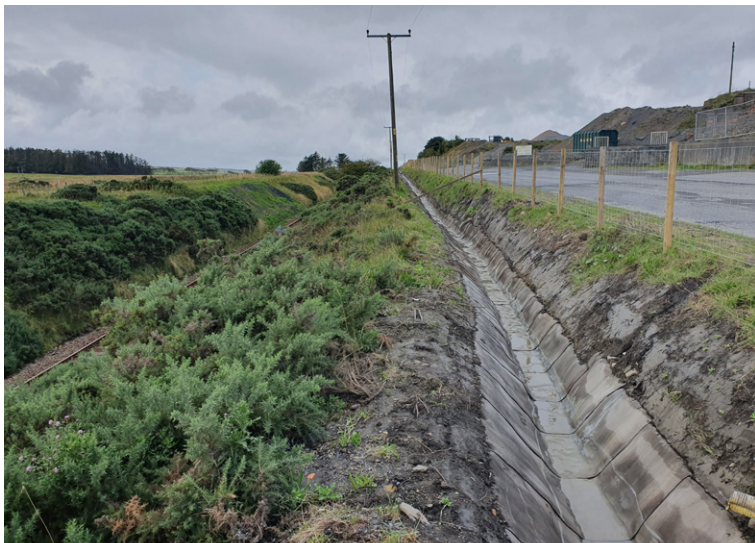
CC lined channel

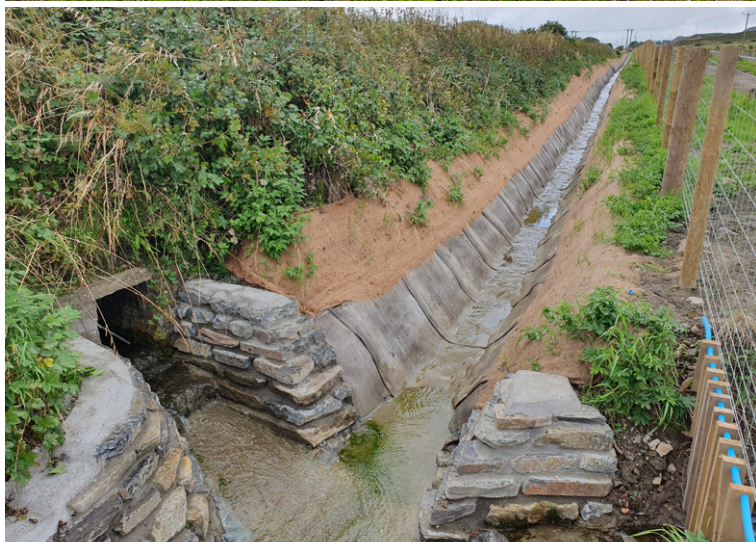
CC junction & culvert interface

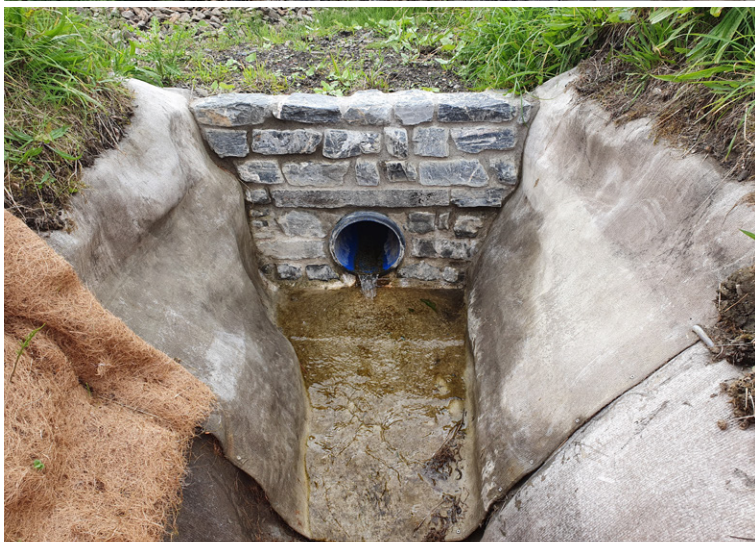
Headwall detail

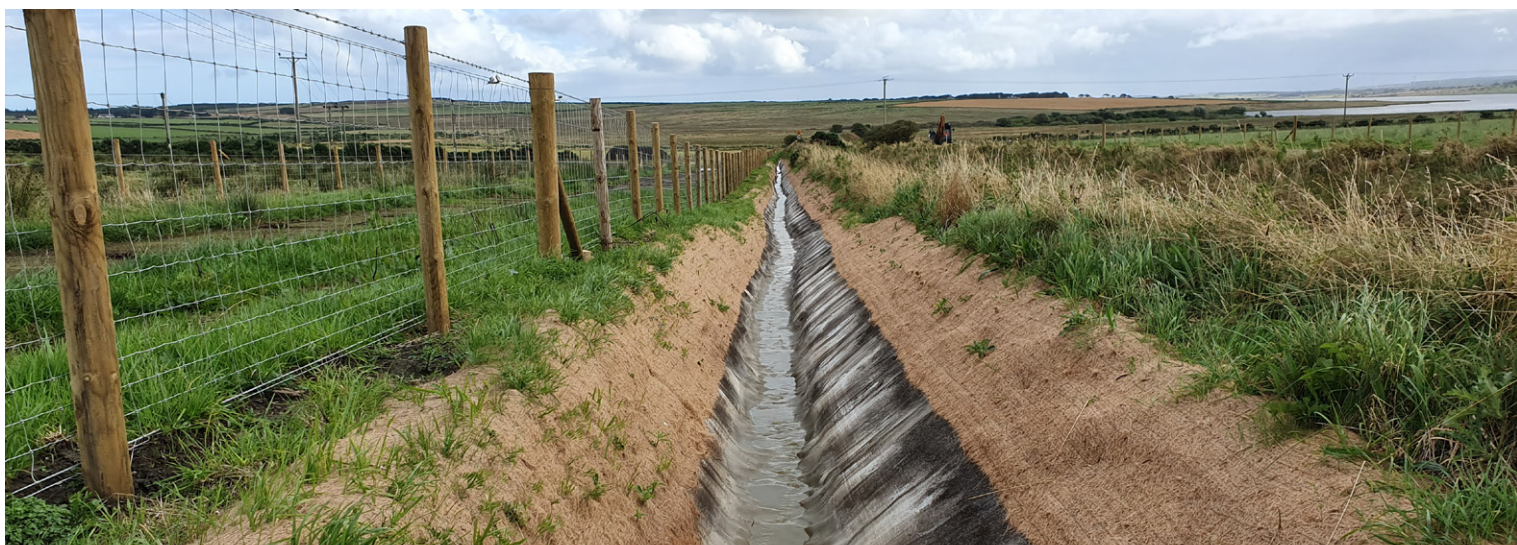
Completed CC lined channel

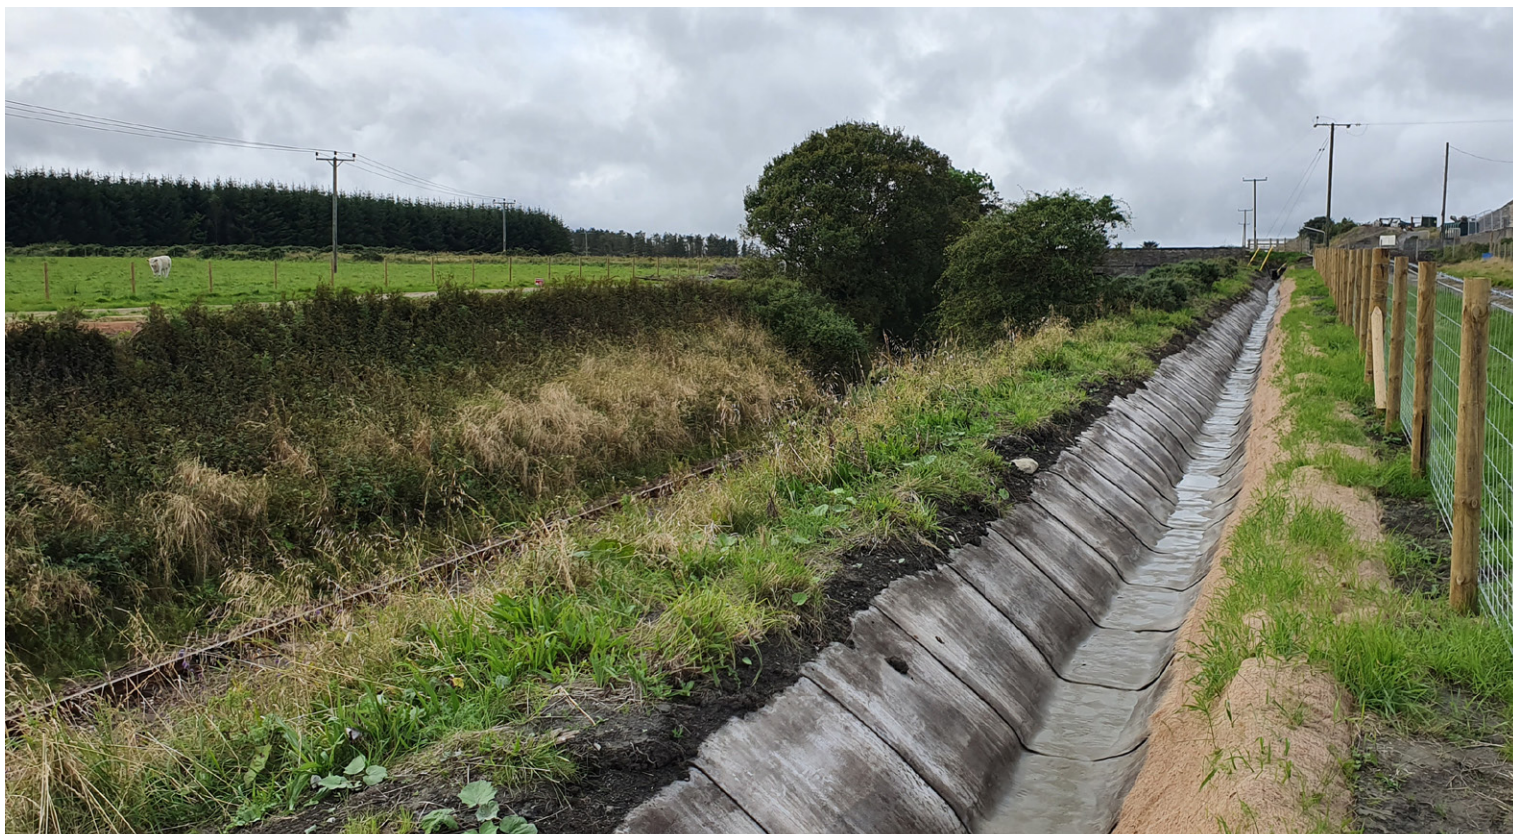
Completed CC lined crest drainage channel
