CC13™ Bulk Rolls

Branscombe, Devon

To prevent erosion and instability of a steep slope that had recently experienced a landslide

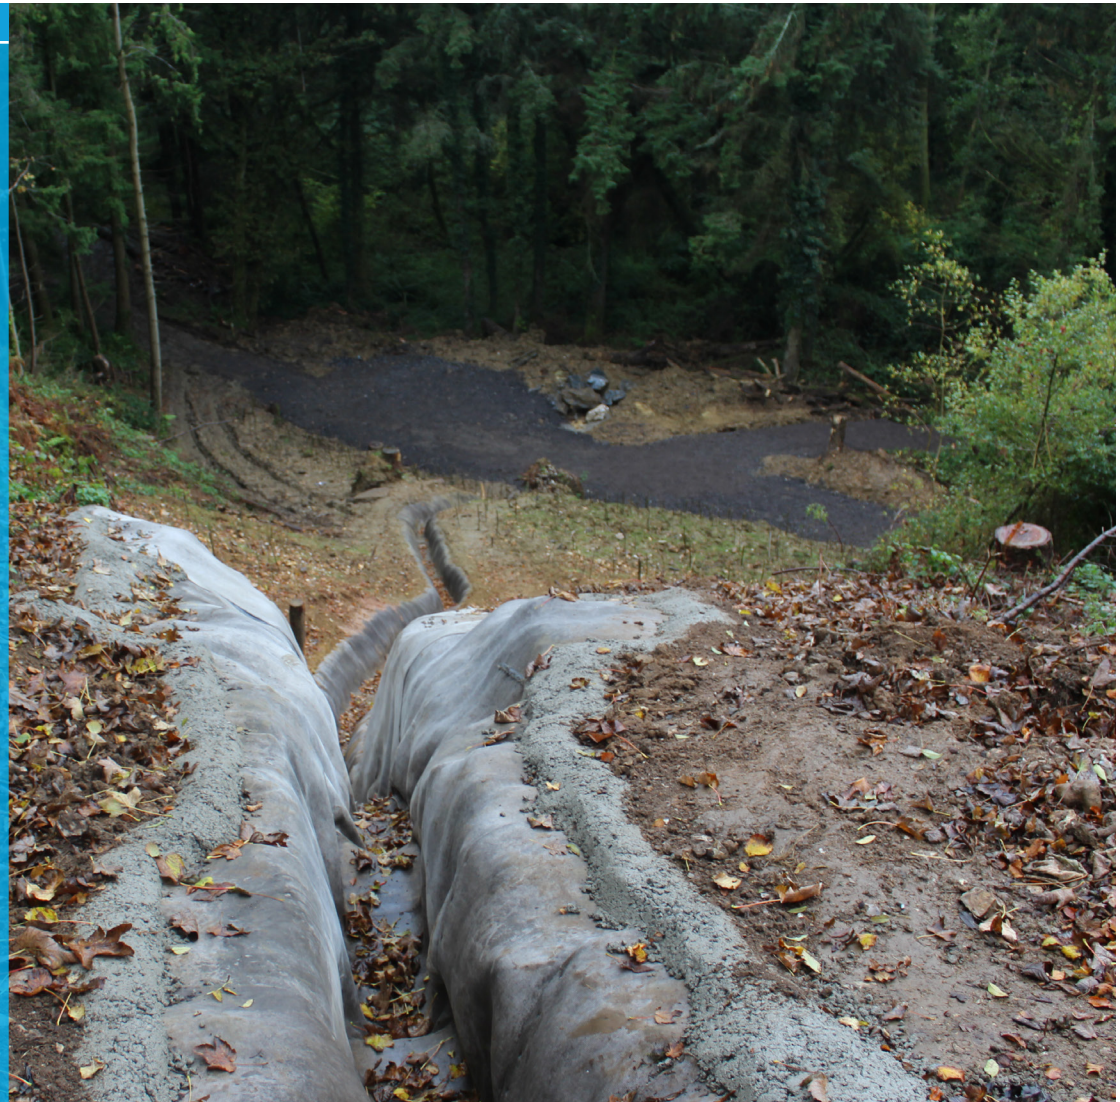
*The finished installation, from the top of the slope*

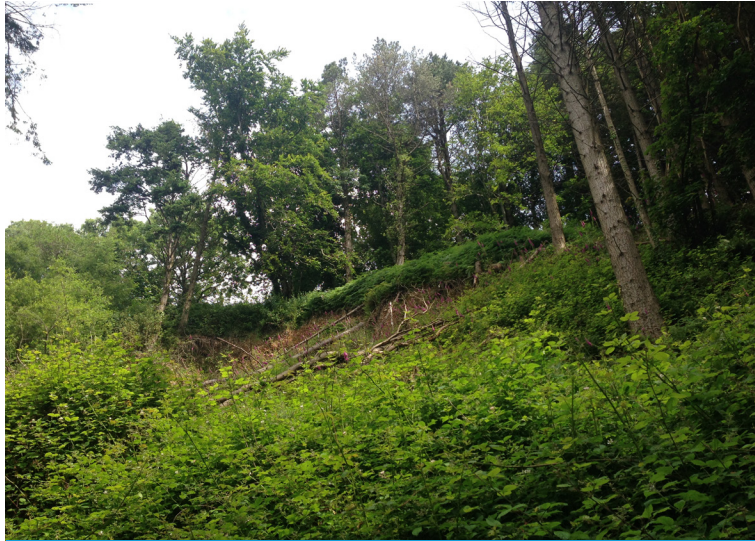
*Visible signs of a previous landslide*

In September 2016, Concrete Canvas® GCCM\* (CC) was used to create a drainage channel as part of remedial works to a recent landslide. The greensand on clay slope had recently experienced a slippage, created by surface water run-off from a neighbouring field, flowing down the slope causing saturation and instability. The solution involved creating a concrete channel to quickly direct future surface water run-off down the slope and under a trackway, where rocks placed in an outfall pool area would take energy out of the water before entering existing streams in the wooded area. The works were carried out by South West Highways for Devon County Council.

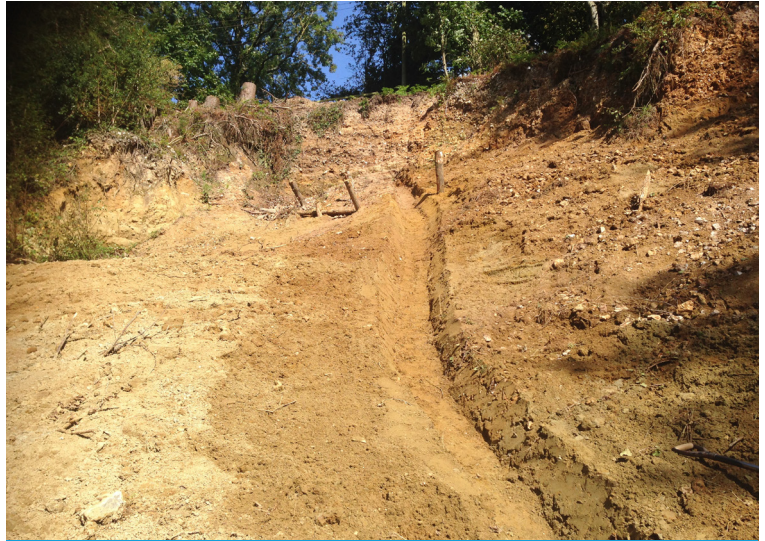
*Vegetation was removed and the channel was dug by hand*

The trees and vegetation were removed from the slope as they were unstable after the slip and were a danger to the workforce. The slope was regraded to a safe angle, before the 70m channel was excavated by hand. The channel was excavated to purposefully create changes in depth and orientation to help control the flow of water down the slope, whilst preventing further saturation and potential further instability. Given the slope angle and soil conditions, access for heavy lifting equipment was limited and the use of conventional concrete channel linings would have been very slow or costly to install.

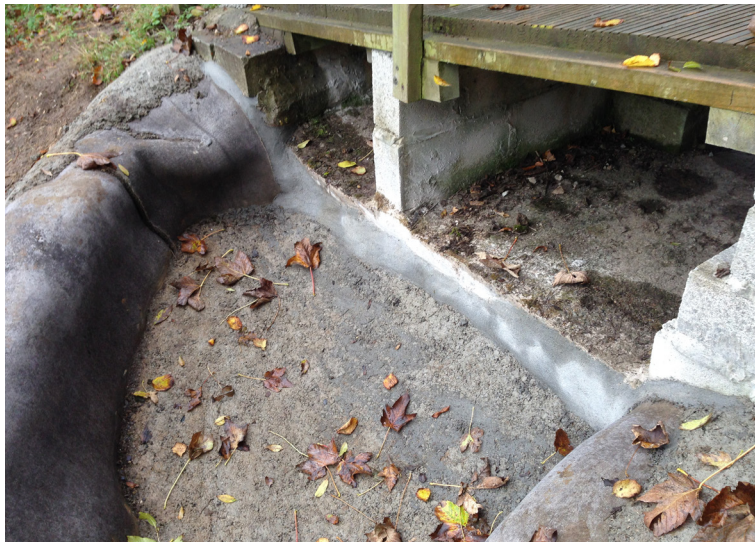
*CC grouted into existing channel*

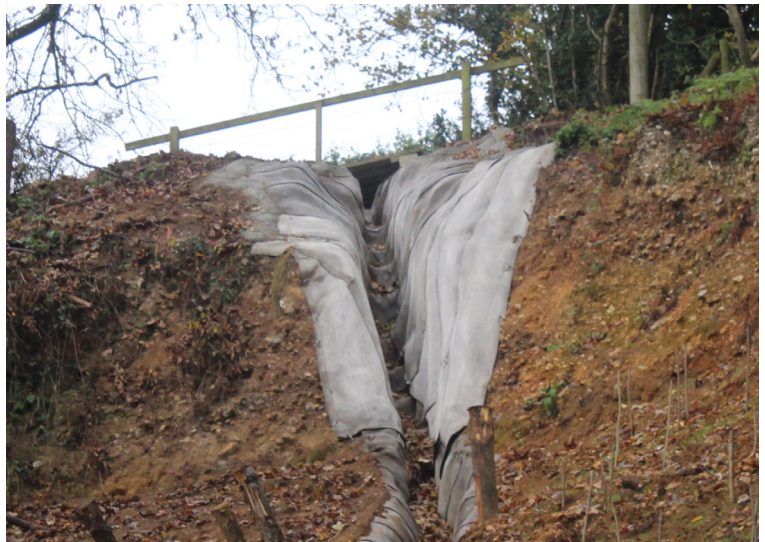
*CC5™ was installed to provide slope protection at the steepest point*

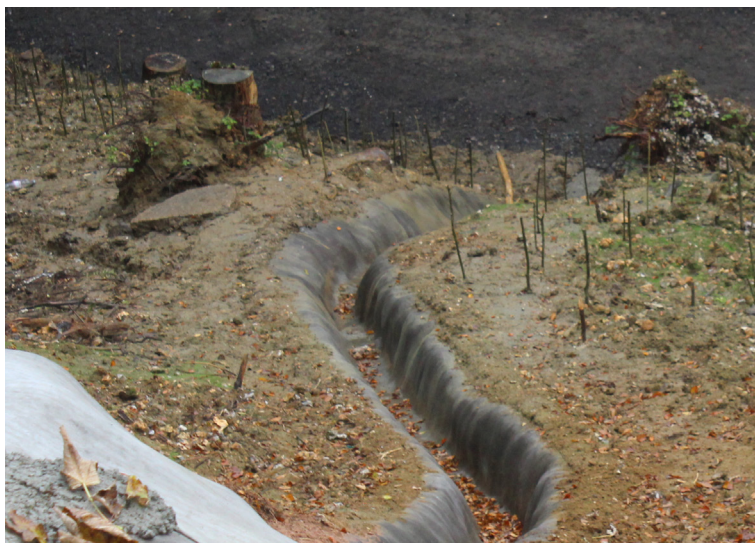
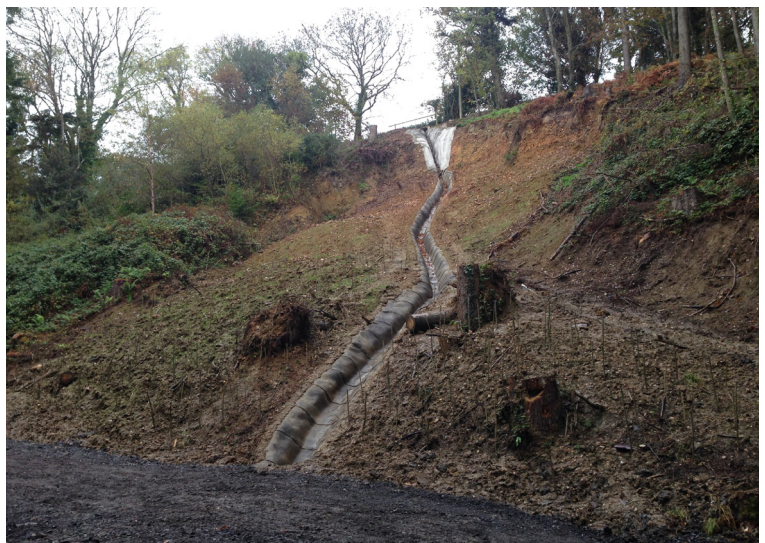
*Channel connected to pipe under trackway*

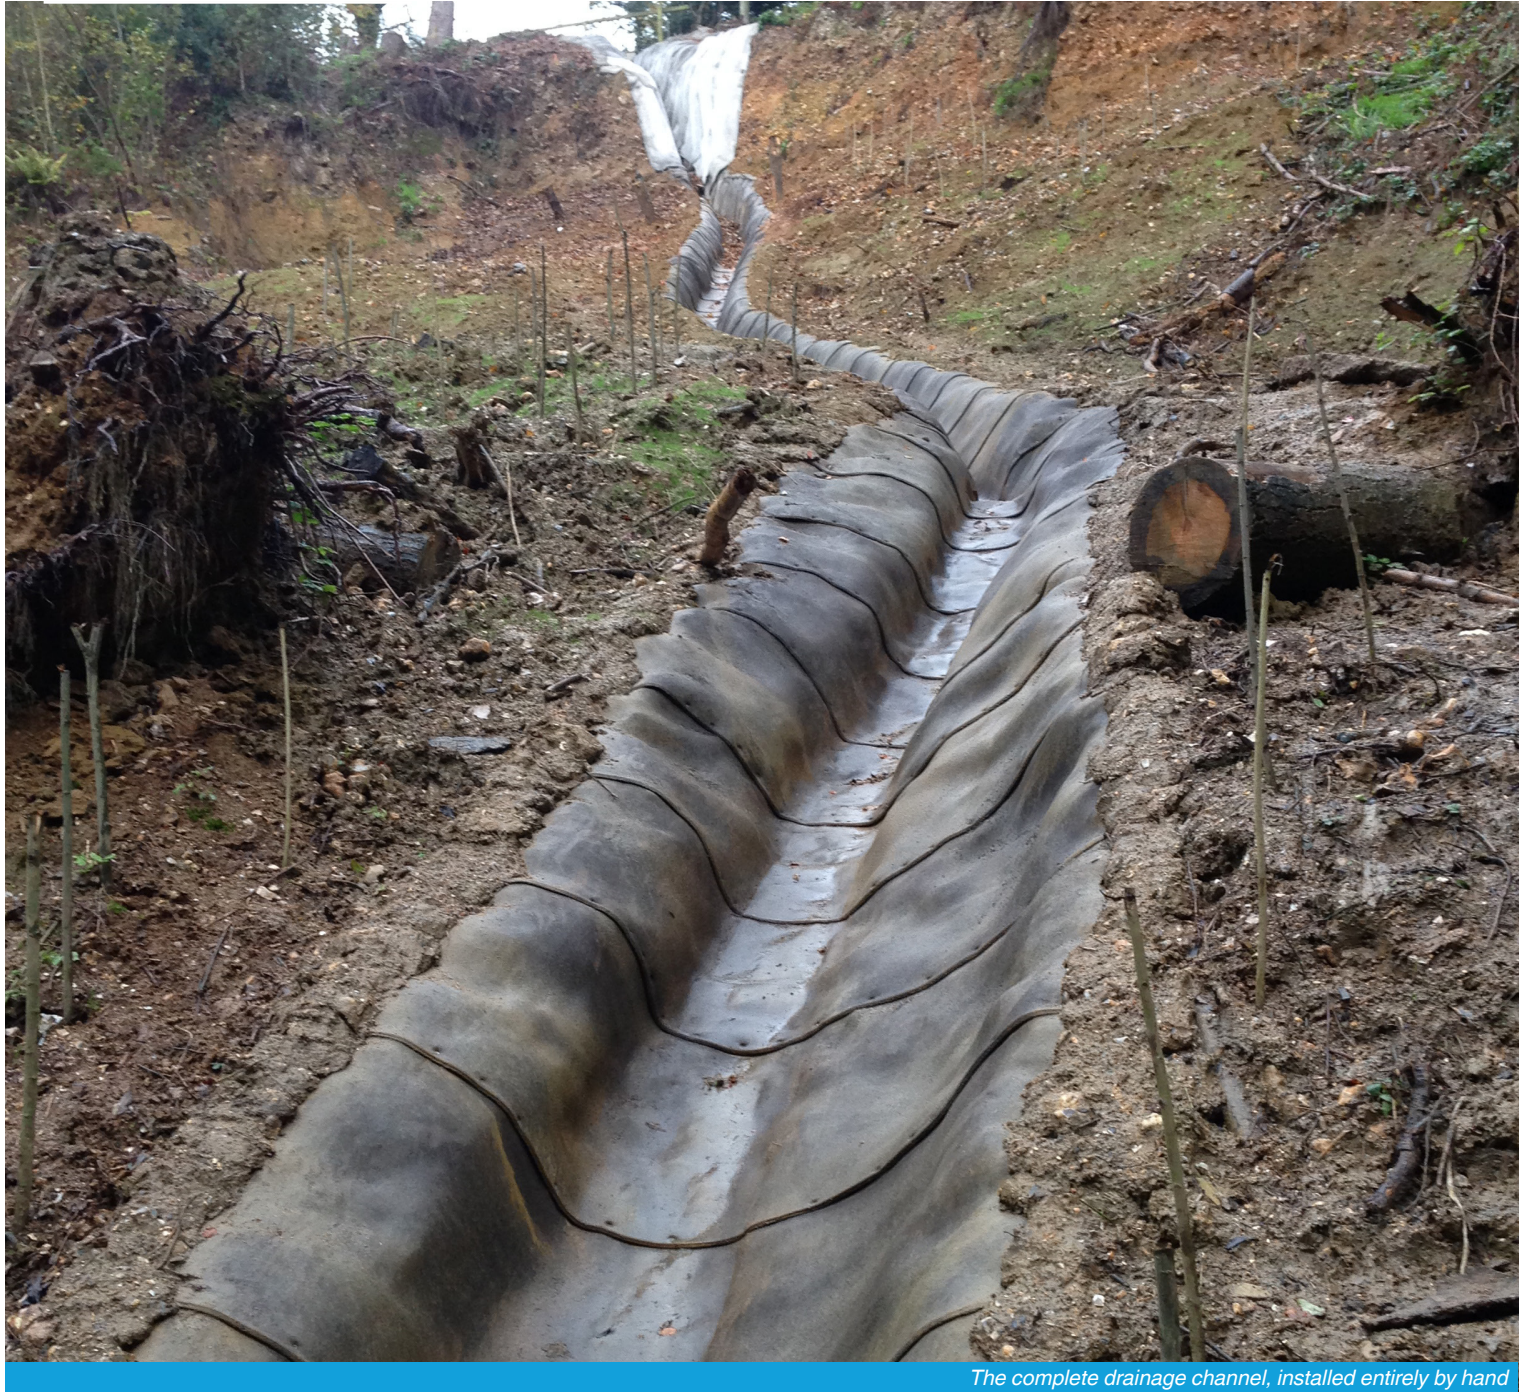
*The complete drainage channel, installed entirely by hand*

CC13™ bulk rolls were delivered to the bottom of the channel, cut to the required cross section length and then transported up the slope by hand. The CC was deployed in a transverse layup to accommodate changes in channel depth and orientation, whilst reducing manual handling requirements. The CC was overlapped in the direction of water flow by 100mm, jointed using stainless steel screws at 200mm centres and anchored to the ground by the use of steel pegs. The anchor trenches at both sides of the channel were backfilled with soil, and the leading edges of the CC were grouted into the existing concrete cattle grid and pipe which ran under the trackway at the base of the structure, to prevent water ingress beneath the CC and to create a neat termination detail.
