CC8™ Bulk Rolls

Corbridge,  
Northumberland, UK

CC8™ was used to line  
a channel as part of a  
scheme to repair the  
landslide which closed  
the Corbridge rail line in  
January 2016.

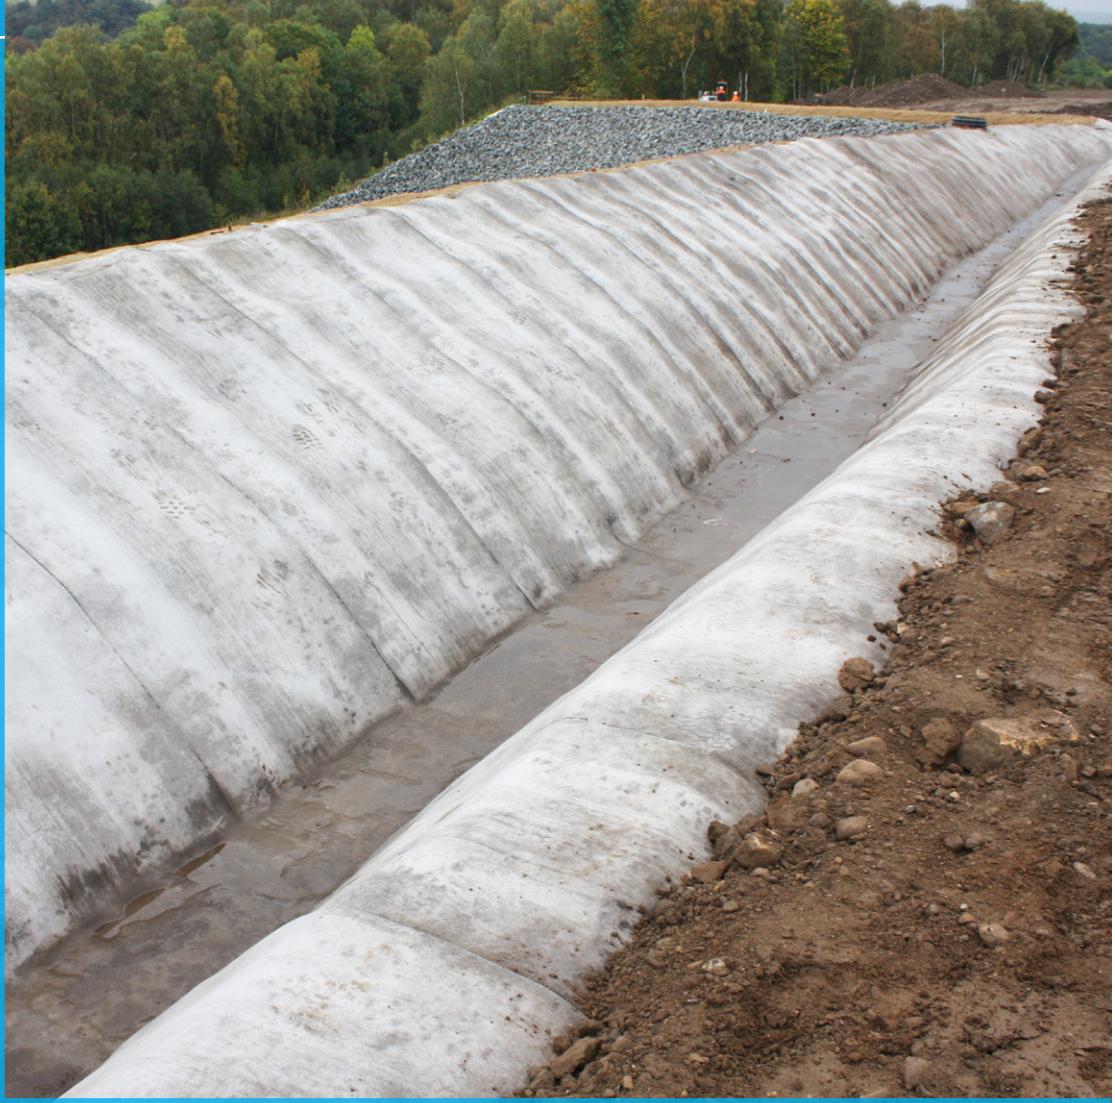
*Completed works near the Corbridge rail line*

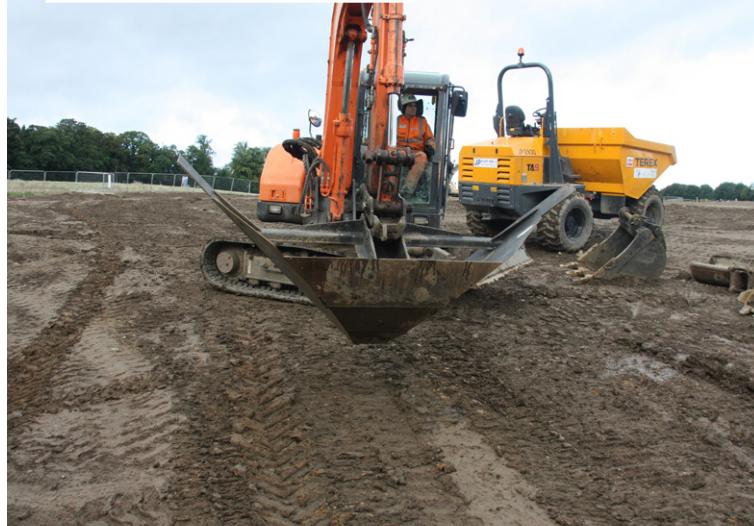
A V bucket was used to dig the channel

In preparation for the installation, CC8™ was delivered to site in bulk rolls and a V bucket was used to dig the crest drain. The CC was then mounted on a spreader beam and hung from plant for easy transportation and unrolling on site. The CC was unrolled transversely across the channel and cut to profile length using hand tools, with layers overlapping by 100mm. The CC was then hydrated between overlaps and fixed using stainless steel screws and ground pegs used to secure it within the pre-dug anchor trenches, which were later backfilled following hydration.

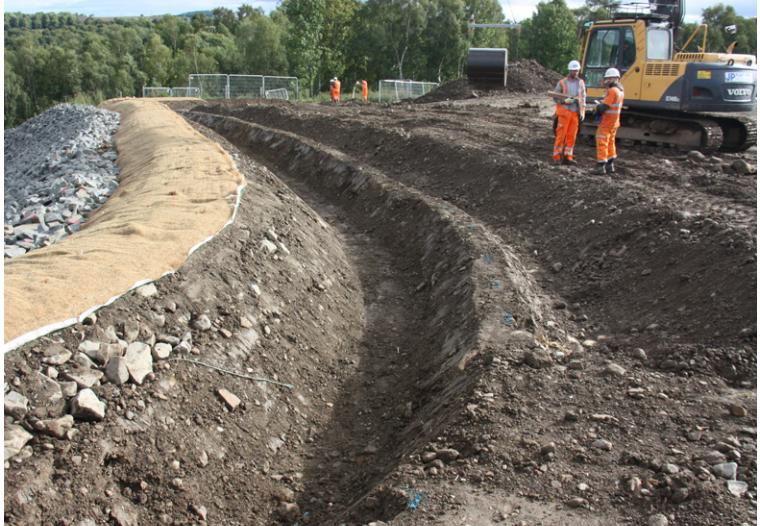
Site after ground preparation

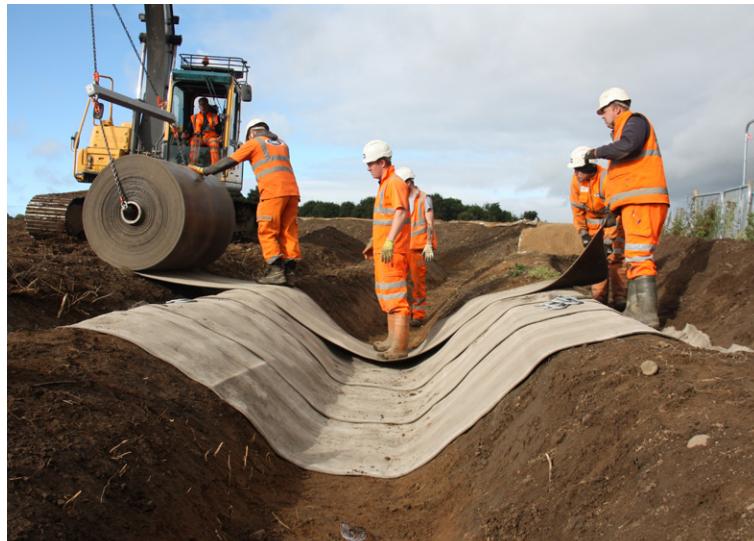
Laying the CC8™

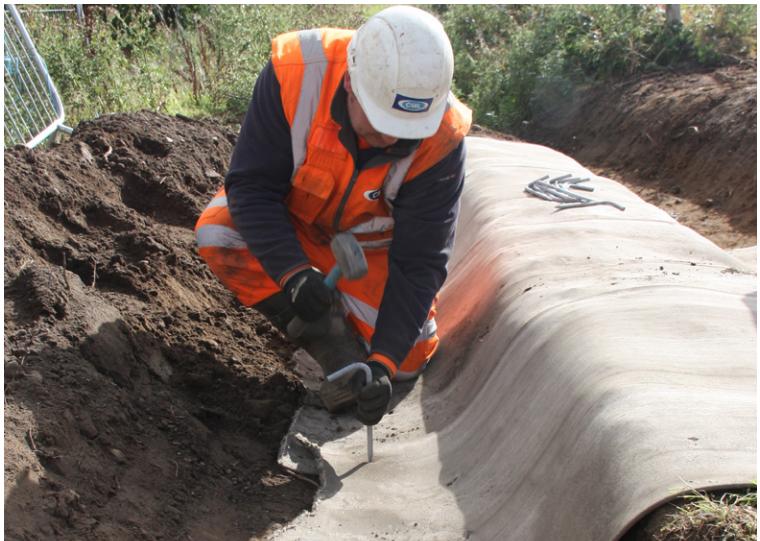
Ground pegs were used to secure the CC in the anchor trenches

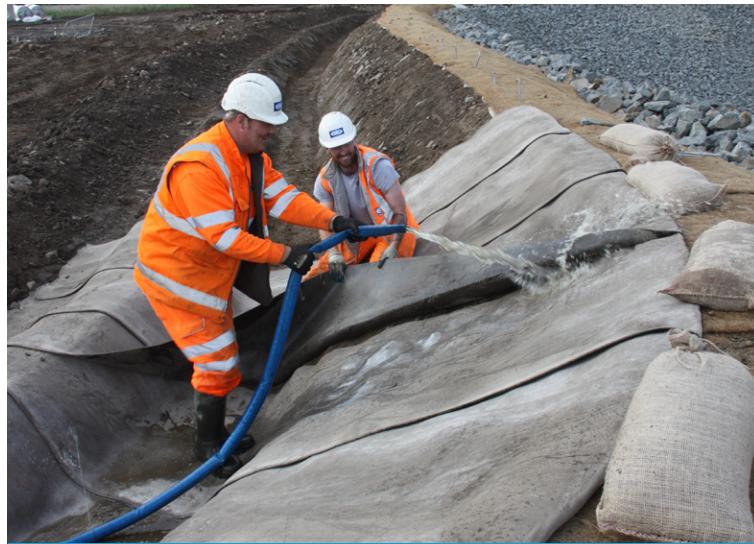
CC under the overlaps were hydrated before fixing

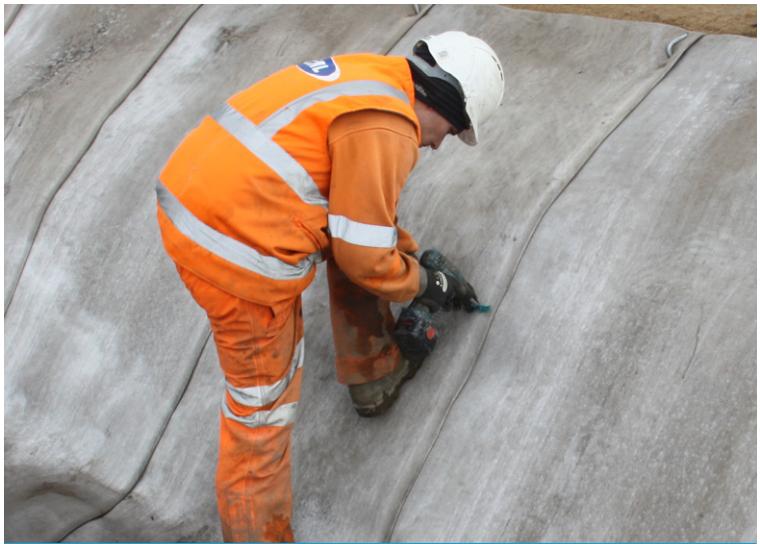
Layers of CC were fixed using stainless steel screws

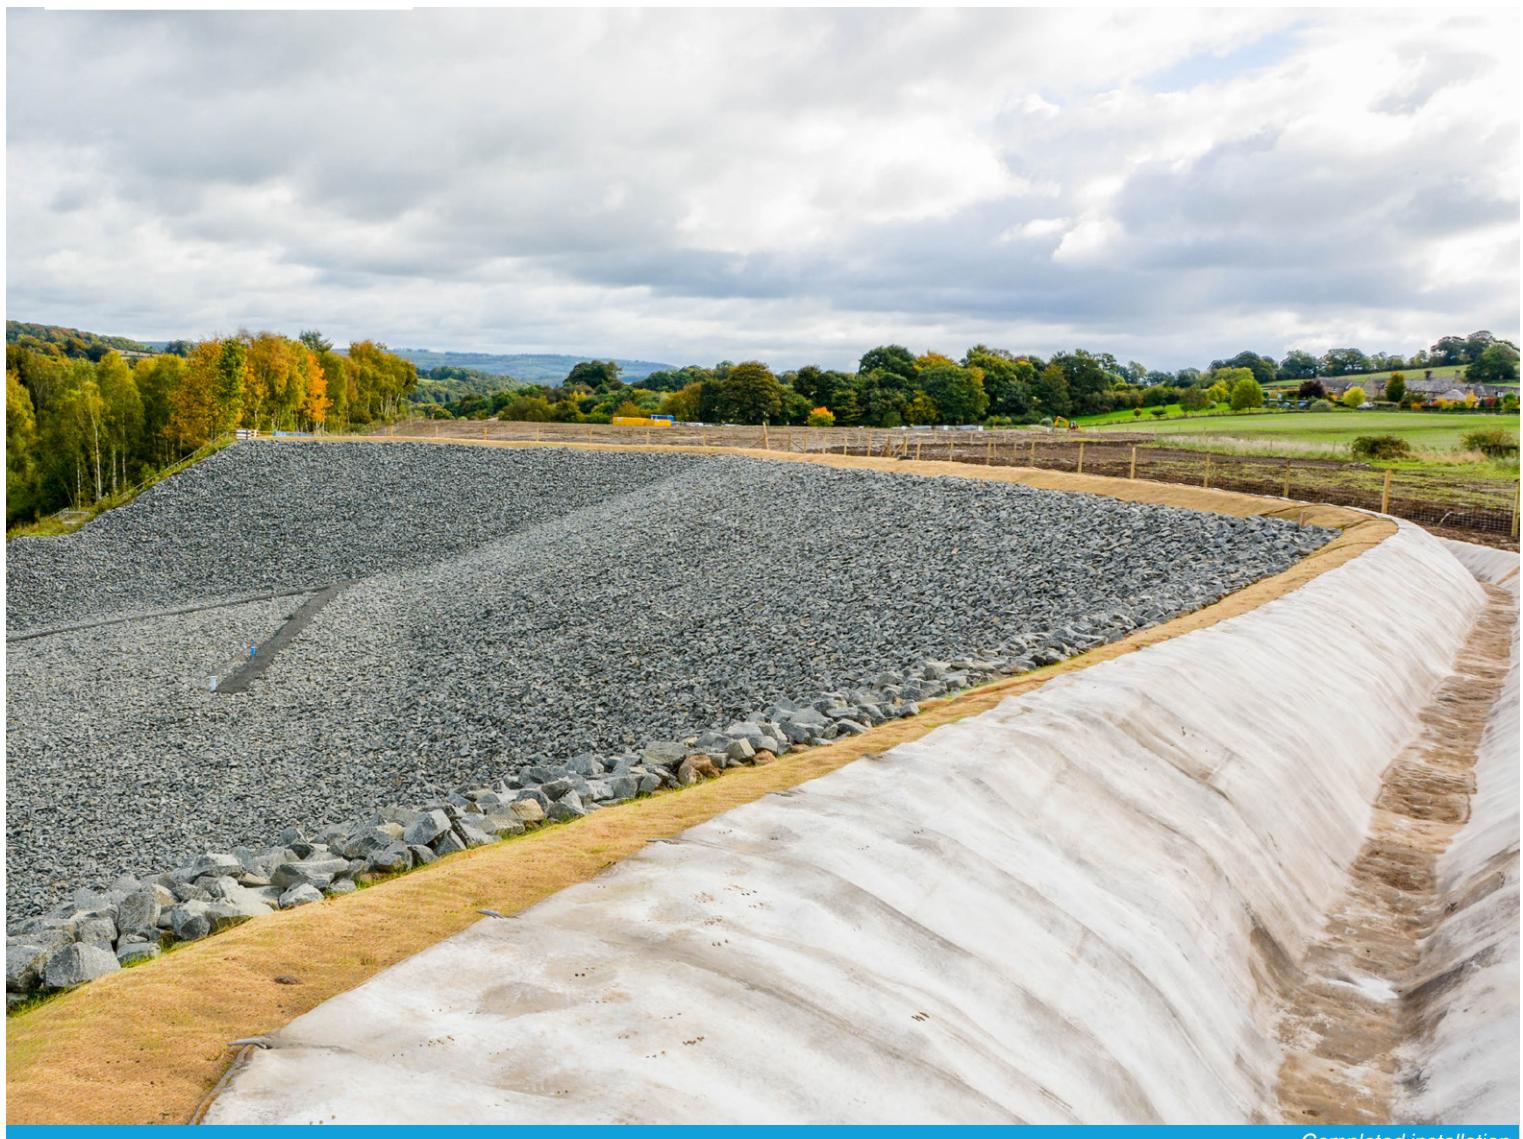
*Completed installation*

In total, 750m<sup>2</sup> of CC8™ were installed by a team of six. The client was pleased with the installation, as it was not only easy and quick to install, but will also help contribute to the long term stability of the cutting and mitigate any potential land slip and subsequent line closures in the future.

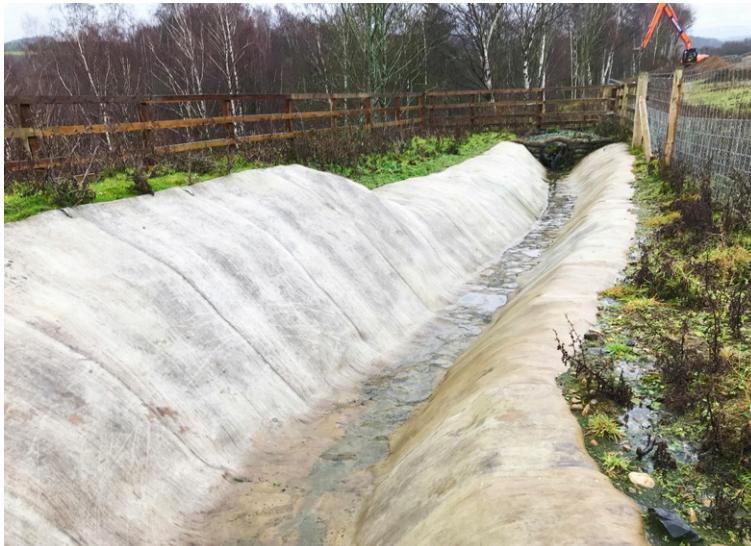
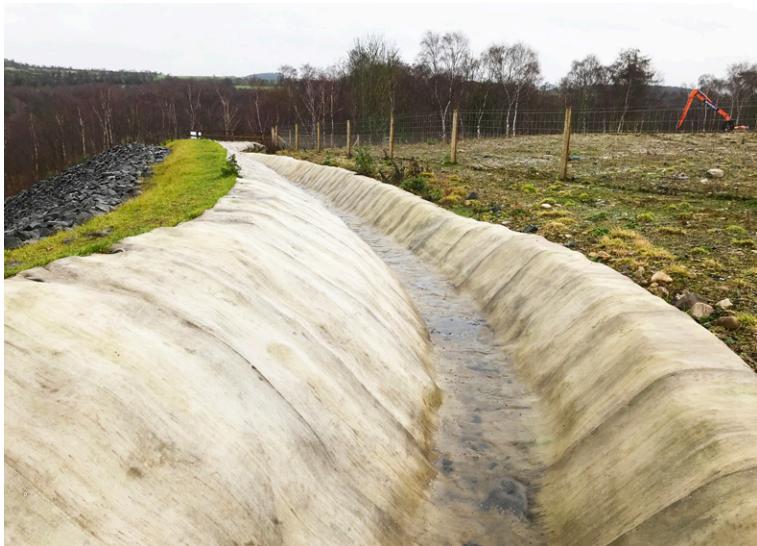
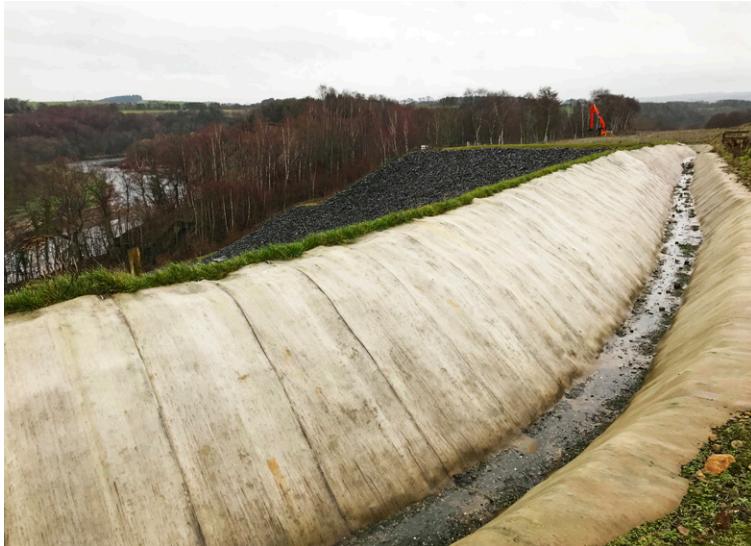
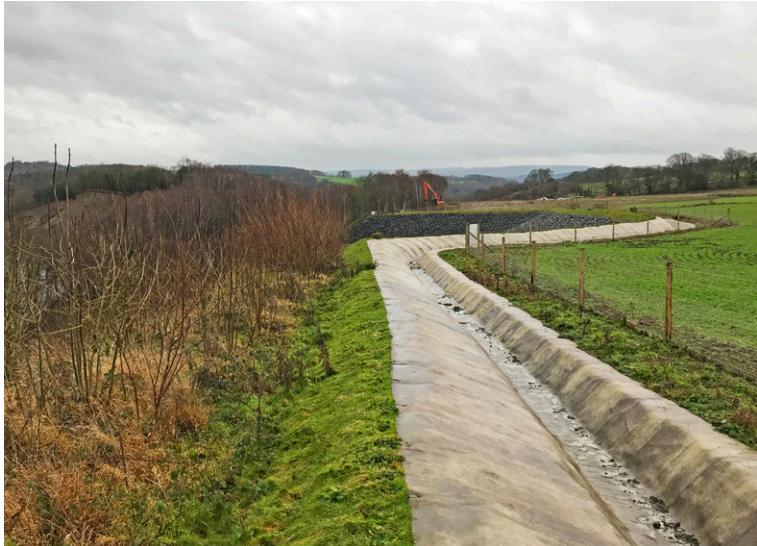
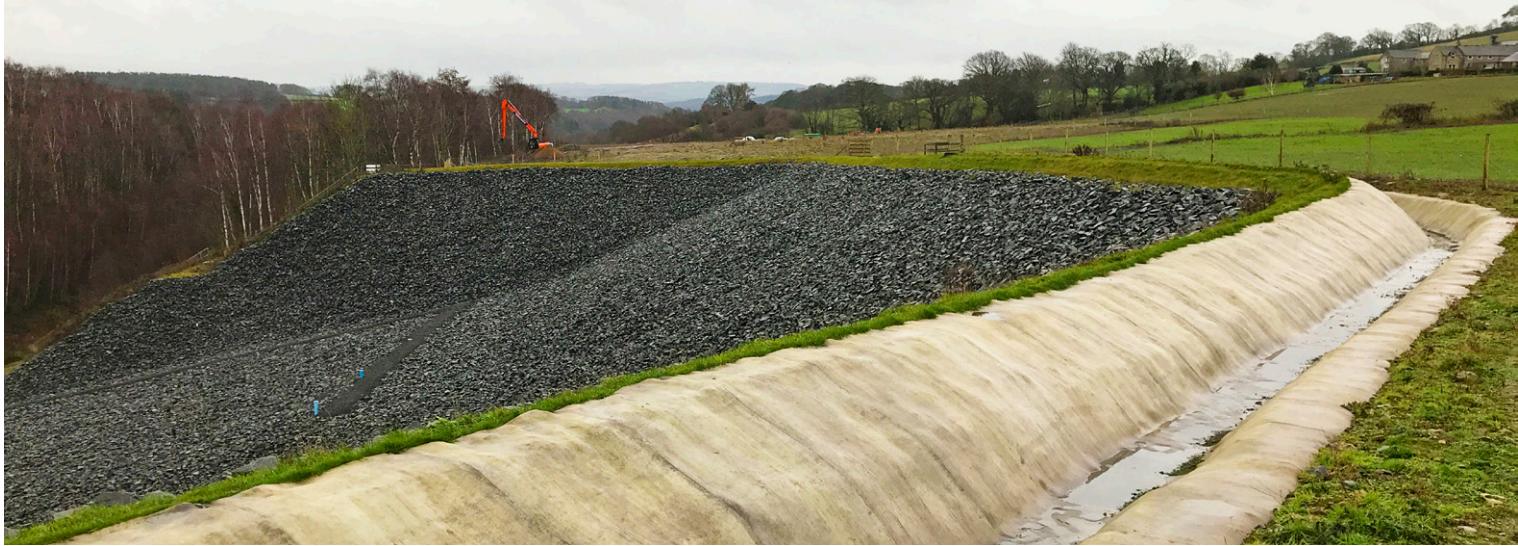
**2 YEARS AFTER INSTALLATION**

Two years after the installation of CC, we returned to assess the performance of the material. CC was found to be performing as per the design specifications. The material is effectively providing water management to the site and is beginning to 'green'. The material will continue to green over time and blend into the surrounding environment.
