CC8™ Bulk Rolls

Covington Road, South Lanarkshire, Scotland

CC used to line a drainage channel along rail cutting to prevent erosion and prevent washout failures.

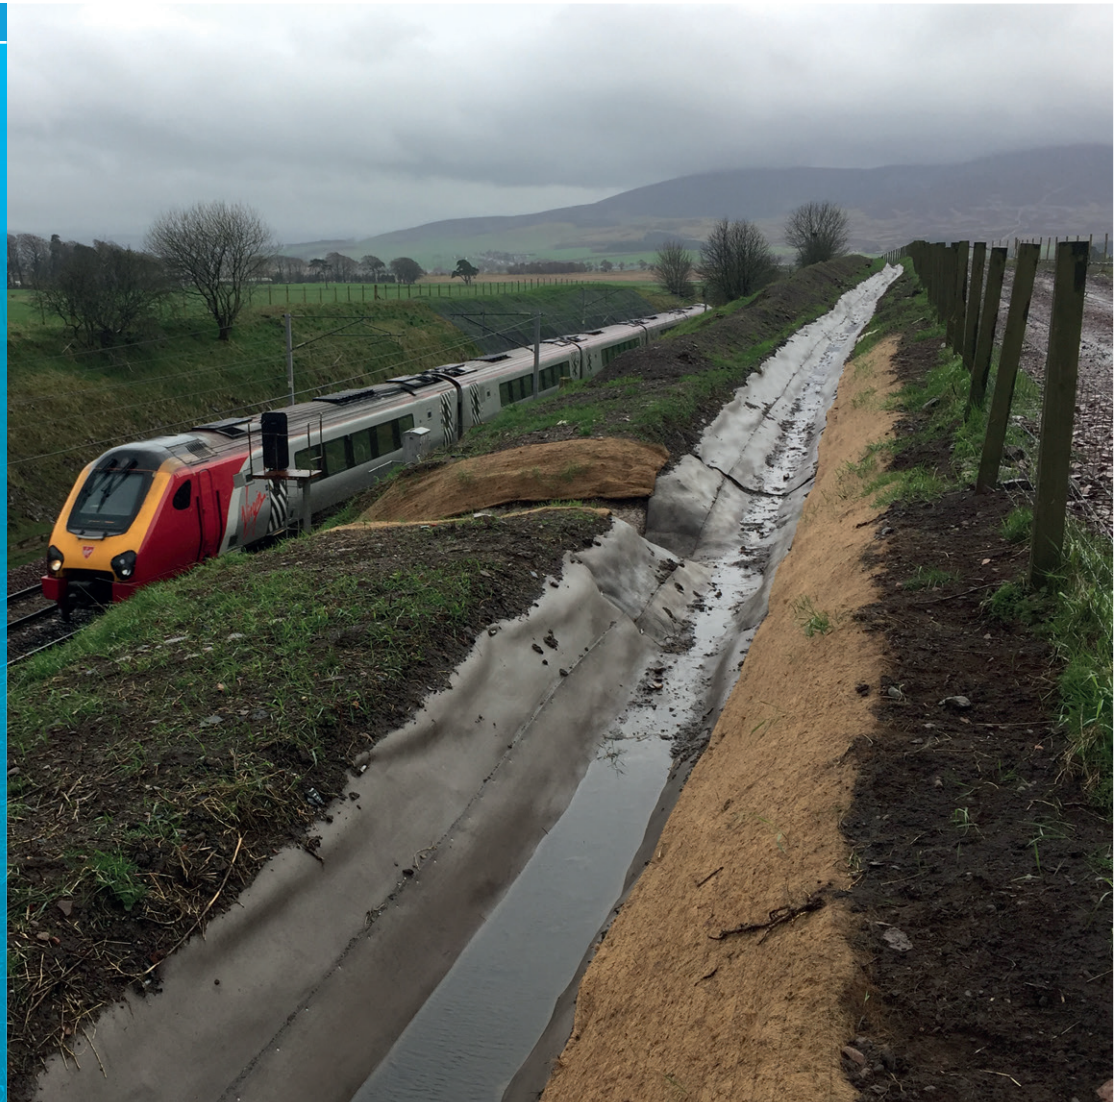
Completed channel lining installation in Scotland

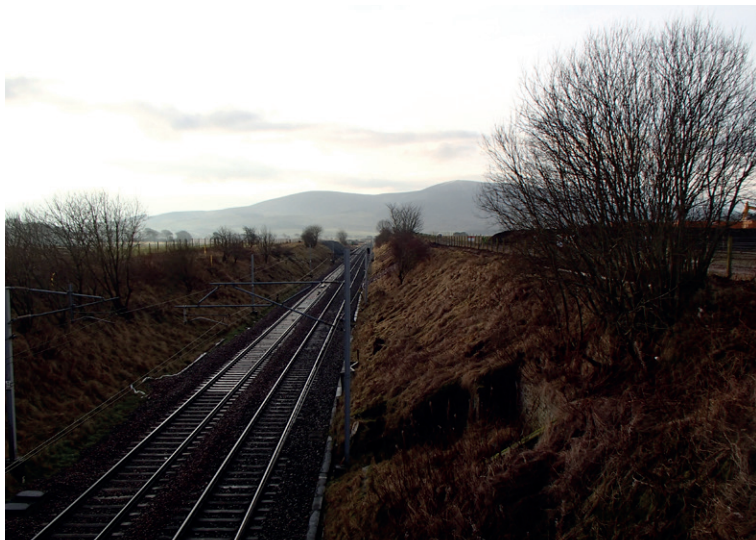
*Railway line and crest drainage channel*

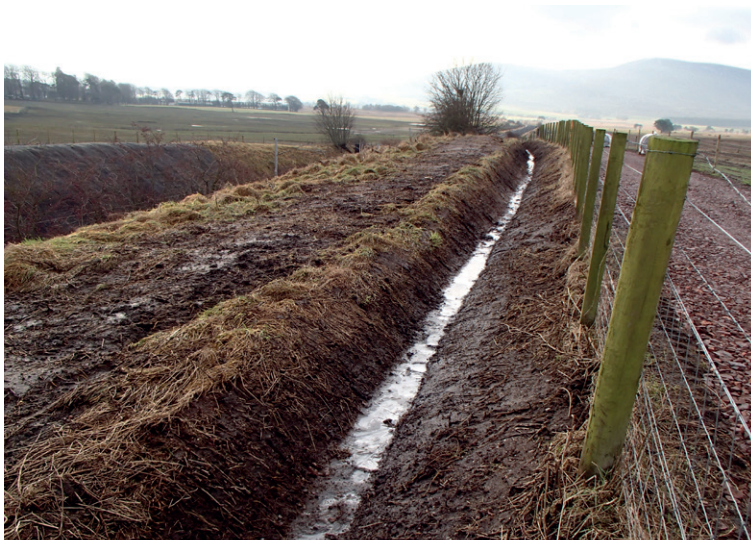
*Excavated channel prior to installation*

10 bulk rolls of 8mm thick CC (CC8™) were delivered to the project site. Prior to installation the channel was excavated and compacted to profile using an excavator and V bucket. Anchor trenches were dug on either side of the channel to allow the leading edge of the CC to be buried so as to prevent undermining. The bulk rolls were deployed with a spreader beam with two layers laid longitudinally and CC overlaps screwed together at 200mm intervals with stainless steel screws.

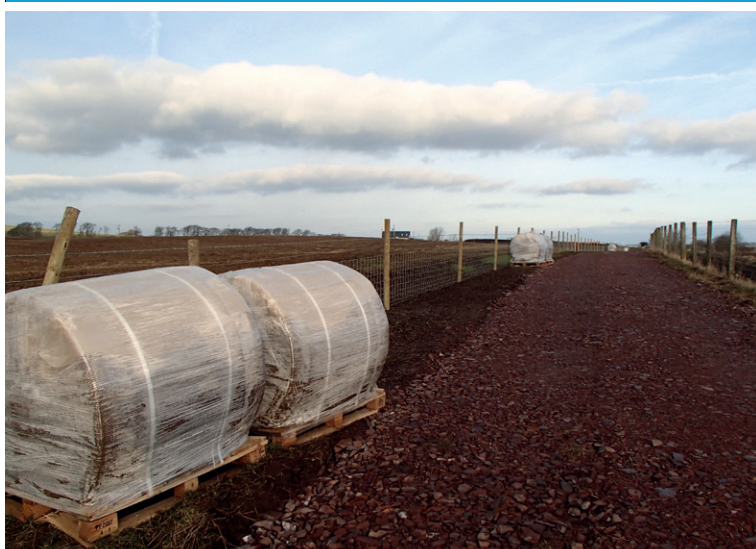
*CC8™ bulk rolls placed strategically at intervals along channel*

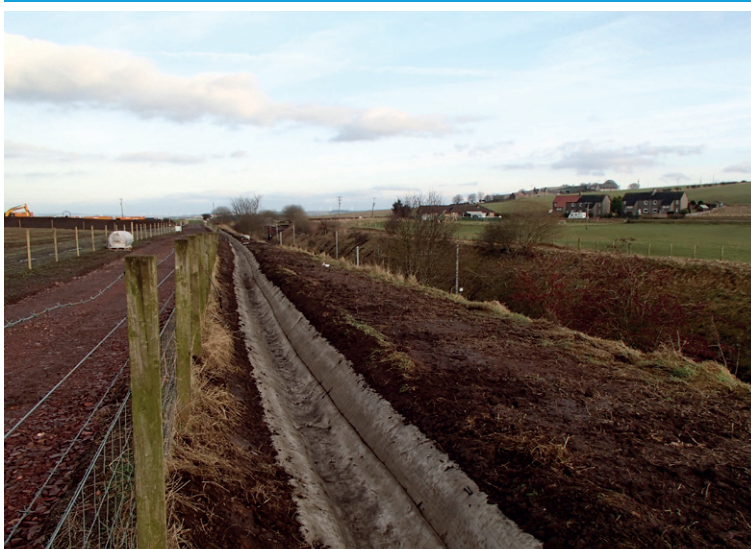
*Two CC layers laid longitudinally and pinned into anchor trenches*

The installation team pinned the material into anchor trenches on either side of the channel with 250mm ground pegs at 2m intervals and the anchor trenches were then backfilled as an extra precaution against undermining. Following each day's work, the CC was hydrated using a 1000L bowser and hose with a diffused spray nozzle. The material cannot be overhydrated and has a working time of 1-2 hours after hydration which meant it could still be installed in the rain without any programme disruption.

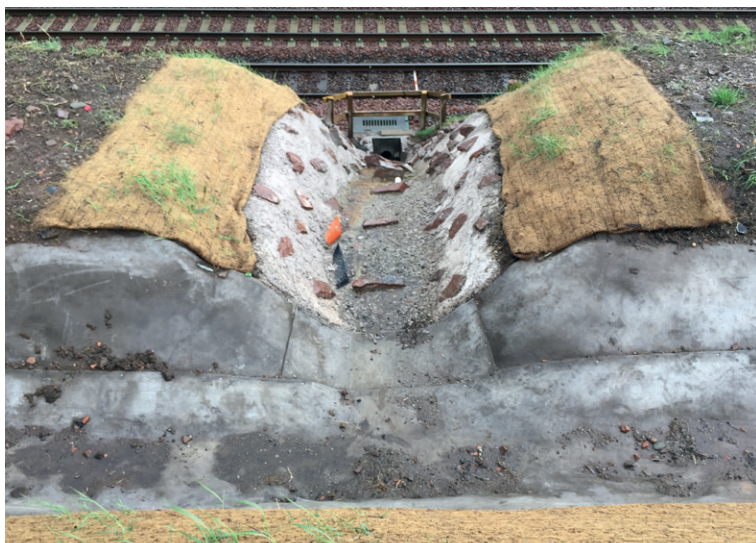
*CC termination at concrete outfall*

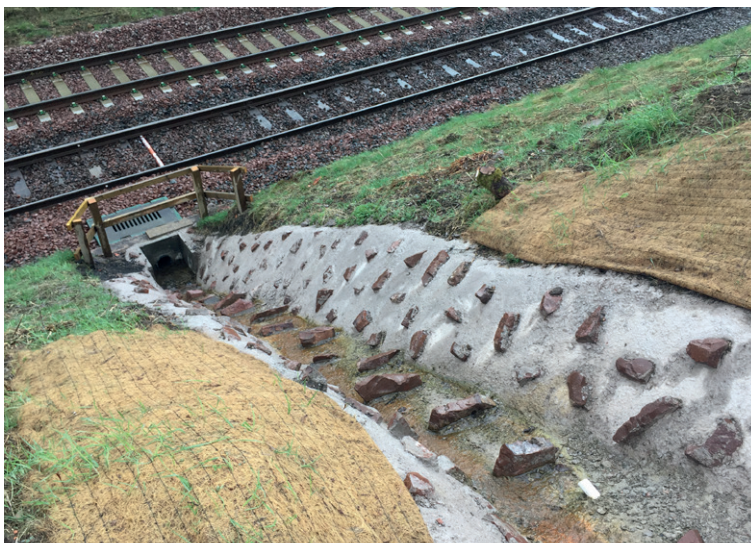
*Concrete outfall diverting water into culvert underneath railway line*

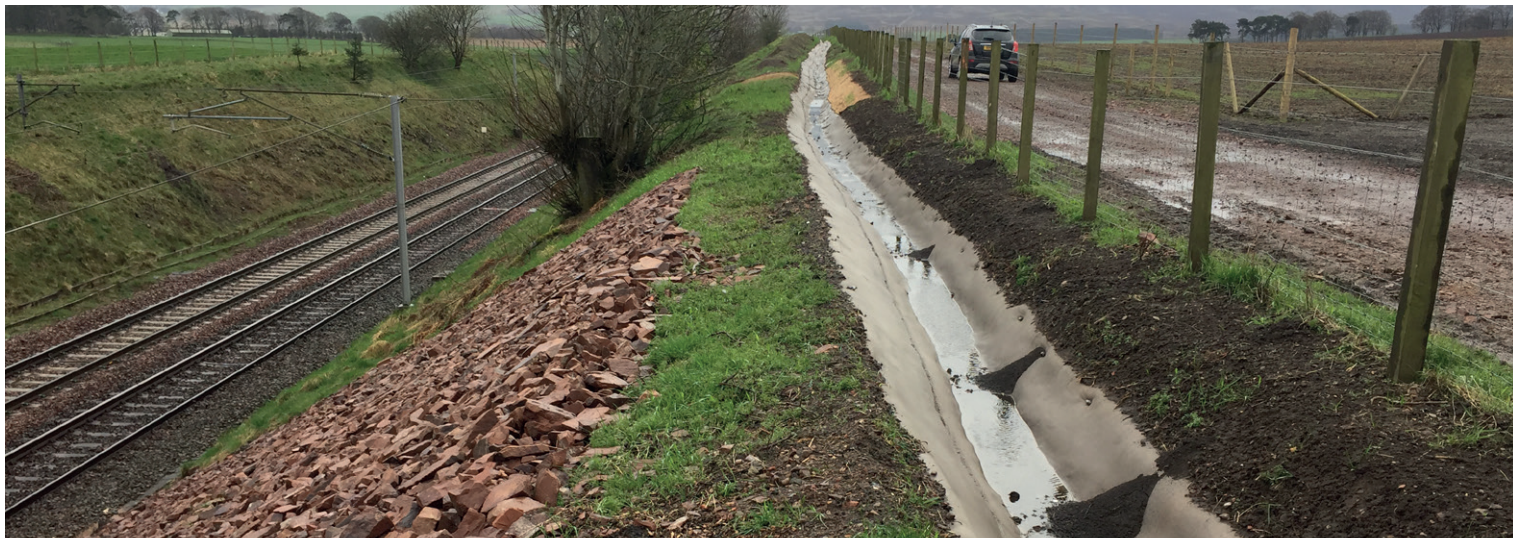
CC channel protecting rail cutting from saturation following previous landslip

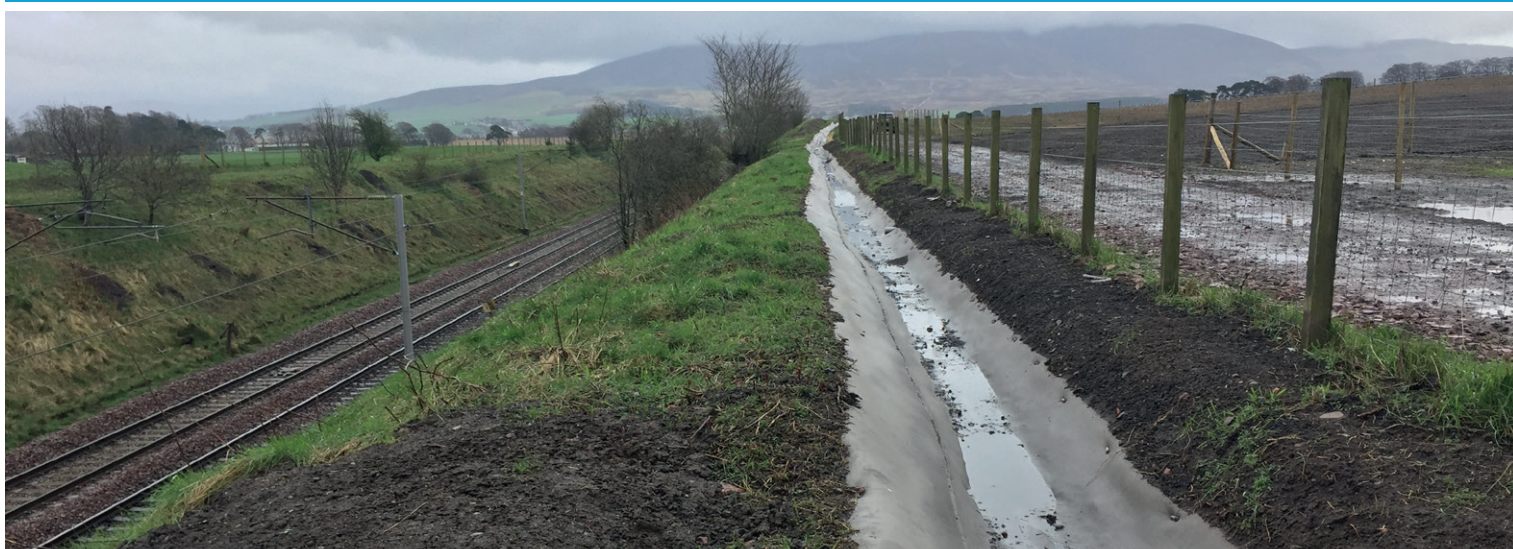
Completed CC lined channel

In total, 1,250m<sup>2</sup> of CC8™ were installed by a team of five in inclement weather conditions in less than 1 week. The client was pleased with the installation as it will prevent erosion and cutting saturation, which could potentially cause land slippage and subsequent line closures.
