## CHANNEL LINING

In January 2018, Concrete Canvas® GCCM\* (CC) was used to line an open drainage channel in Cowra, New South Wales, Australia.

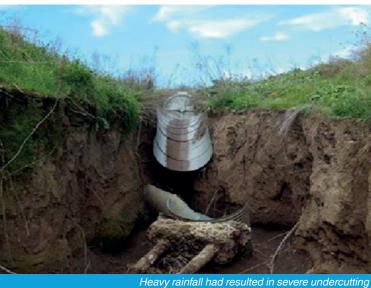
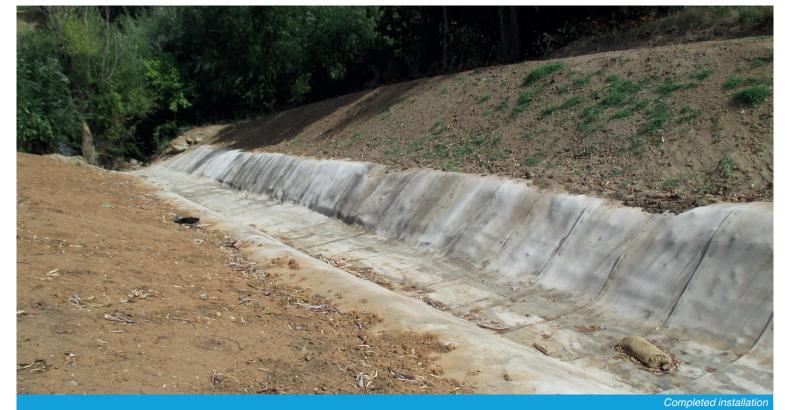
375m² of CC8™ were installed in 3 days by 4 people, in dry weather conditions. However, CC can be installed in inclement weather as the material remains workable for up to 2 hours following hydration. CC was considerably quicker to install compared to traditional concreting methods.

CC bulk rolls were delivered to the site, mounted onto a spreader beam and excavator and deployed transversely across the drainage channel. Subsequent layers of CC were overlapped by 100mm in the direction of waterflow, and lengths cut as required using a Stanley knife. The material edges were captured in a pre-dug anchor trench using 380mm ground pegs. The council construction teams followed the installation guidelines provided by Concrete Canvas Ltd, folding the overlaps back and hydrating them before jointing using adhesive sealant and stainless-steel screws inserted at 200mm intervals. Once installation was completed, the rest of the material was hydrated from a water truck.
