Project Info

-   26 / 12 / 16
-   CC8™ Bulk Rolls Rolls
-   1,000m²
-   Longitudinal layers
-   Tiplam Vale Fertilizantes VLI Cubatao, Brazil
-   GRN - Construções Sustentáveis
-   Drainage of water into channels to prevent soil from saturation, due to the low water table.

The completed installation

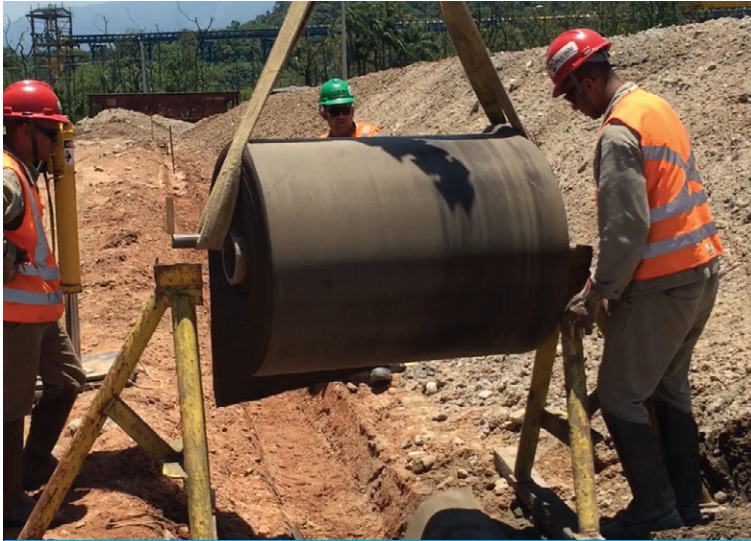
The CC being mounted onto a static spreader beam

1,000m² of CC8™ was installed in a longitudinal layout by Service Provider GRN Ambiental, for VLI/Vale. The CC was delivered to the site by truck, and unloaded, one bulk roll at a time, on to steel stands for manual unrolling. The CC was jointed with 35mm stainless screws (via an auto-feed driver) at 150mm centres. The CC was fixed to the ground with 10mm Ø, 60cm steel pegs at 1.5m intervals, into anchor trenches situated at either side of the channel shoulders'. The anchor trenches were then back-filled with soil to provide a neat termination detail and prevent water ingress.

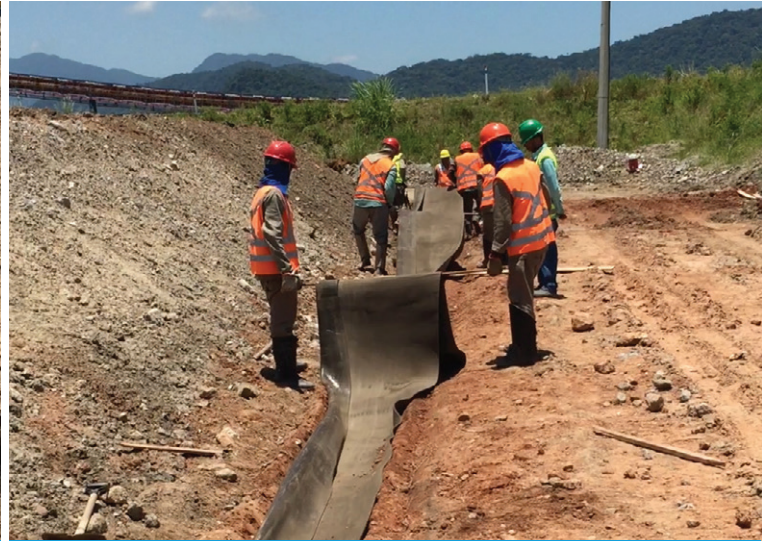
The CC being walked into place from the mounted Bulk Roll

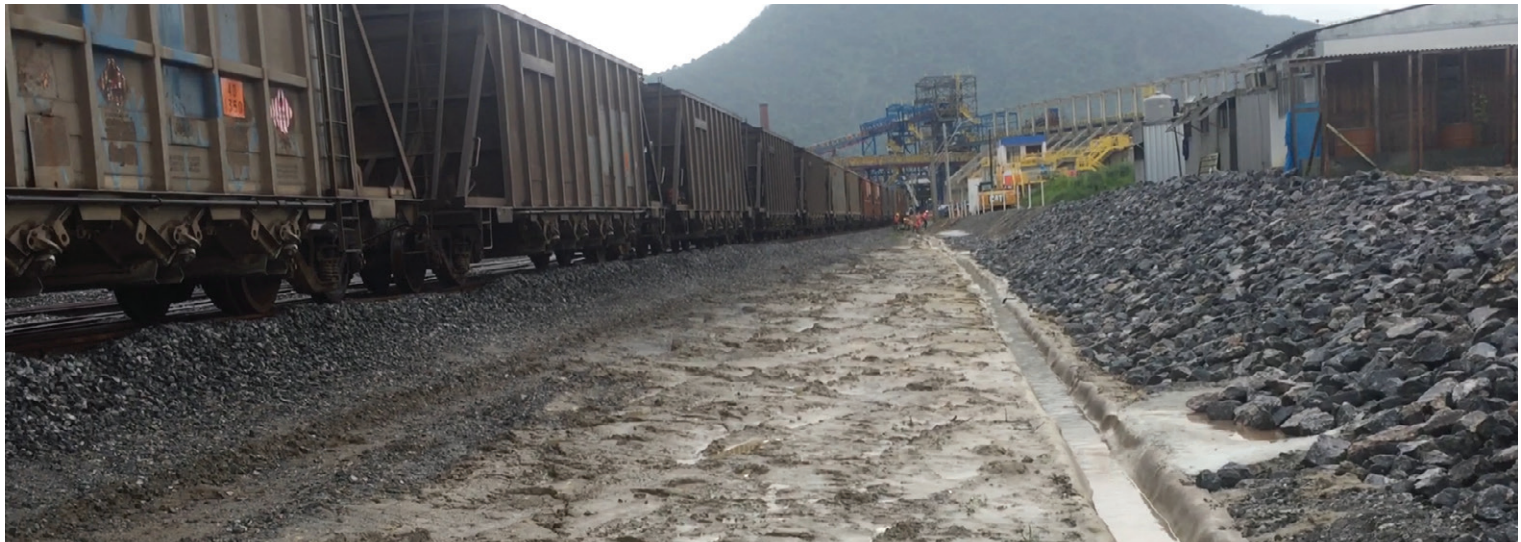
The completed channel

Successful drainage was achieved in all areas where the CC was installed, with the water then being channelled into the existing supplementary drainage system.
