CC5™ Batched Rolls
-   270m²
-   Transverse layers
-

Brecon, Wales, UK
-   Natural Resources Wales
-   CC5™ was used to line a damaged leat in Brecon, Wales

In January 2014, Concrete Canvas GCCM* (CC) was specified as an erosion protection liner for a leat at Cynrig Hatchery, near Brecon in Wales. The leat was used to direct overflow from the river Cynrig, a tributary of the River Usk. The overflow posed a risk to the hatchery's stocks of juvenile salmon. The leat had sustained damage and erosion over time; its original wood-lined face and an adjoining rock bed was leaking into a nearby reed run and threatened the hatchery's infrastructure. The site is currently owned and operated by Natural Resources Wales (NRW), who also carried out the works.

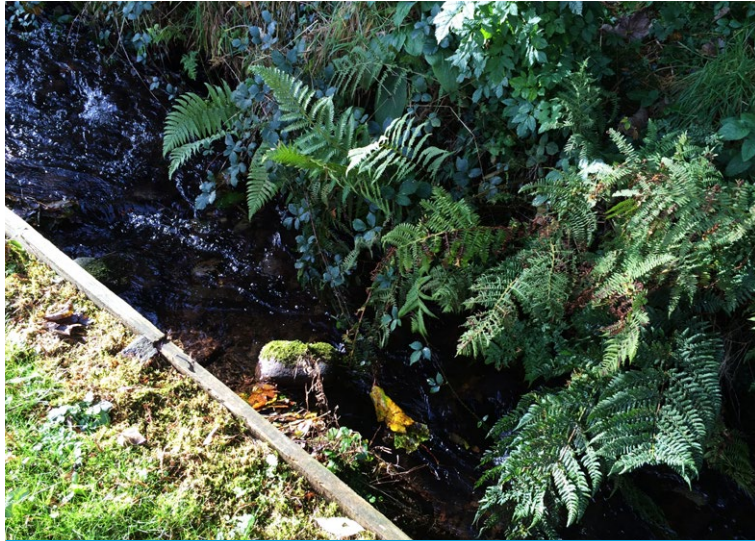
Damage to a leat had caused leaks which threatened the hatchery

Upon close inspection, the condition of the leat was such that the decision was taken to excavate it out to profile first, and then line it with CC5™. Man-portable batched rolls would be used, due to the difficulty of getting heavy plant near the installation site. CC5™ was used to line 40 linear meters of channel with a varying profile at an average of approx. 5.5m wide and 1.5m deep.

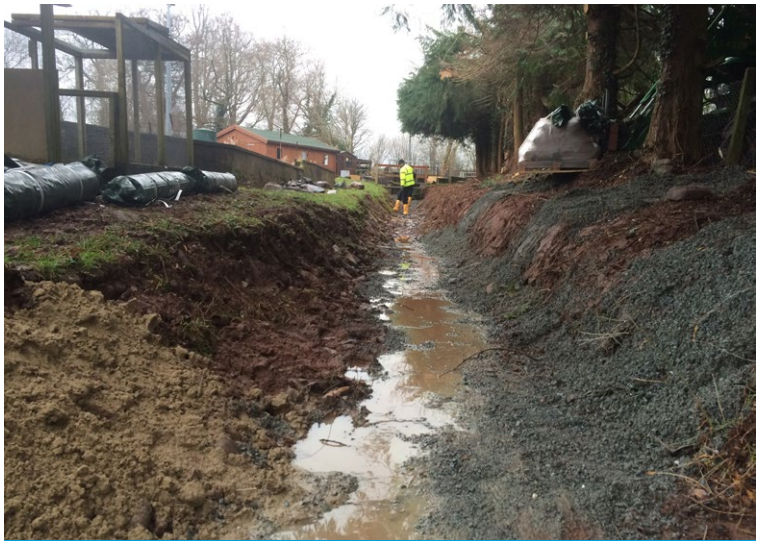
The site was excavated and graded, and batched rolls delivered

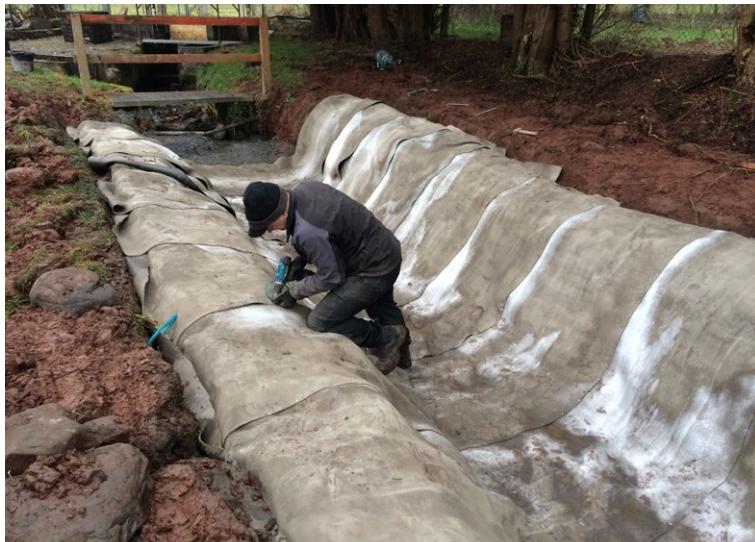
CC5™ was applied in transverse layers with a 100mm overlaps

The CC was laid transversely, with adjacent layers overlapped by 100mm before being screwed in place. The overlaps were not sealed, allowing natural weep paths to form and preventing the build-up of hydrostatic pressure behind the material. The leading edge at the mouth of the channel, beneath a footbridge, was anchor trenched into a poured concrete base. The material at the crest was also buried to provide a neat termination and prevent water ingress. Rocks of ecological concern were recovered and placed on top of the CC after installation, creating natural baffling. CC5™ had the flexibility to negotiate existing pipe work and a concrete base that was unearthed at the foot of the channel.

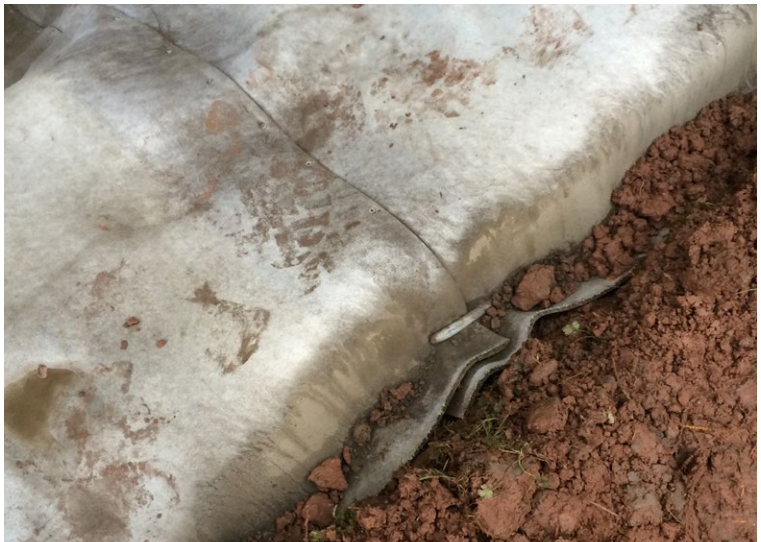
CC was fixed using steel ground pegs and concrete masonry fixings

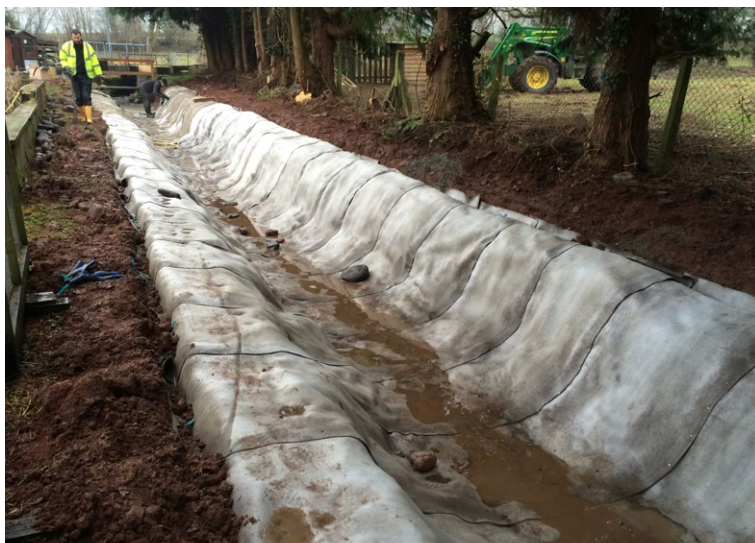
CC5™ was captured within anchor trenches and hydrated

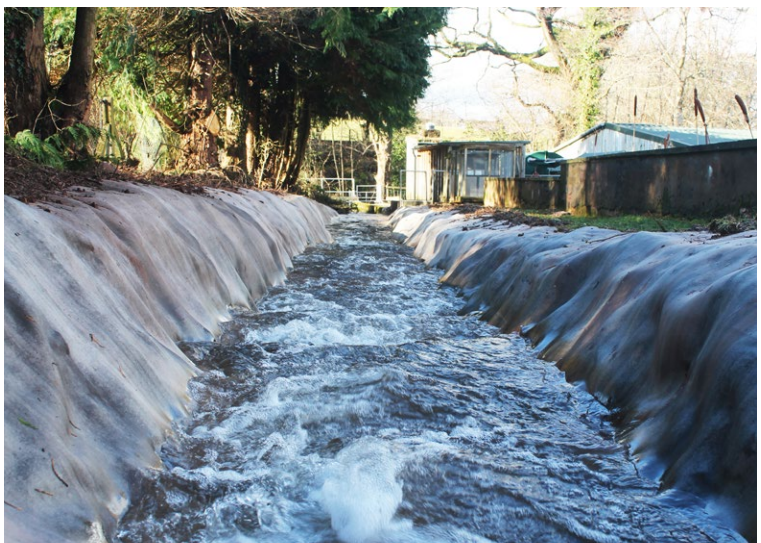
Completed channel installation

A total of 270m² of CC5™ was used in the project, which was completed by 3 NRW operatives in less than five hours.

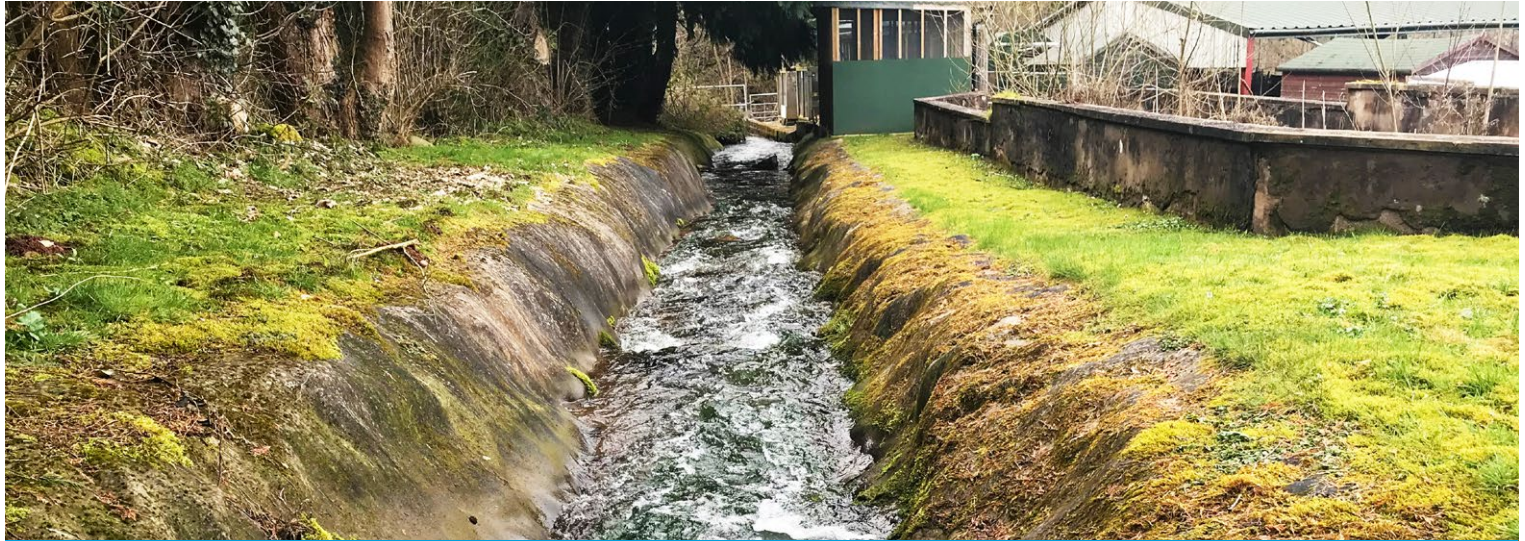
The site was re-visited 4 years after the installation

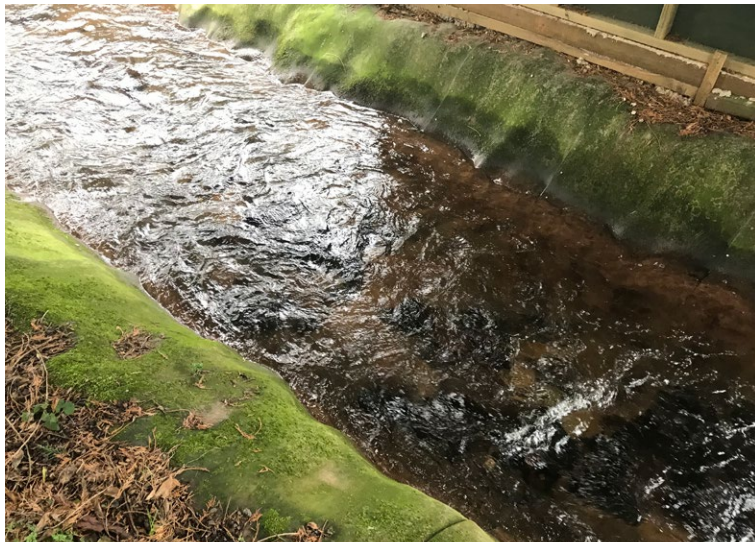
CC successfully 'greening', blending in with its surroundings

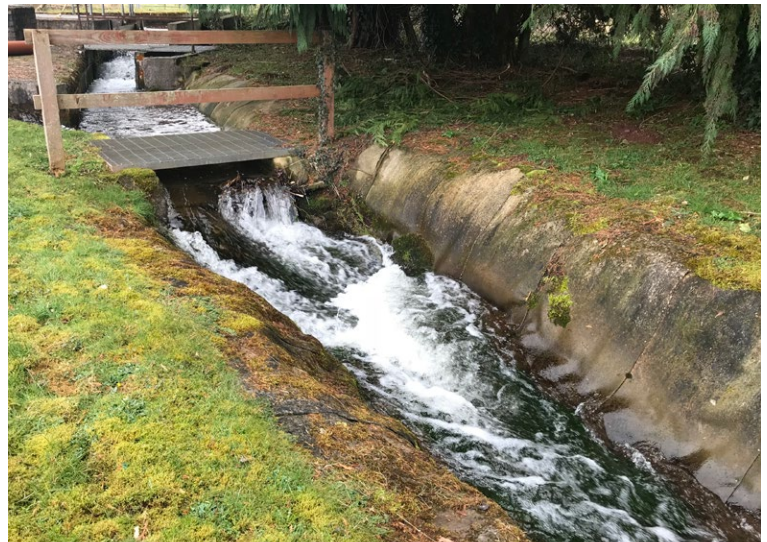
CC is providing durable erosion control, successfully coping with varying flows

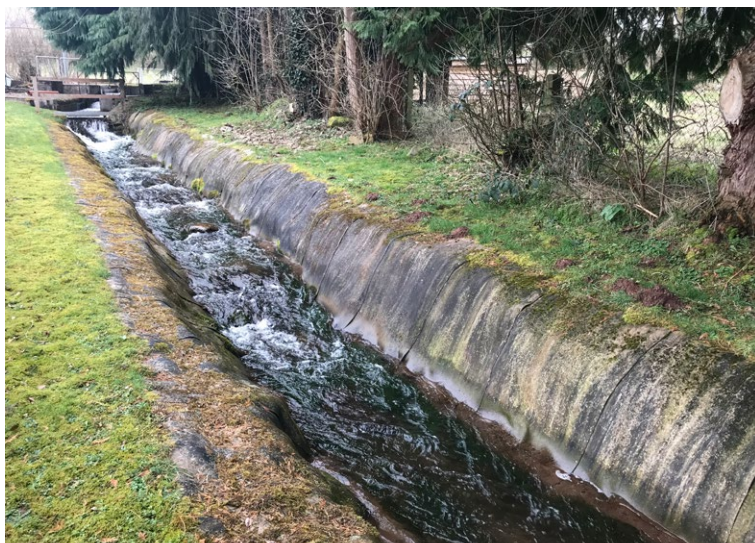
CC is preventing leaks and helping to protect the hatchery's juvenile salmon

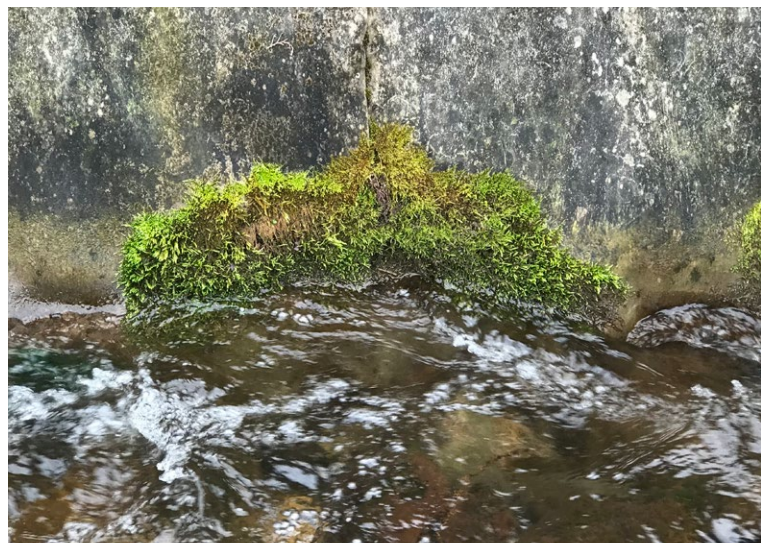
Moss growth on CC's surface
