CC8™ and CC13™  
Bulk Rolls

Eagle Gold Mine, Yukon,  
Canada

CC8™ and CC13™ were  
used to provide erosion  
control and channel lining  
to two spillways

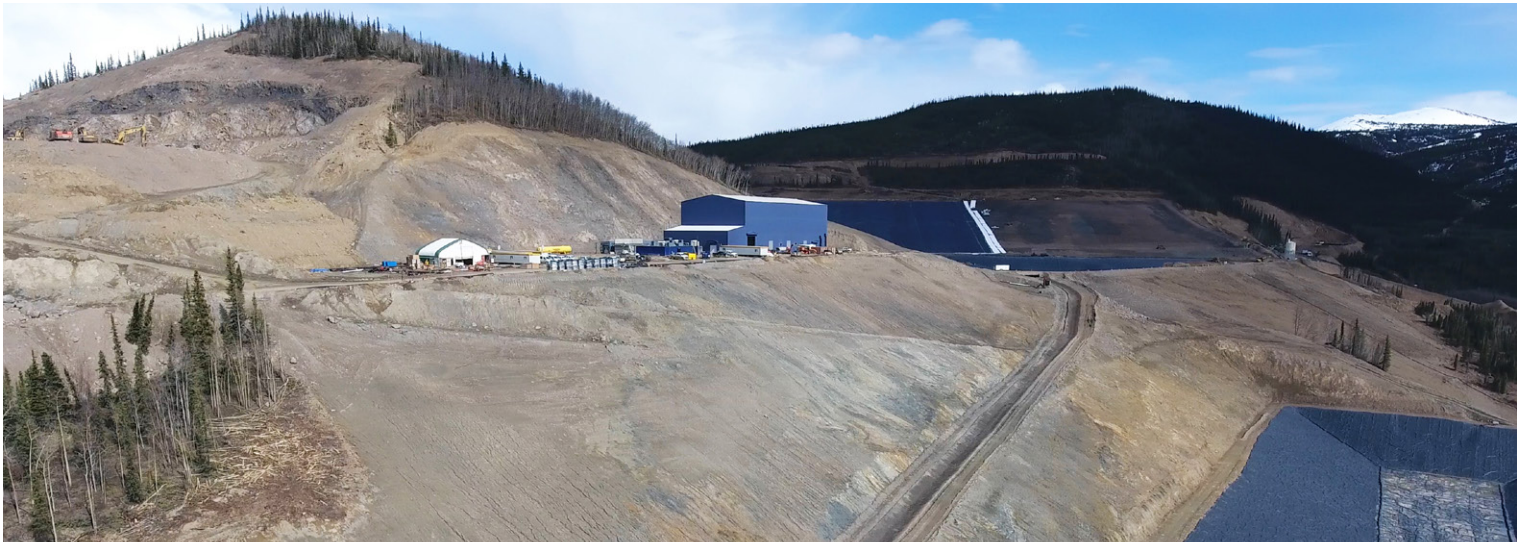
*Main spillway*

The main spillway is approximately 500m in length with profile sections of 5-8m at 7-15%. CC8™ was used for fall sections of 7.5% and CC13™ was used where the fall of the section increased to 15%.

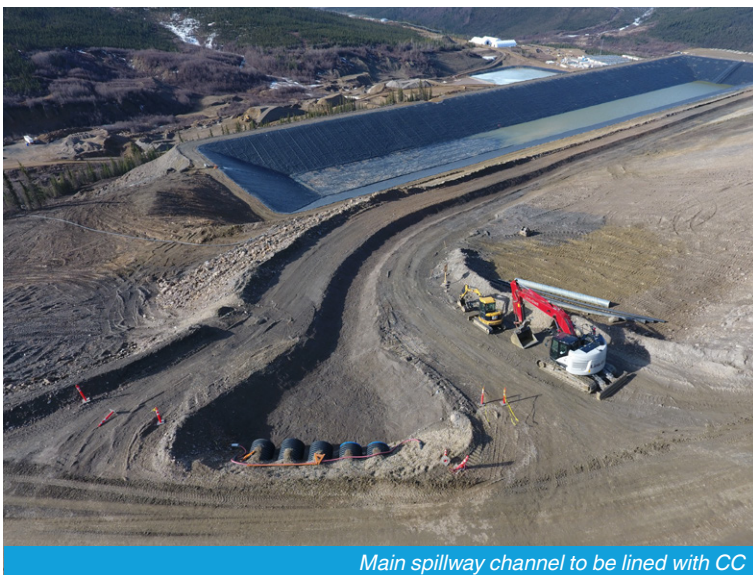
*Main spillway channel to be lined with CC*

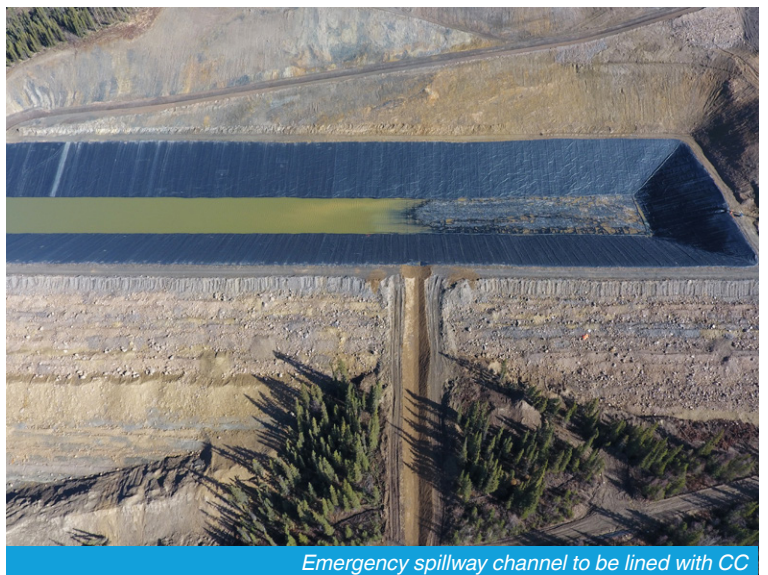
*Emergency spillway channel to be lined with CC*

The emergency spillway is approximately 140m in length of varying width at 50% gradient and lined exclusively with CC13™ as per the specification of the engineering consultant, BGC Engineering.

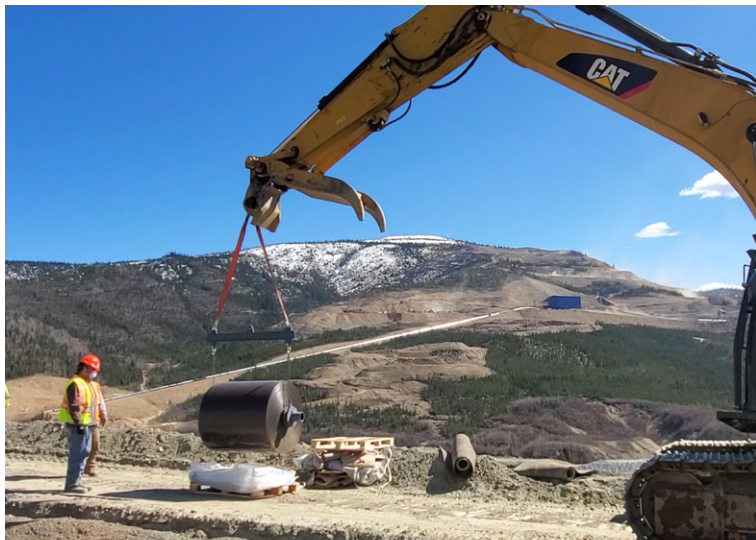
Bulk rolls of CC13 and CC8 deployed via spreader beam

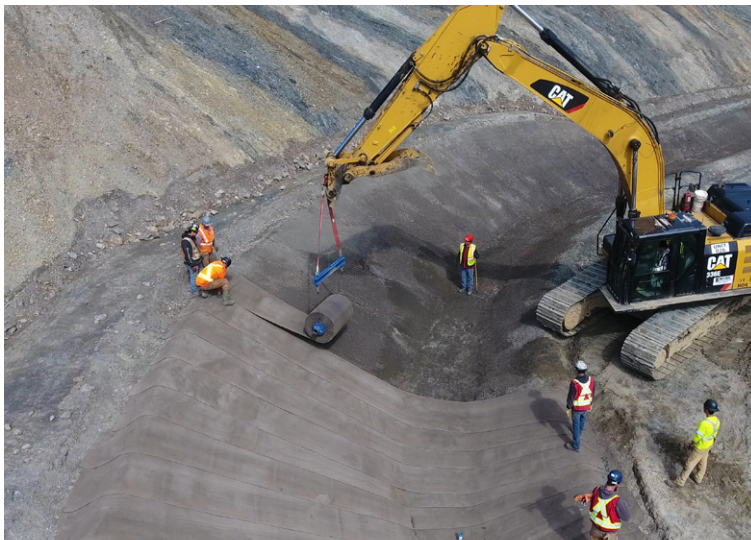
Installation starting downstream of main spillway.

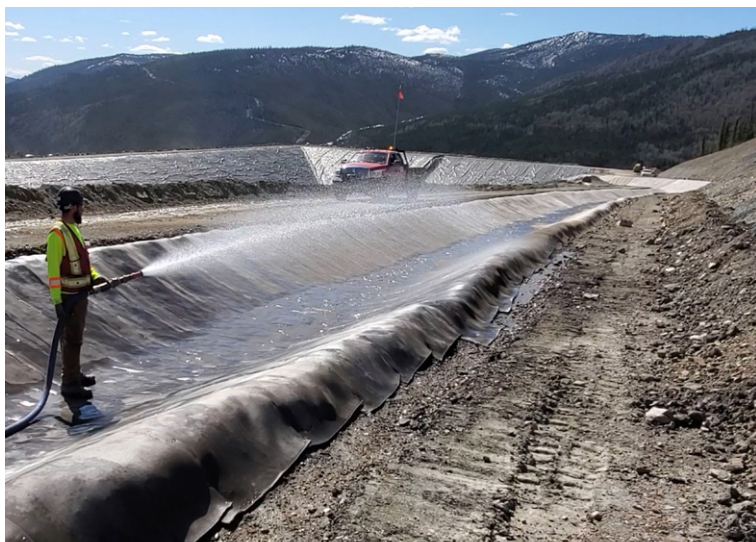
Hydration of the lined channel

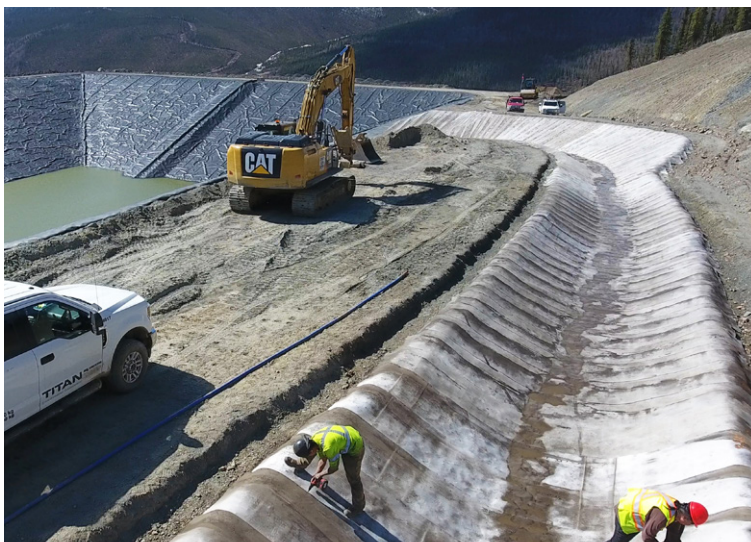
Joints were sealed and screwed for increased impermeability

The main spillway was installed using a standard CC screwed and sealed overlap joint; by hydrating the underlaps and applying an 8mm bead of Soudal 250XF adhesive sealant, then folding the overlap back into position and securing the material together using stainless steel screws at 200mm centres. The CC was secured in an anchor trench at the crest with ground pins before backfilling to prevent perimeter water ingress.

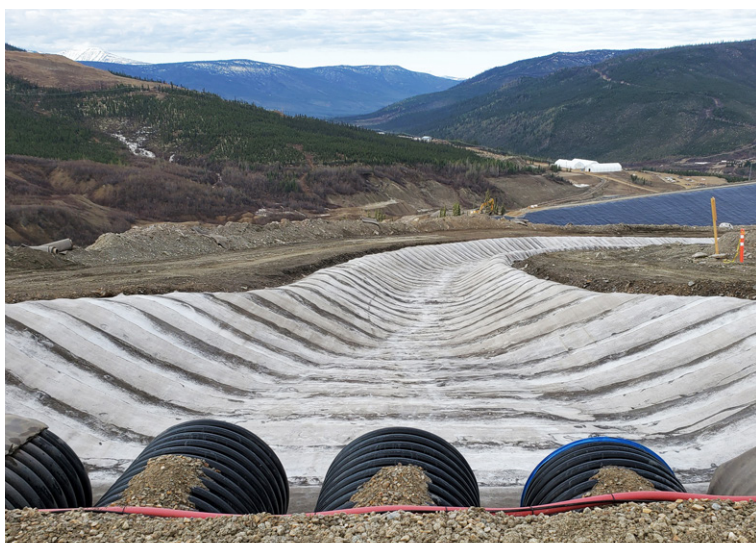
Upstream section of completed channel

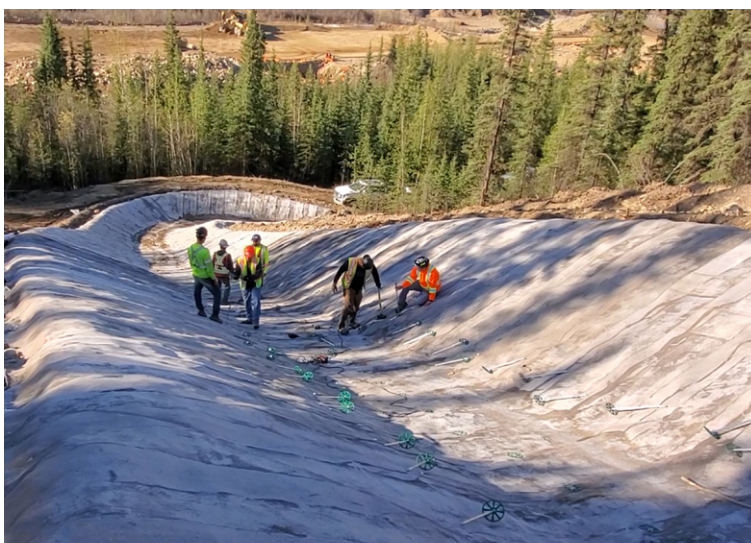
Installation of percussion anchors on emergency spillway section

BCG asked Concrete Canvas Ltd to review the hydraulic design of the spillways to advise on whether the CC material required intermediate fixings in order to resist the anticipated hydraulic shear forces. Concrete Canvas input site parameters into their hydraulic calculator. It was determined that the main spillway did not require intermediate fixings, but they were necessary for the emergency spillway due to the shear forces generated along the 50% channel gradient. Rock anchors were installed at 1.8m centres along each overlap joint for the main spillway section. At a 90° corner, anchor centres were no more than 0.5m apart.

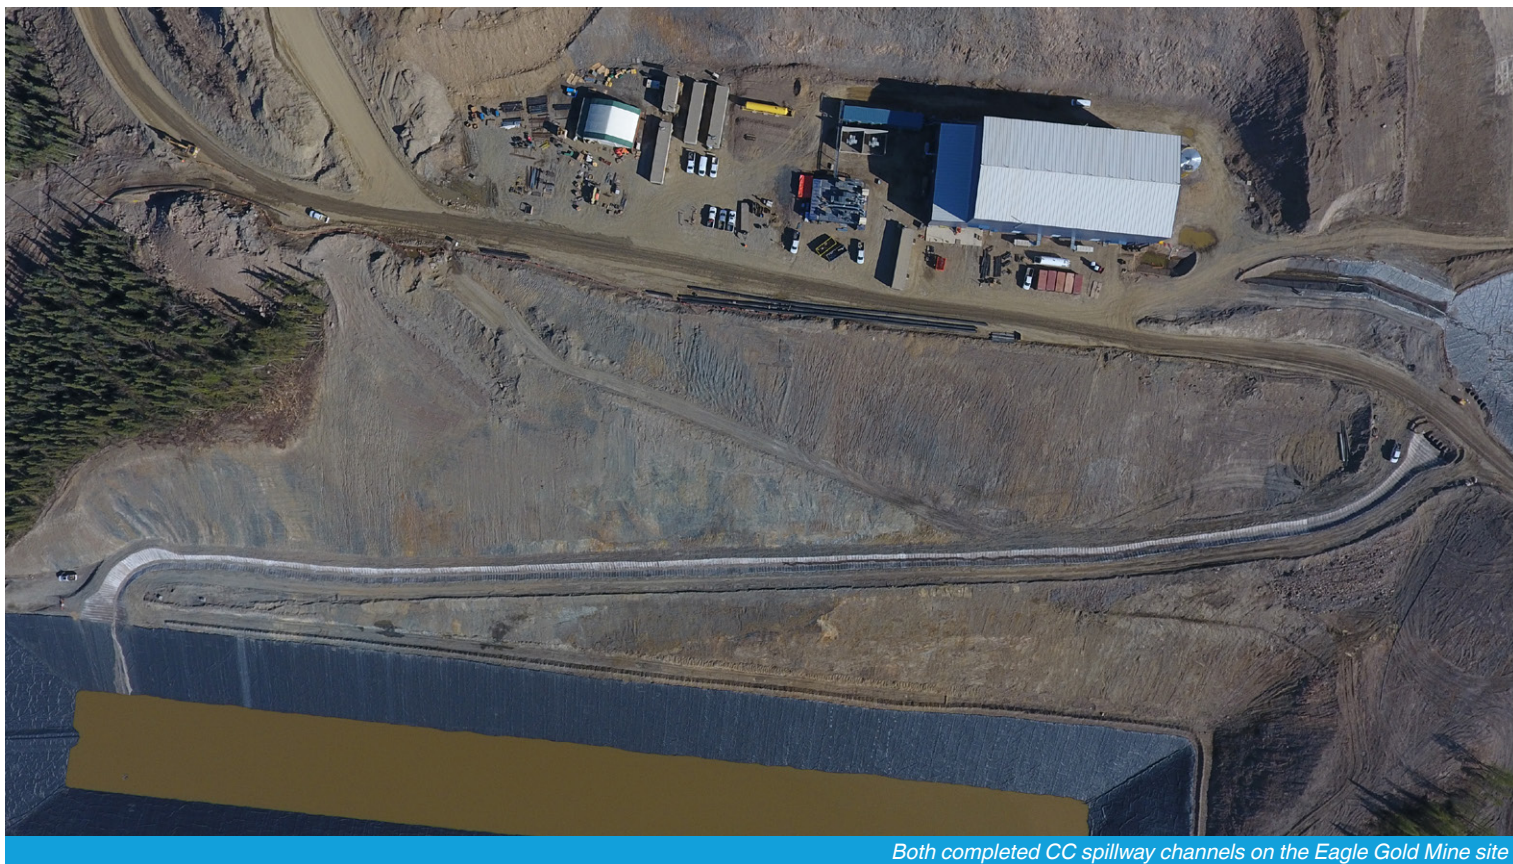
*Both completed CC spillway channels on the Eagle Gold Mine site*
