In November 2017, Concrete Canvas® GCCM\* (CC) was used to line an irrigation channel in Accra, Ghana. The installation was carried out as part of the Ashaiman Irrigation Scheme for the Ghana Irrigation Development Authority.

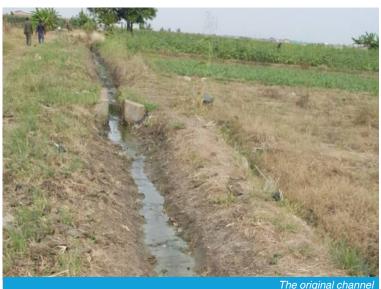
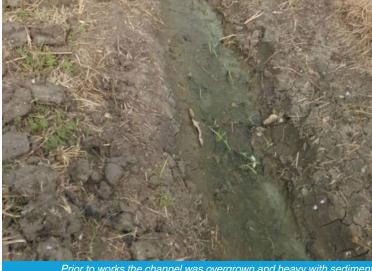
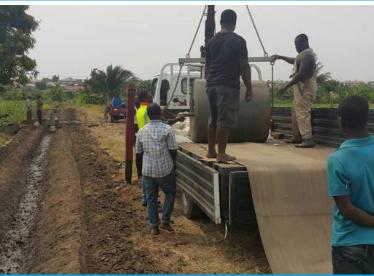
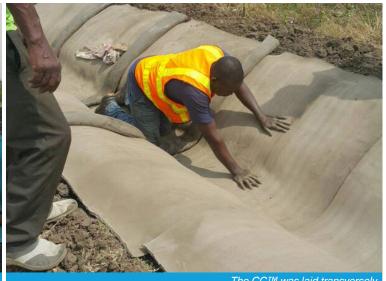
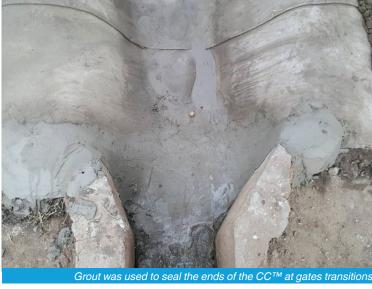
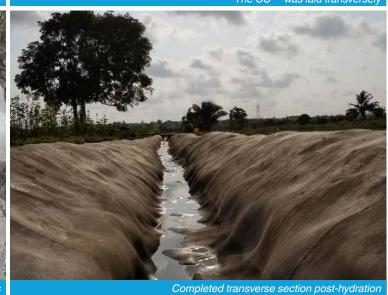
Prior to installation, any vegetation was removed from the ground within the channel and its profile was re-graded and shaped. Anchor trenches were then dug on each shoulder and a bulk roll of CC8™ was delivered to site. The CC was then mounted onto a spreader beam, unrolled and cut to specific profile length. These pieces of material were then moved by hand to the channel and laid transversely, with additional layers laid with overlaps of 100mm. CT1 Sealant was then used for jointing the CC™ layers, along with 20mm stainless steel screws at intervals of 200mm. The edges of the CC8™ were anchored with 375mm ground pegs at 1m intervals where a transverse layup was used, and where a longitudinal layup was used instead, 2m intervals were implemented. Once the installation was completed, a 650-litre water bowser was used to hydrate the CC™, and the process was repeated after one hour to ensure sufficient saturation.

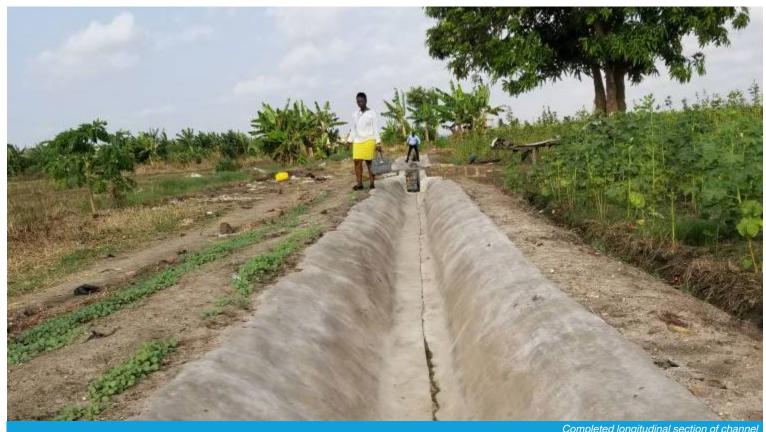
A total of 125m<sup>2</sup> of CC8<sup>™</sup> were installed in just 2 hours, by a team of 7. Due to the use of CC <sup>™</sup>rather than conventional methods, there was a significant reduction in closure time of the canal during installation, and the supply gate from the dam was able to be re-opened shortly after its completion.

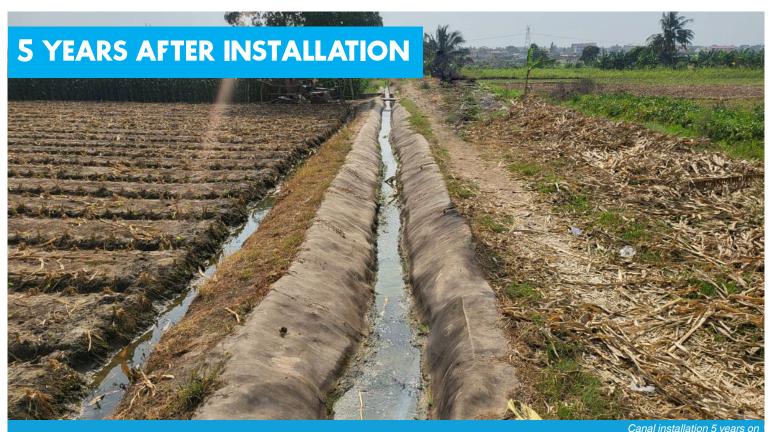
During a site visit in November 2022, the installation and material were found to be in optimal condition and full operation - channelling vital water to irrigate local farmlands. The performance in service of Concrete Canvas® CC8™ has provided the client with the assurances needed for further specification on other irrigation projects around Ghana.
