CC8™ Bulk Rolls

Hidden Valley Gold Mine,  
Lae, Papua New Guinea

Installation of CC at Hidden Valley Gold Mine in Papua New Guinea

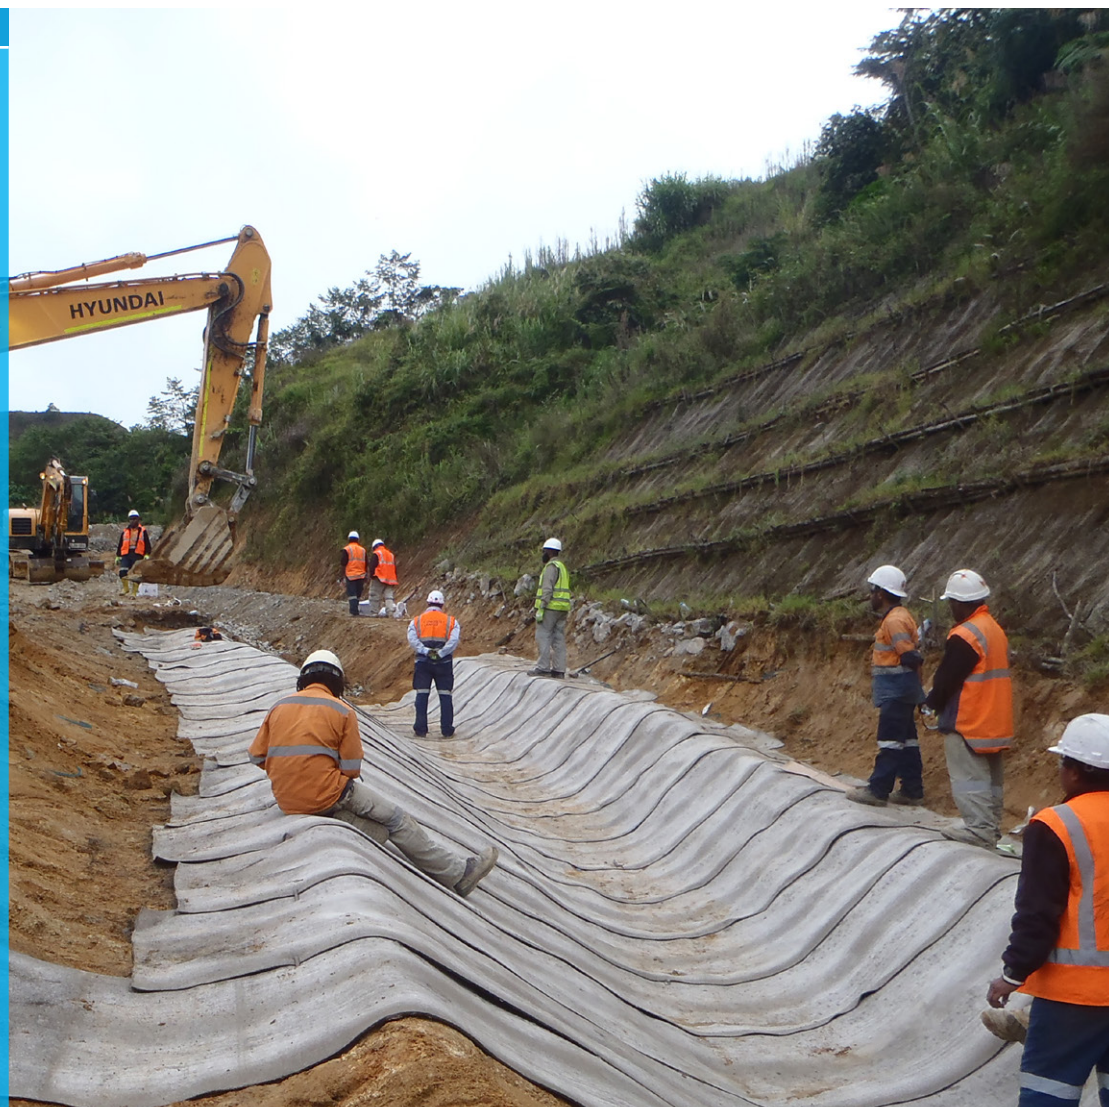
CC8™ was used to line  
a diversion channel  
used to prevent run-off  
water from flowing into  
the Hamatta Mine Pit

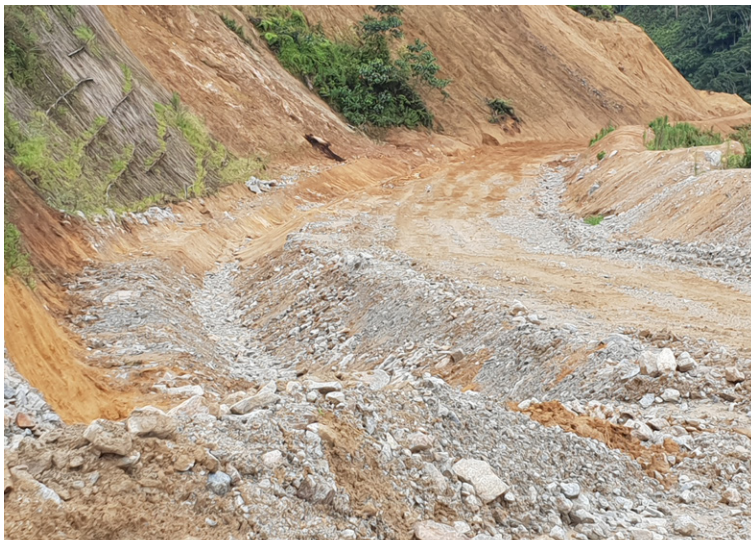
Channel profile cut from substrate

Prior to installation, vegetation was removed and the side ditch re-graded. The CC was delivered to site in bulk rolls, and dispensed from a spreader beam hung from a 20T excavator. The material was laid transversely across the channel's width, with 200mm ground pegs used to secure the material in pre-dug anchor trenches at every joint, placed every 1m.

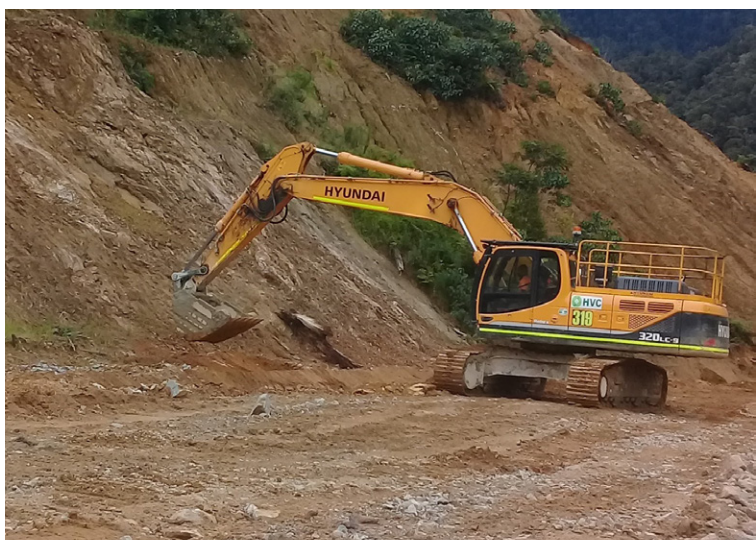
Excavator used to prepare channel

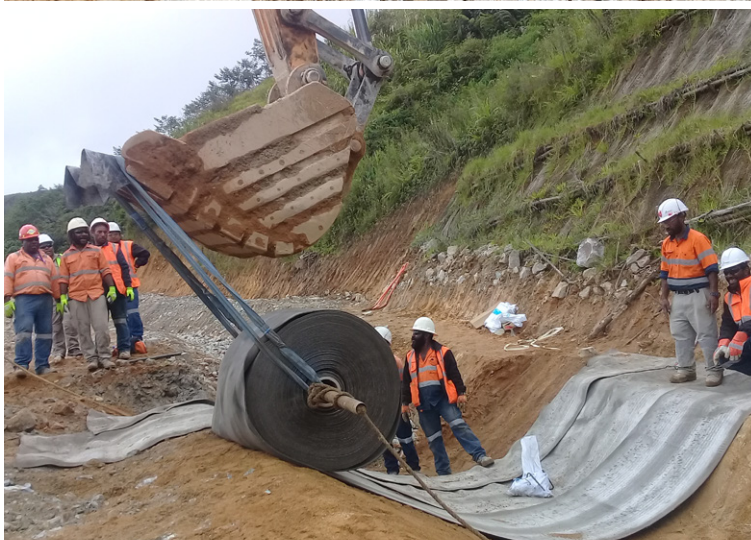
Deployment of CC

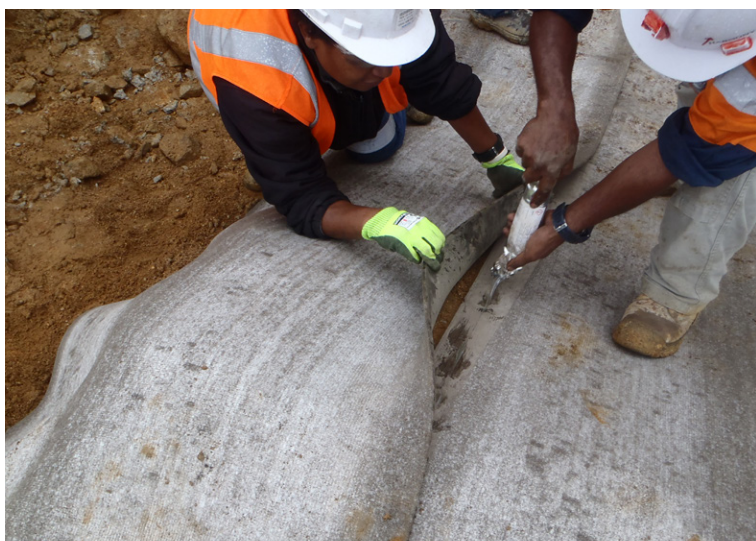
Applying sealant to CC overlaps

The CC was laid with overlaps shingled in the direction of water flow. Adhesive sealant beads and 30mm stainless steel collated screws used to joint the overlaps and 200mm centres following hydration of the material below the overlaps. Hand tools were used to carry out the installation and preparatory works, including a hand knife, hammer and shovel.

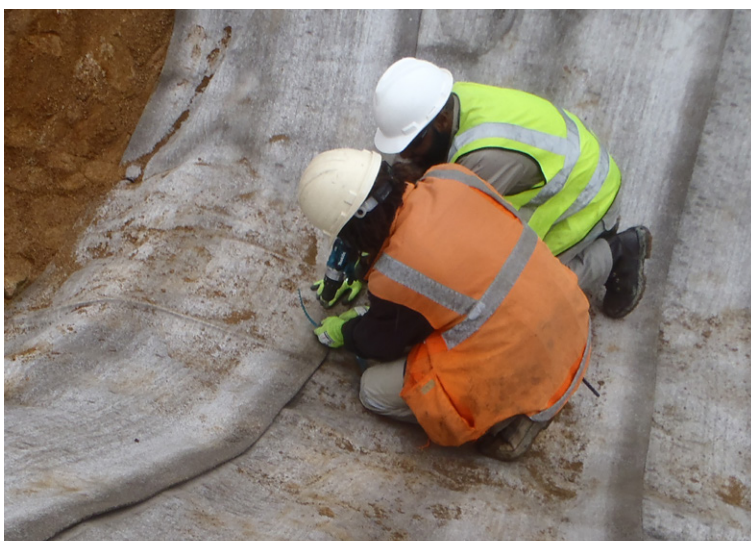
Joining CC overlaps

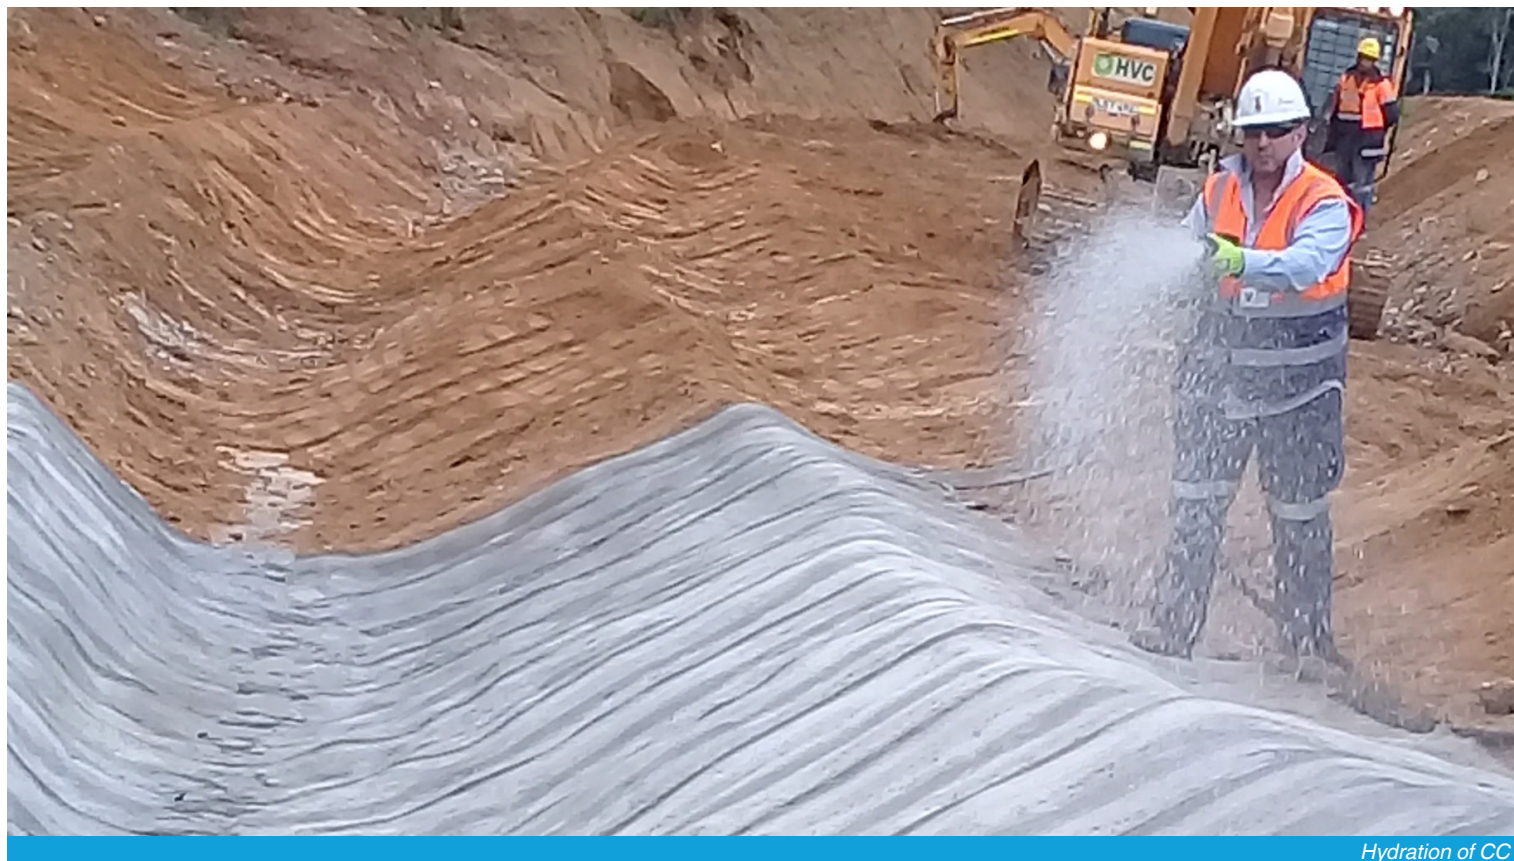
Hydration of CC

Following installation, hydration was given using a 7kL water cater with pressure hose and repeated three times at 25-minute intervals to ensure adequate hydration in the high temperatures and dry conditions.
