CC5™ Bulk Rolls & Batched Rolls

Laguna Niguel, California, USA

CC5™ was used to line a series of drainage channels in a public park.

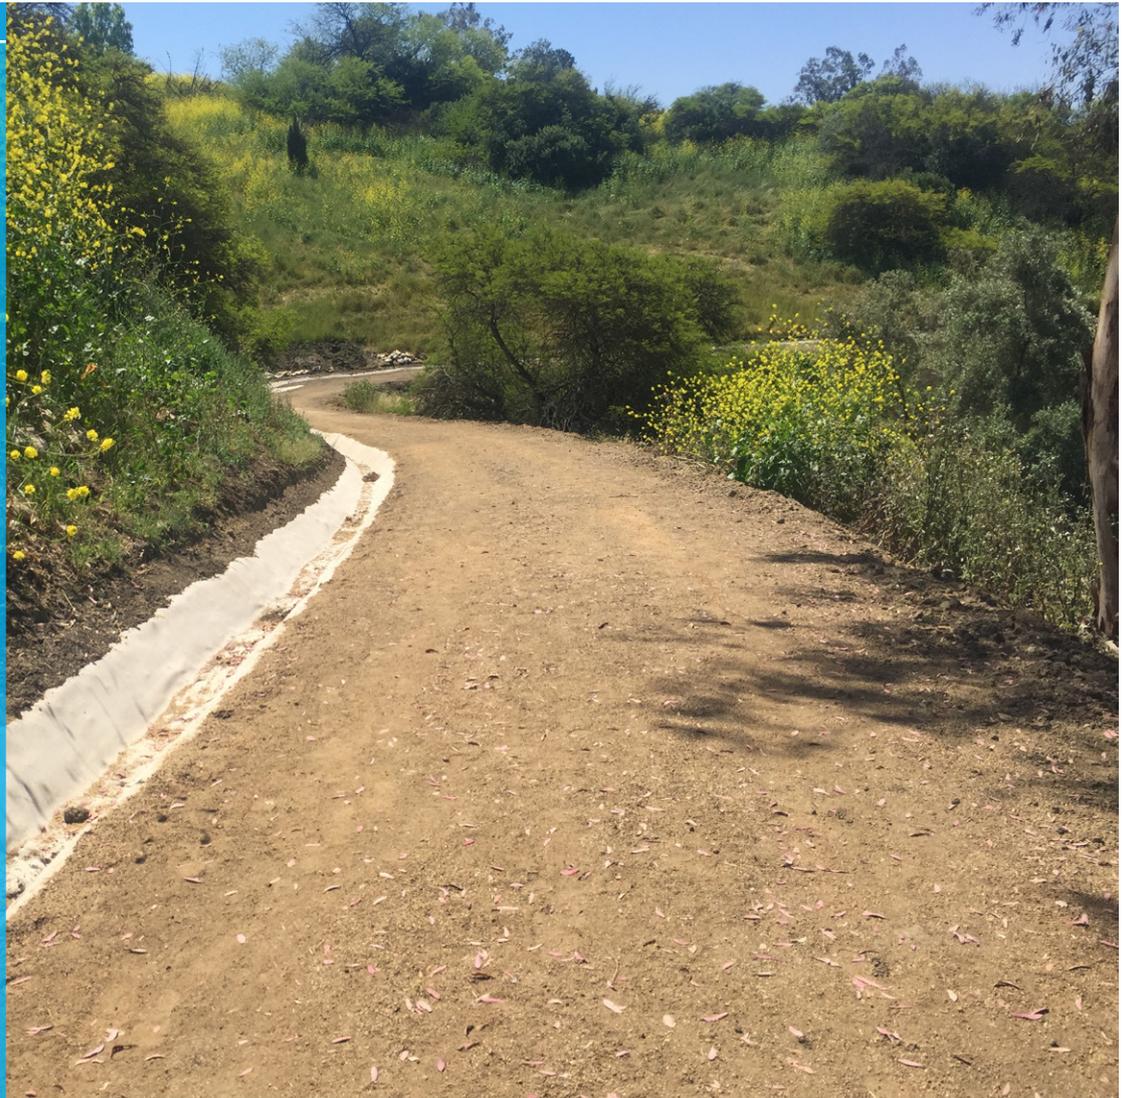
Completed channel along a stretch of the footpath

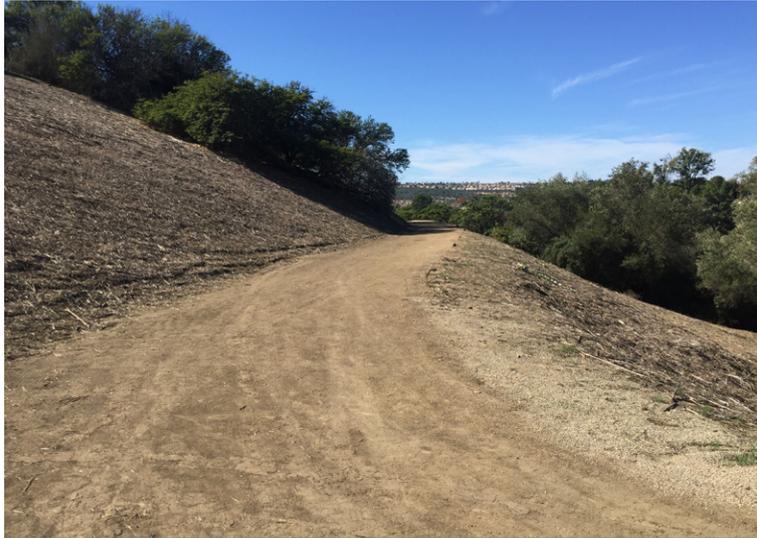
Path prior to installation

The local Public Works department needed to find a solution for a drainage and erosion issue on a popular walking trail in a public park. The trail, which runs across a large slope, was prone to damage and erosion from water runoff. Captured runoff was being directed to a point where it was dissipated with sandbags and riprap before entering a surface inlet leading to a drainpipe. This system frequently clogged with sediment and debris.

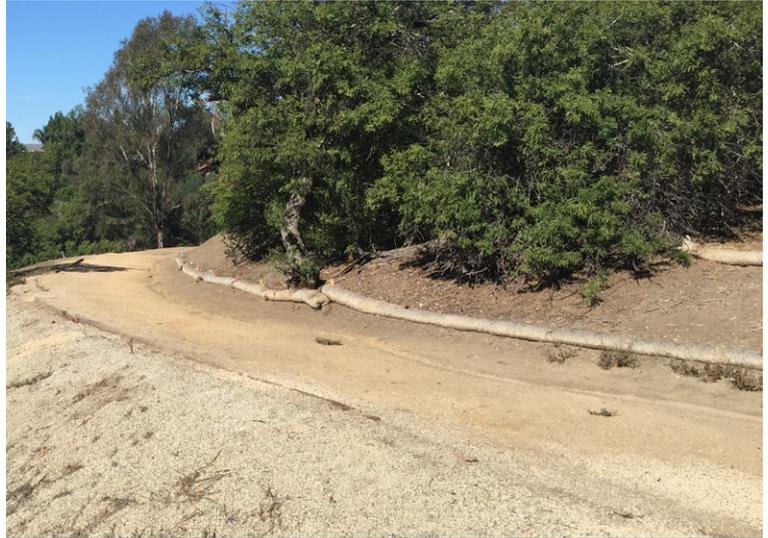
Existing drainage system

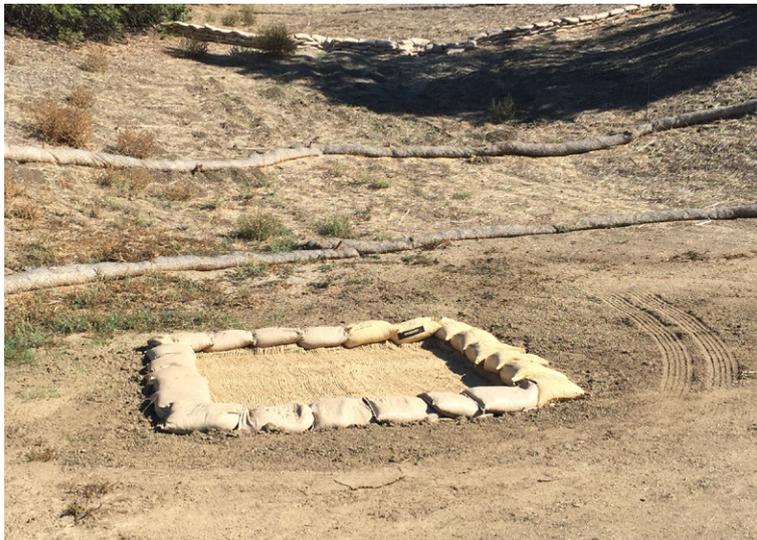
Drain prior to installation

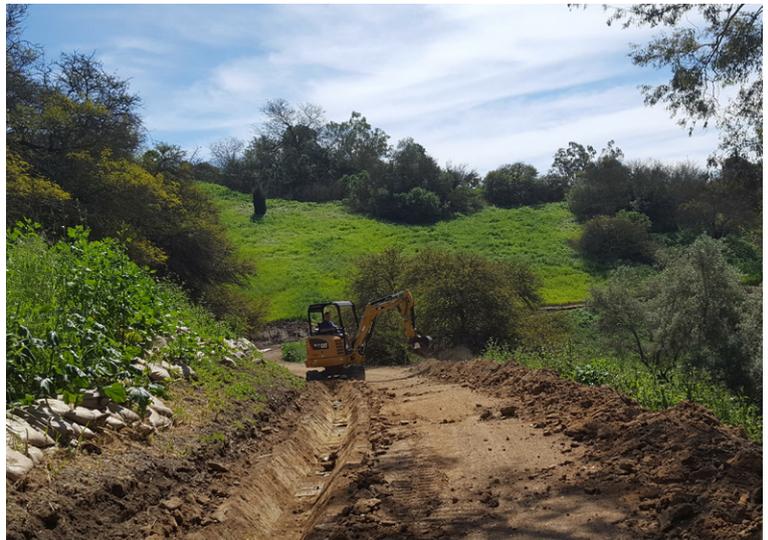
Creation of channel and anchor trenches

The CC was installed longitudinally, with a layer each side and an overlap of 100mm. The overlaps were jointed using screws and an adhesive sealant while CC edges were fixed using ground anchors. Pre-dug anchor trenches captured material edges, which were then buried to prevent undermining.

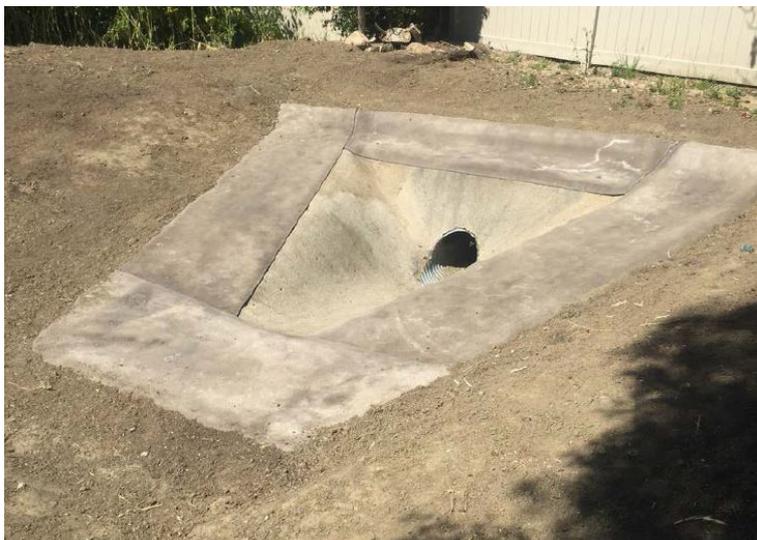
Completed drainage pipe section

The installation crew converted inlets – previously made with stone and sandbags – to more permanent structures. Around inlet basins, sediment capture areas were created and lined. Gravel bags placed on the slopes to aid run-off dissipation were also covered with CC, increasing durability. A 500-gallon tank was used to provide hydration.

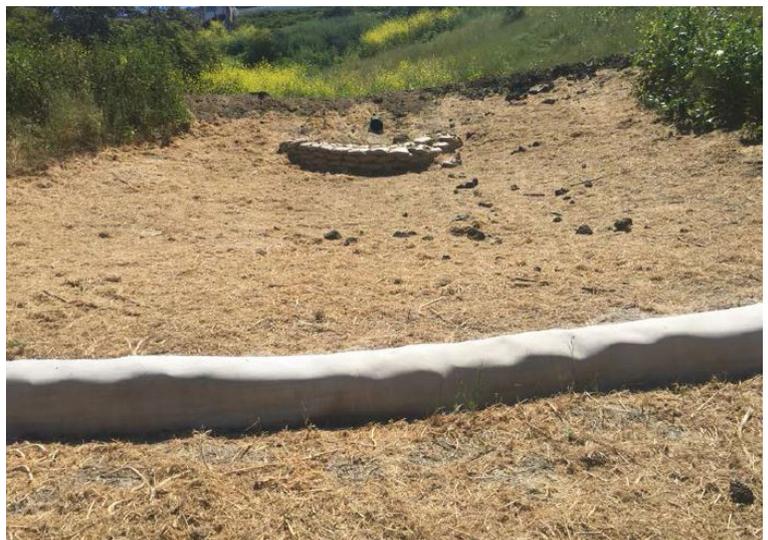
Completed baffling section

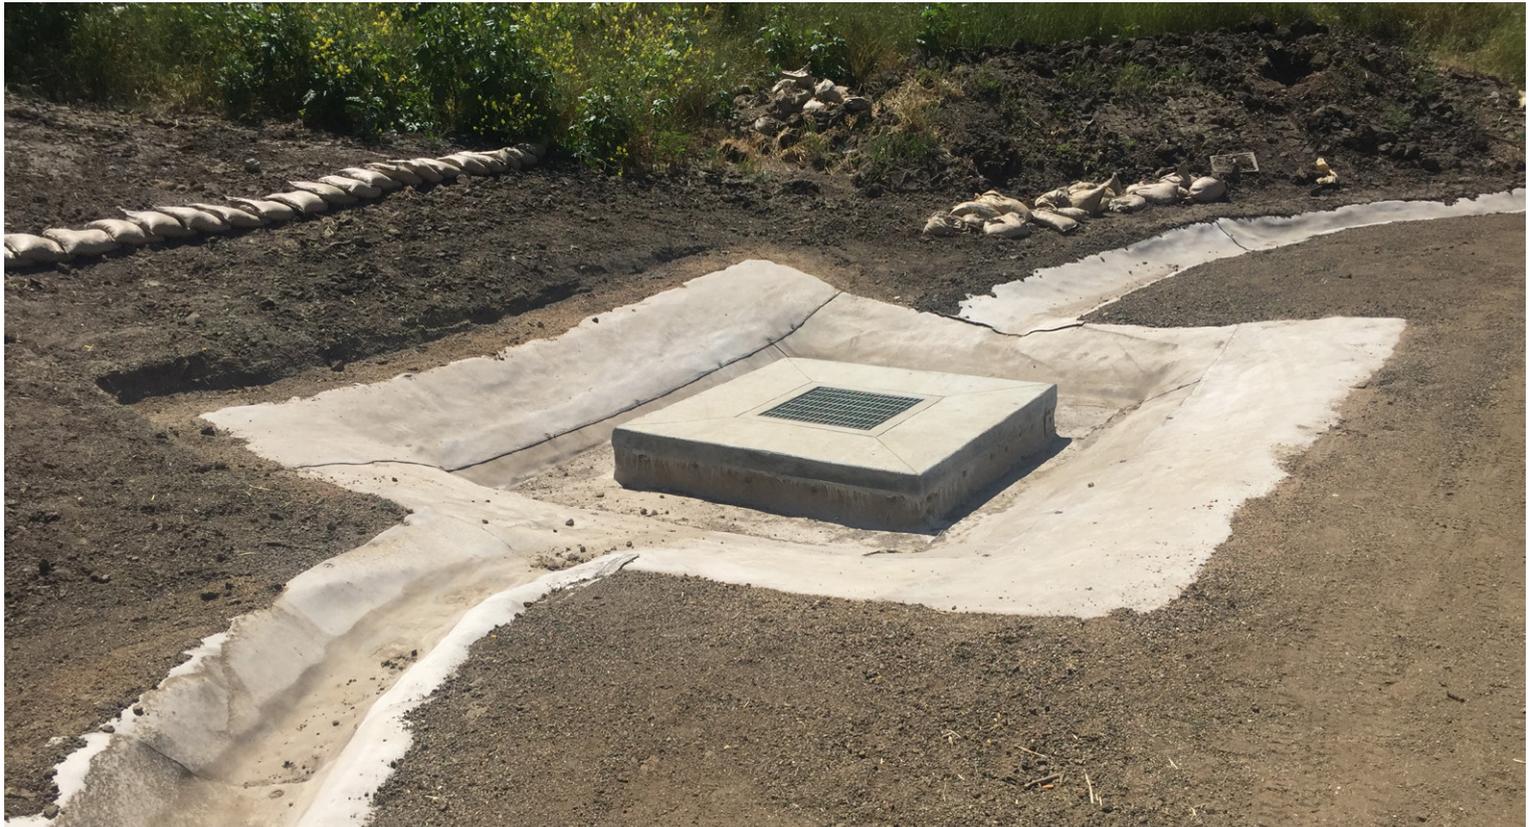
Completed channel and drainage section

The crew were able to create a unique, field adaptable application method with the custom trapezoidal channels, which incorporate sediment collection areas. CC has not only provided the area with a substantially more durable solution to handling runoff and sediment but has also eliminated a significant amount of maintenance requirement, making post-storm clean-ups safer, easier and faster to carry out, reducing labour and expenses.
