CC8™ Bulk Rolls

Lynemouth Mine Water  
Treatment Scheme, UK

CC8™ installed as a  
channel lining solution at  
a mine water treatment  
works site in Lynemouth,  
Northumberland

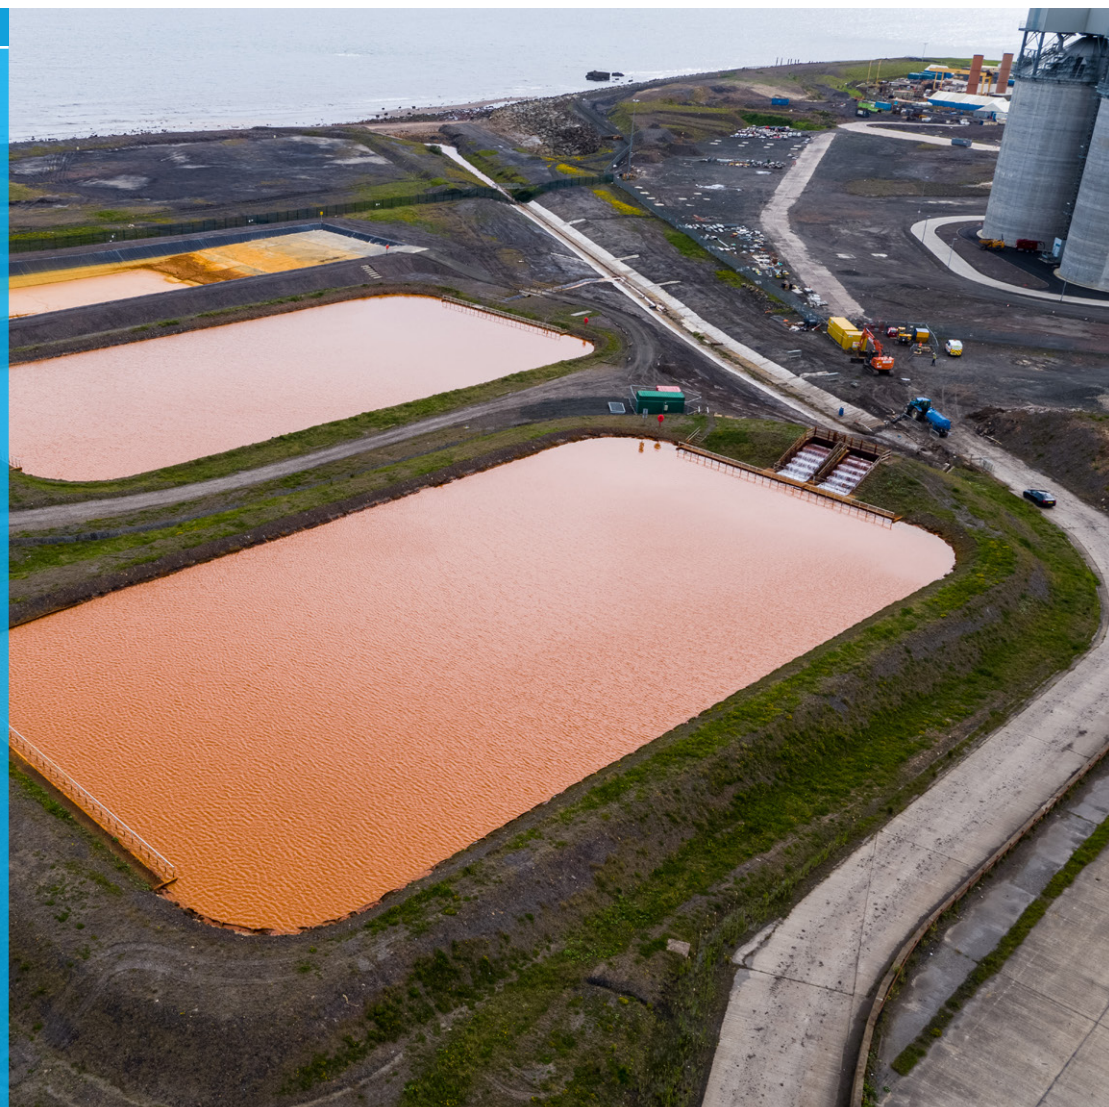
Overview of the MWTW site and completed CC channels (top right - Image courtesy of Coal Authority)

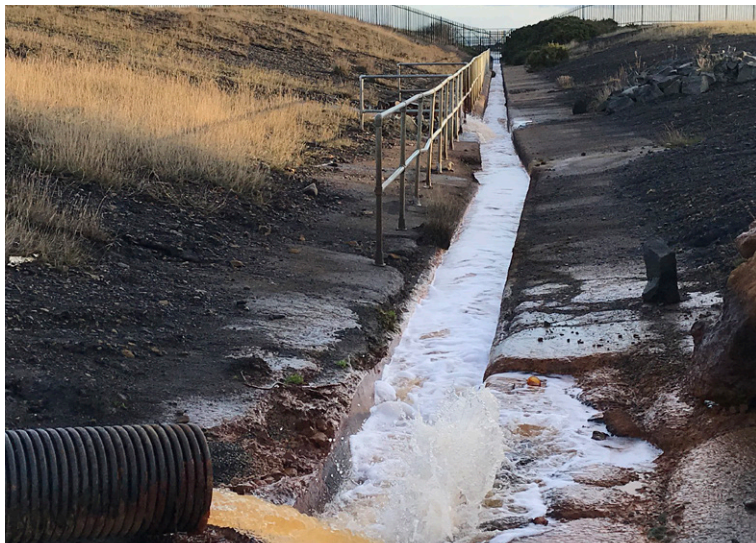
*Existing concrete channel prior to works*

The existing outfall channel was constructed using poured concrete. The amount of discharge expected due to the construction of new lagoons on the site meant that there was a need to increase the overall capacity of the existing channel and provide erosion control to the existing slopes above the discharge channel. The channel measures 195 linear metres with its sides measuring 2.5m.

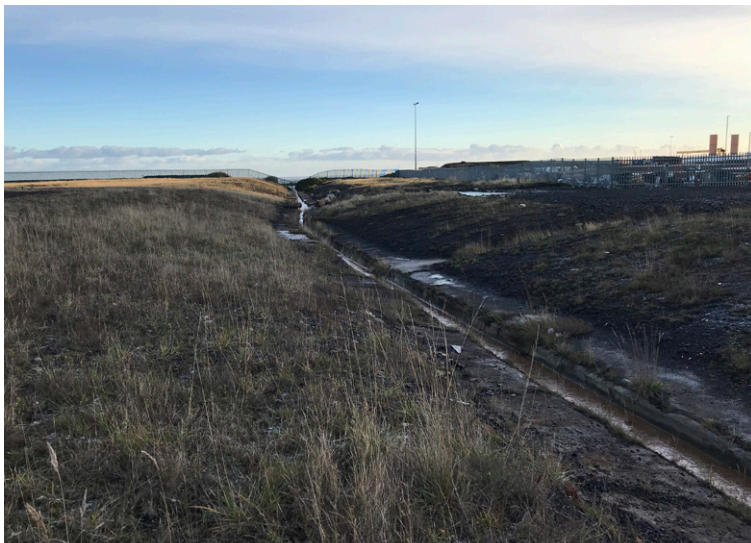
*Overview of concrete channel on the site*

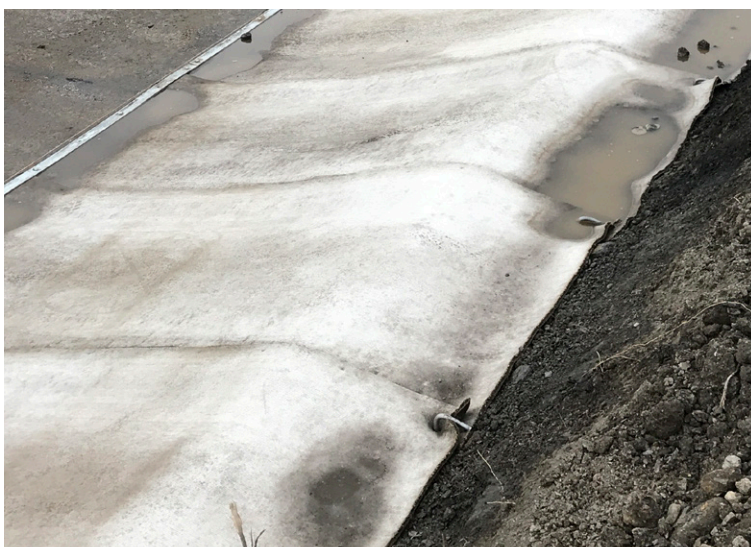
*Edges secured using ground pegs*

The CC8™ material was delivered to site in bulk rolls and deployed from a plant-mounted spreader beam. The material was laid transversely across the channel profile and vertically on the slope from crest to toe. Edges of the material were captured within anchor trenches and secured to the substrate using galvanised mild steel ground pegs, inserted through the overlapped CC layers. Overlaps were hydrated prior to jointing using stainless steel screws inserted at 200mm intervals. Where CC terminated against a concrete apron, a combination of masonry bolts, nitrile gaskets and a termination bar were used to fix the material to the structure. Following hydration, the anchor trenches were backfilled.

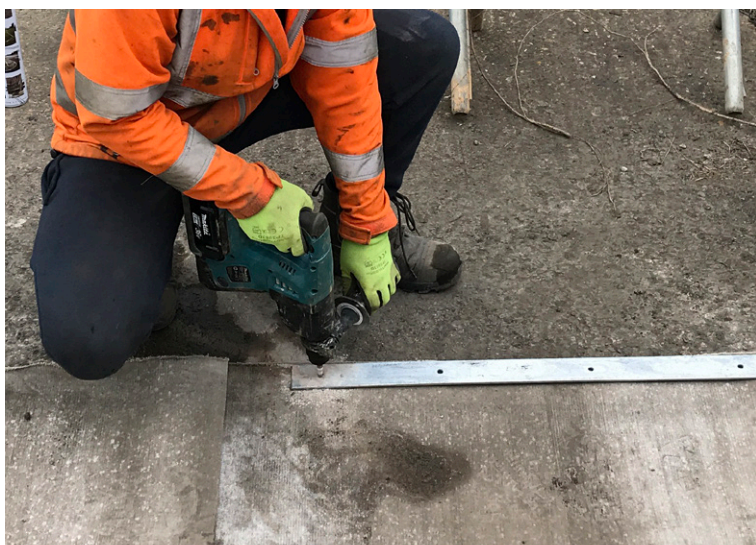
*Termination of CC at existing concrete using steel bars and masonry bolts*

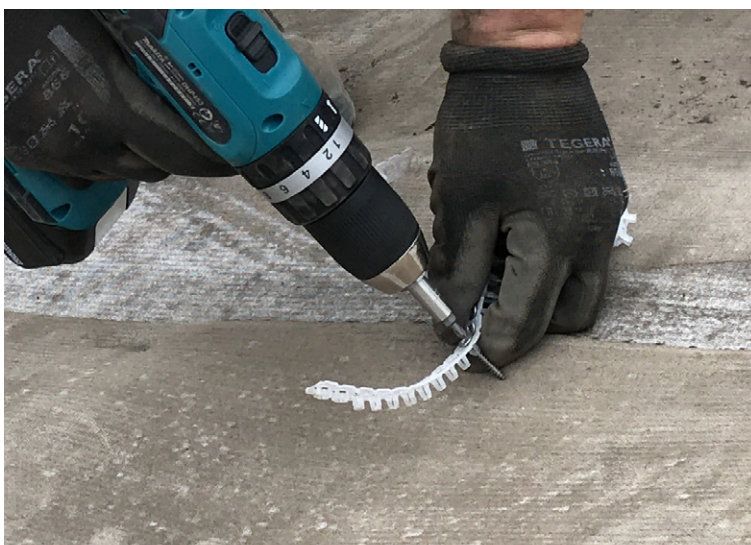
*CC overlaps were jointed using stainless steel screws*

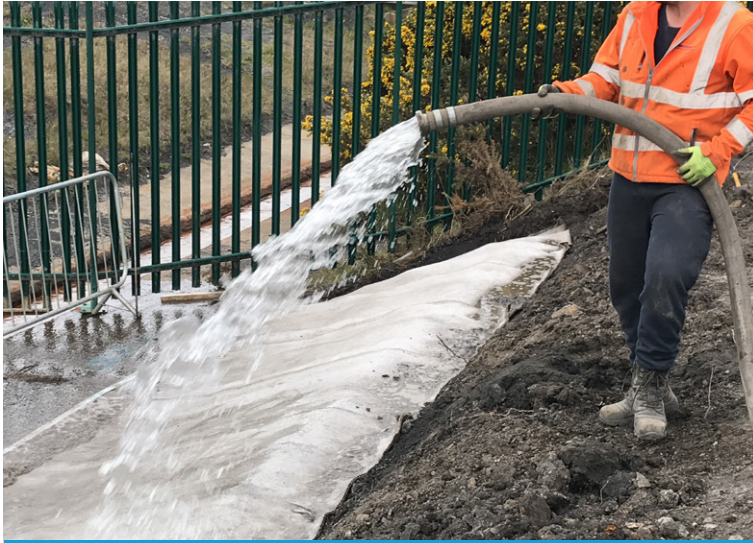
Hydration of CC following installation

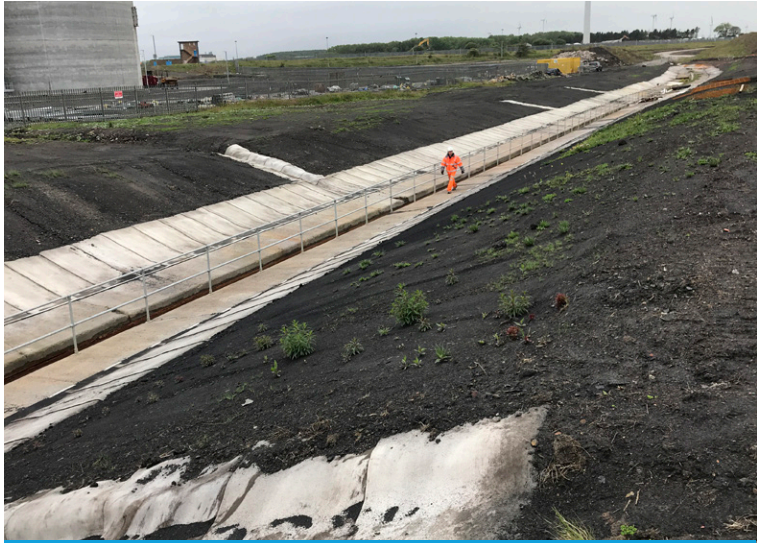
Completed section of CC installation

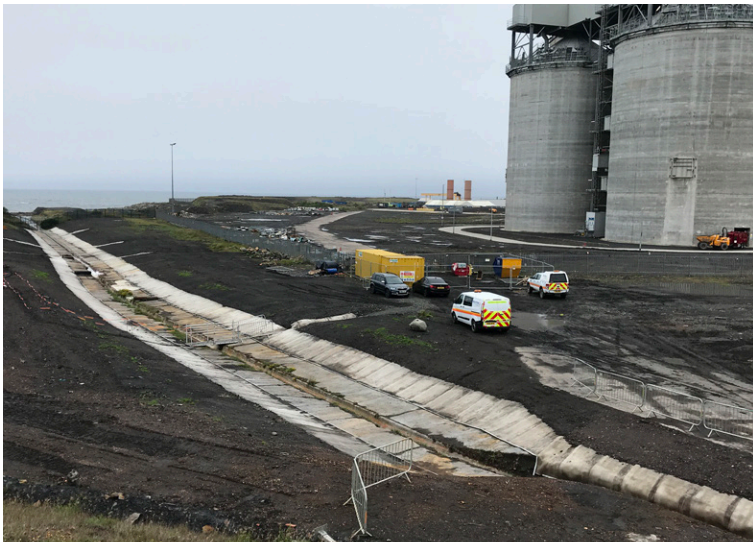
View of completed CC lined channel

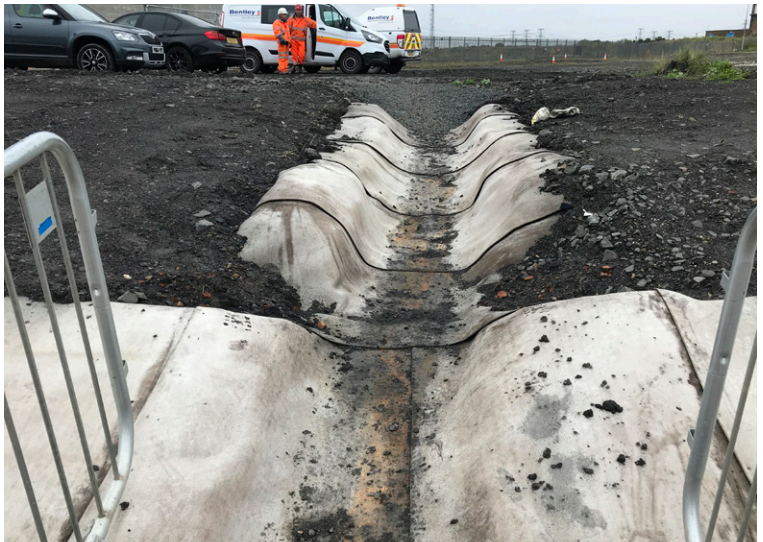
Smaller sections of channel were also lined to improve water management

Along the length of the channel there are several small channels that are prone to suffering from the washing out of the substrate when heavy rain occurs. These smaller channels were also formalised and lined in CC8™ as part of the works to help with the overall management of water on the site.

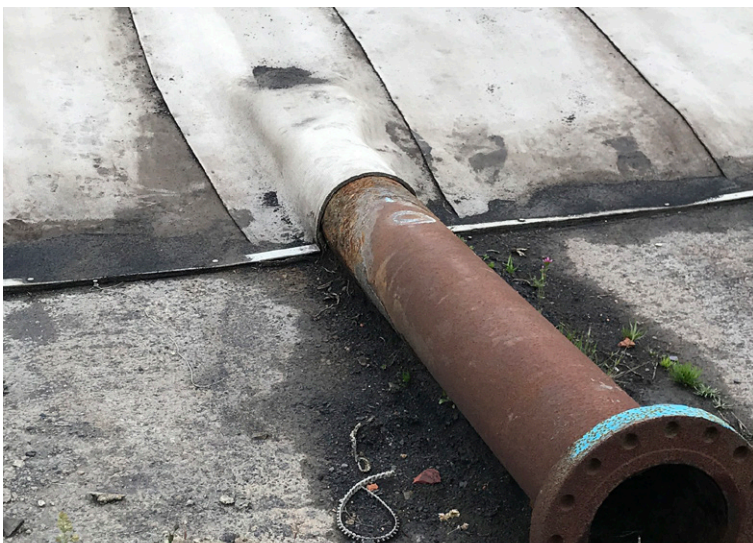
CC was able to easily accomodate existing pipes and other infrastructure

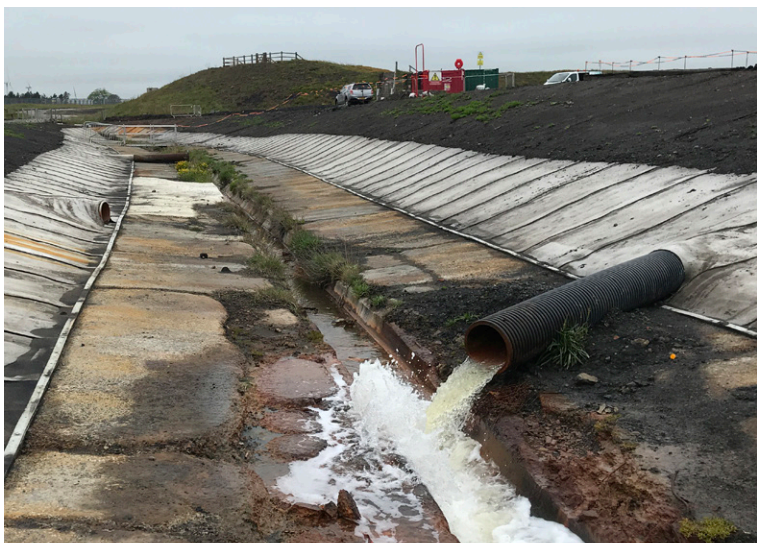
CC provided additional capacity to the channel

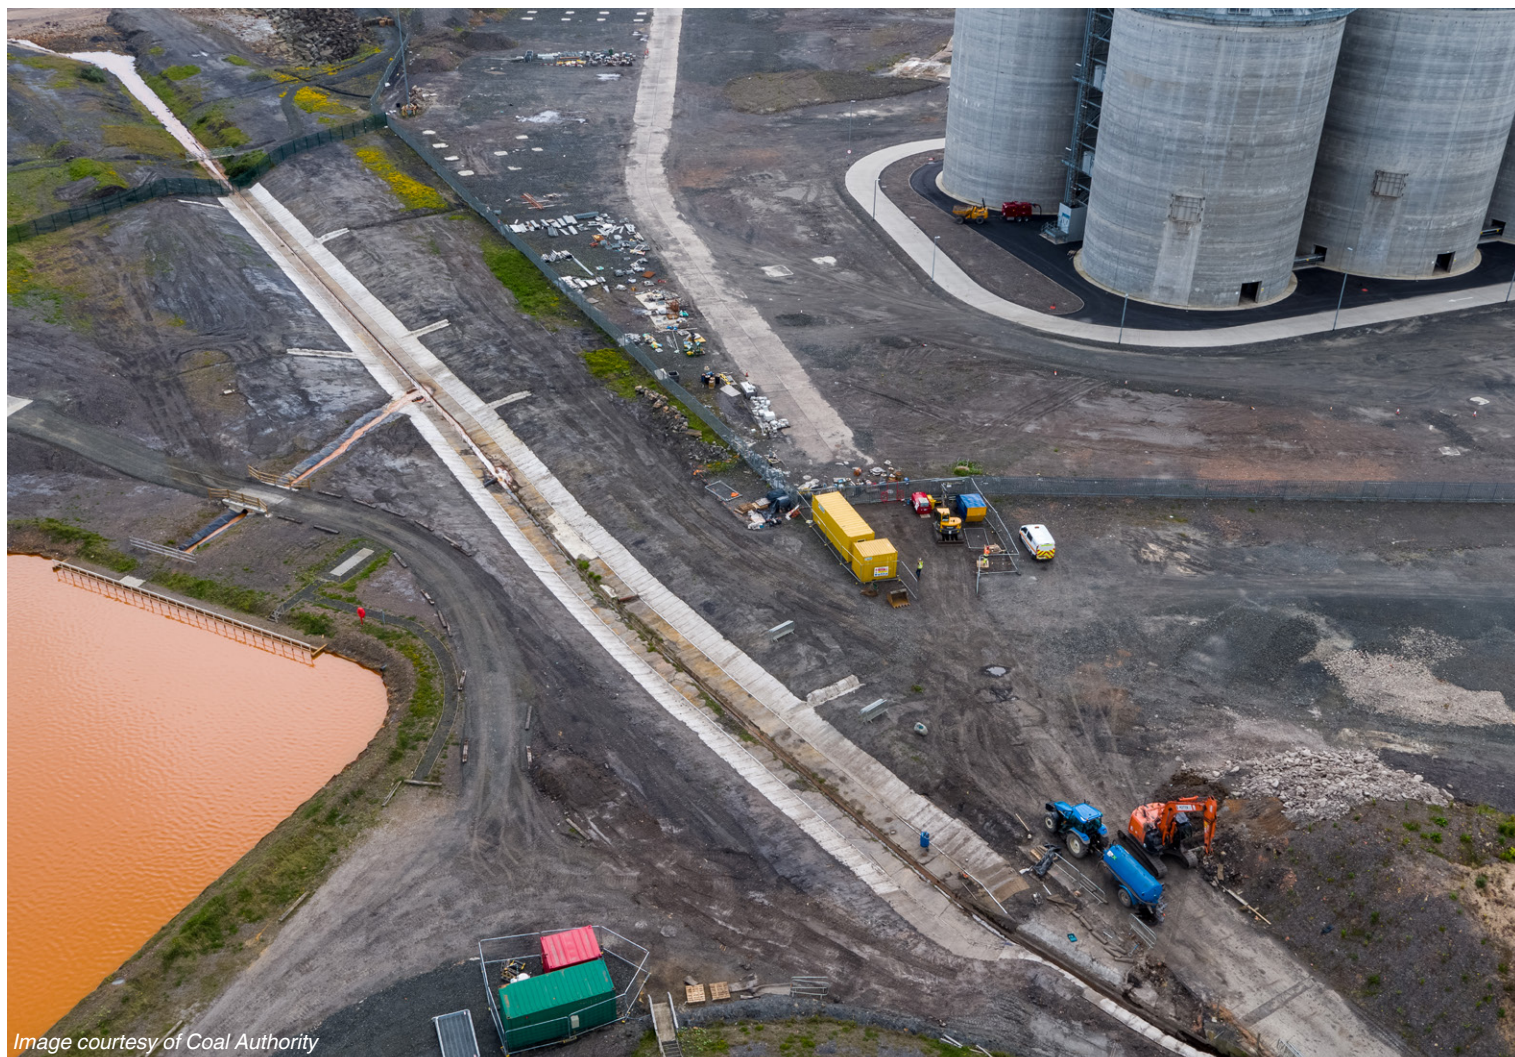
Aerial view of completed CC lined channels
