CC8™ Bulk Rolls

M6 Junction 39/40,
Shap, UK

CC8™ used to prevent further erosion of the drainage channel after heavy rainfall from the adjacent fields.

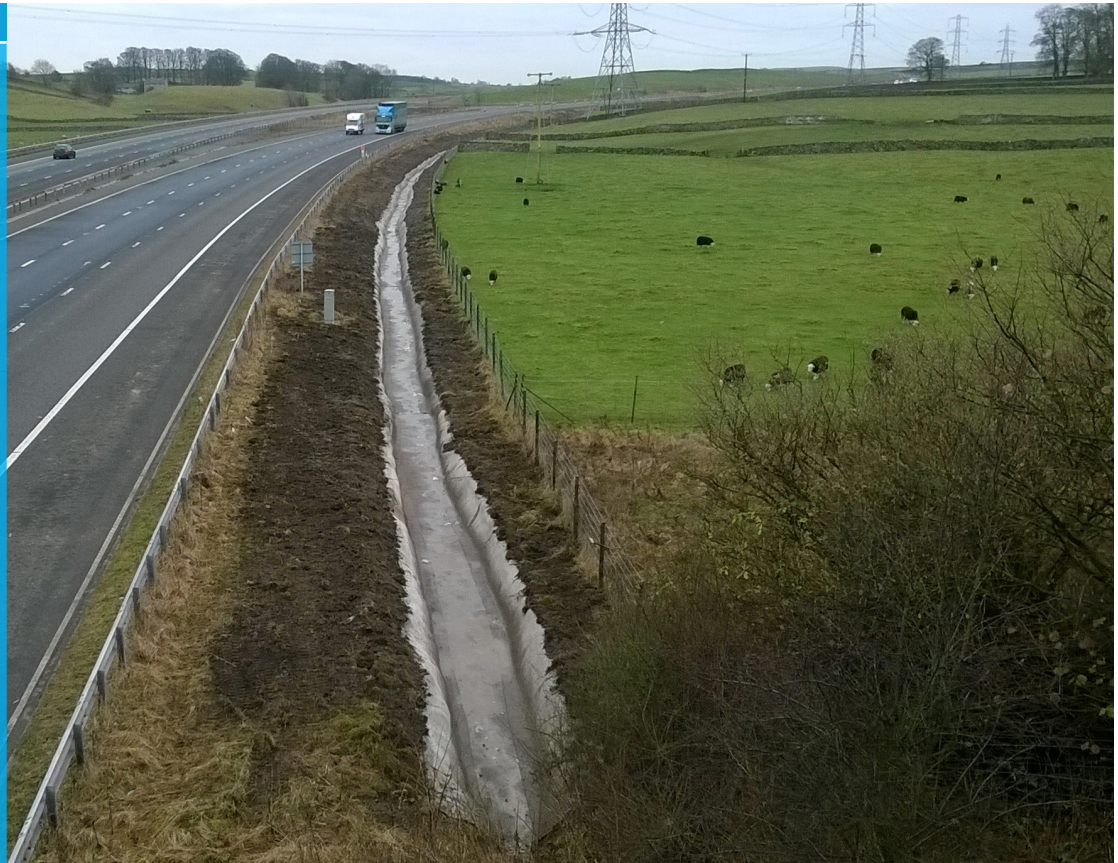
Completed project

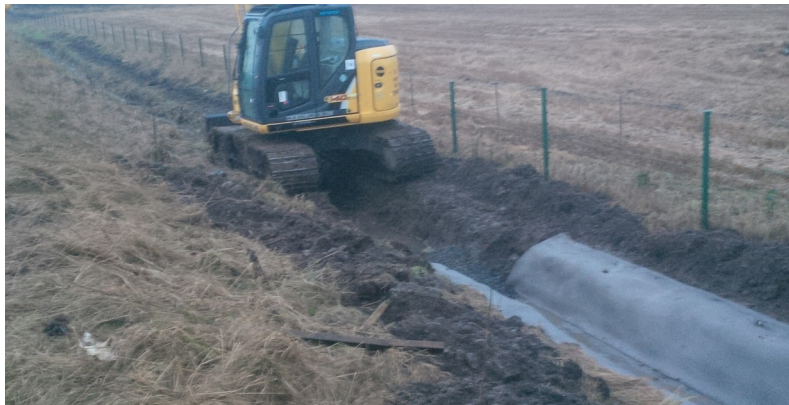
Excavation and laying CC

Prior to the installation of CC8™ the ditch was re-profiled/excavated as parts of it had collapsed due to the erosion. Bulk rolls of CC8™ were deployed using a spreader beam hung from plant, and unrolled along the ditch in two layers, with a 100mm overlap. The CC was fixed to the substrate with ground pegs at intervals of 2m, and the overlap was jointed with screws. The CC was then hydrated using a 1000L IBC and hose, with joints weighed down during setting.

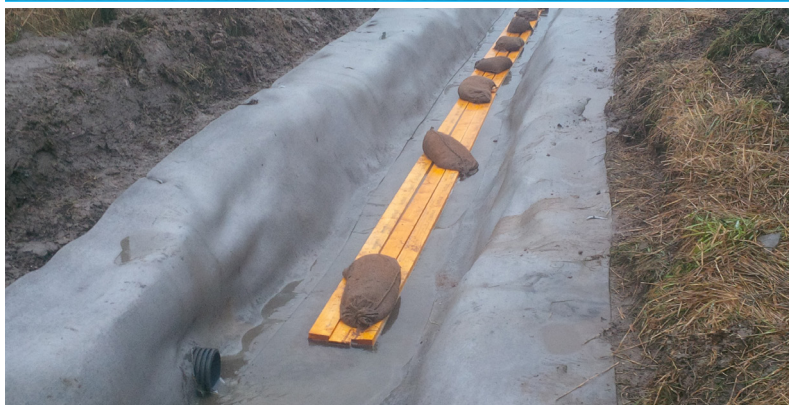
Weighing down joints and a pipe penetration
