CC8™ Bulk Rolls

M6 Junction 3  
Northbound, England, UK

CC8™ used to provide  
a channel lining solution  
to newly constructed  
Accidental Spillage  
Containment channels

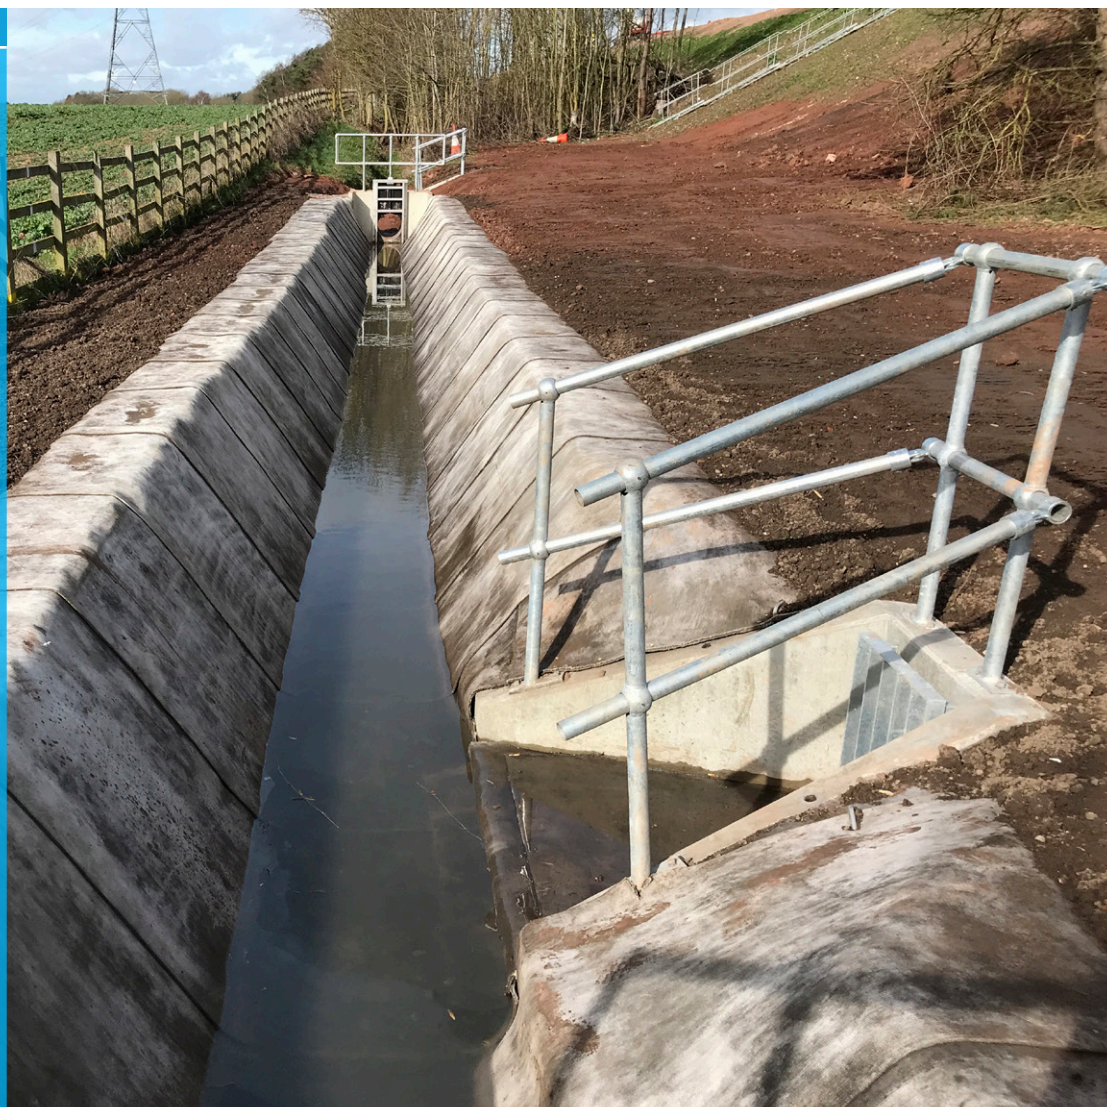
Completed channel alongside M6 in England, UK

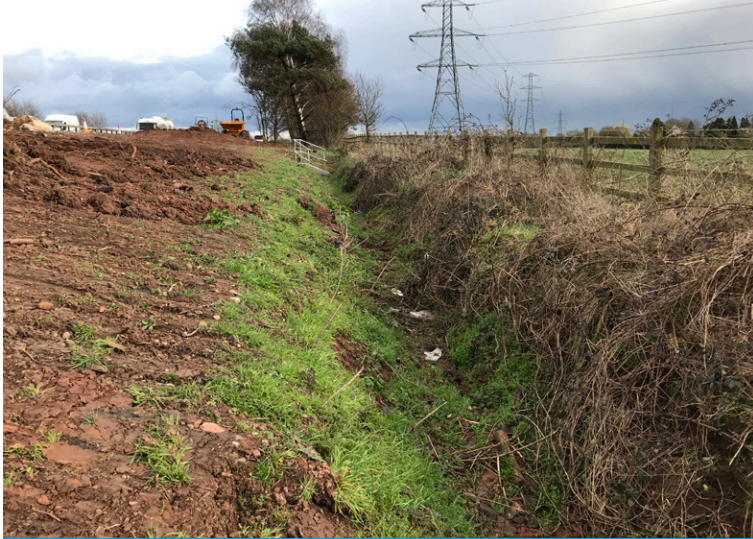
*Original channel had suffered erosion and was overgrown*

The original ditch was in a poor state, with erosion and scour having altered its profile, as well as significant weed growth reducing its effectiveness. The attenuation solution, such as ASC lining with Concrete Canvas® and associated penstocks, improve the control of unforeseen pollution or incidents.

Due to the state of the ditch, it was filled in and recut prior to lining to ensure a consistent profile and smooth substrate on which to lay the CC, avoiding the possibility of voids beneath the material.

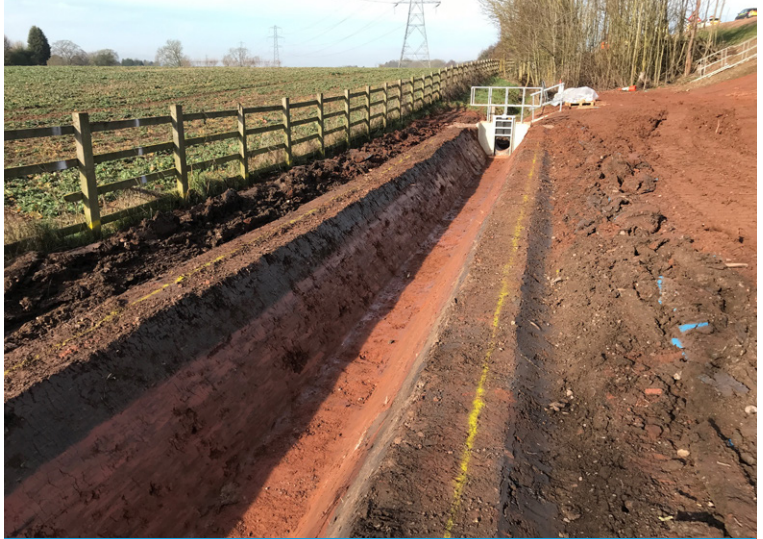
*Newly constructed ASC following ground works*

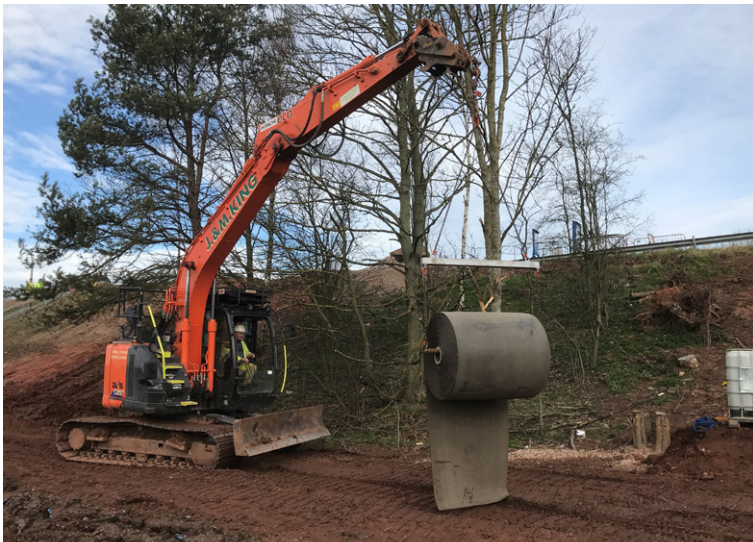
*CC bulk rolls deployed from plant mounted spreader beam*

The material was laid using a 13.5t tracked plant, deploying the material via a mounted spreader beam. The material was laid in a transverse layup across the width of the ASC and in the direction of water flow, with CC edges captured in anchor trenches and fixed using Galvanised Mild Steel pegs. Overlapped layers of CC were jointed together using stainless steel screws to prevent ingress. Where the material terminates against precast concrete headwalls, grout was used to secure it and prevent ingress of water between the material and headwall. Once installation was completed, the material was hydrated directly from bowsers and the material captured in the anchor trenches buried.

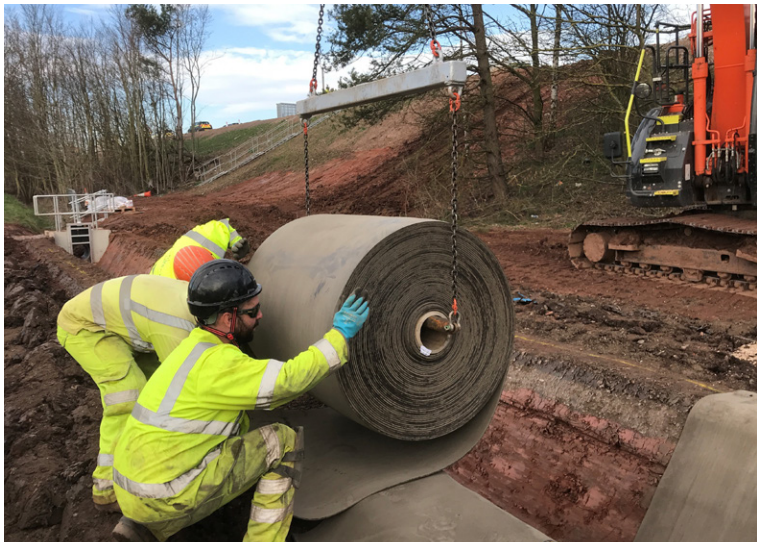
*CC deployed transversely across channel width*

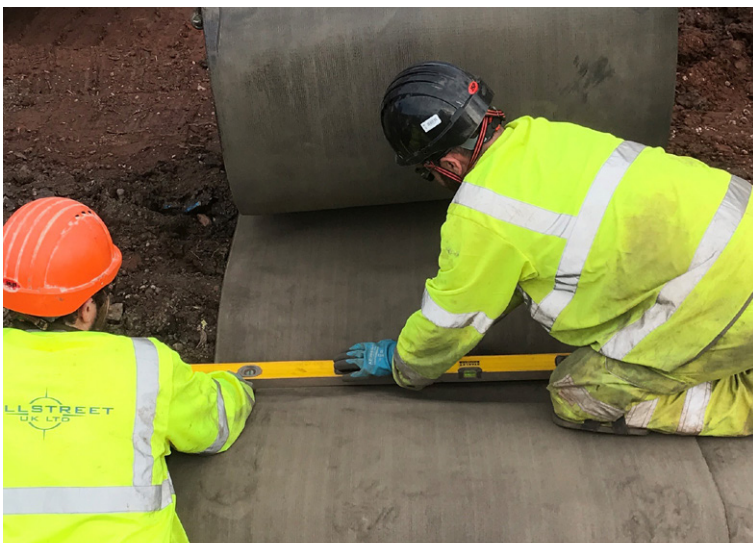
*CC cut to length in-situ to minimise waste*

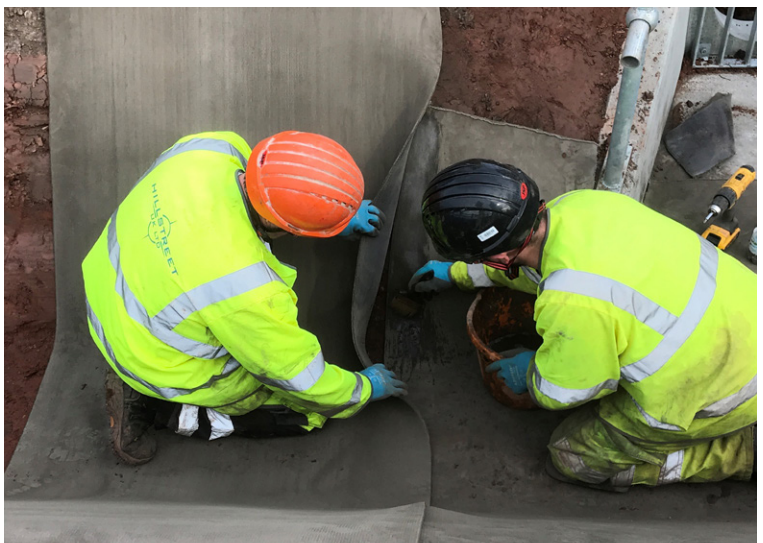
*CC material hydrated under overlaps prior to jointing*

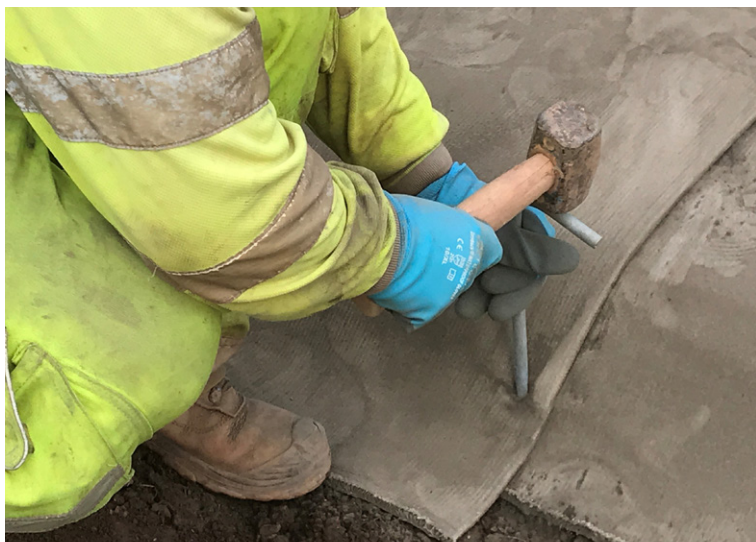
CC edges secured in anchor trenches using ground pegs

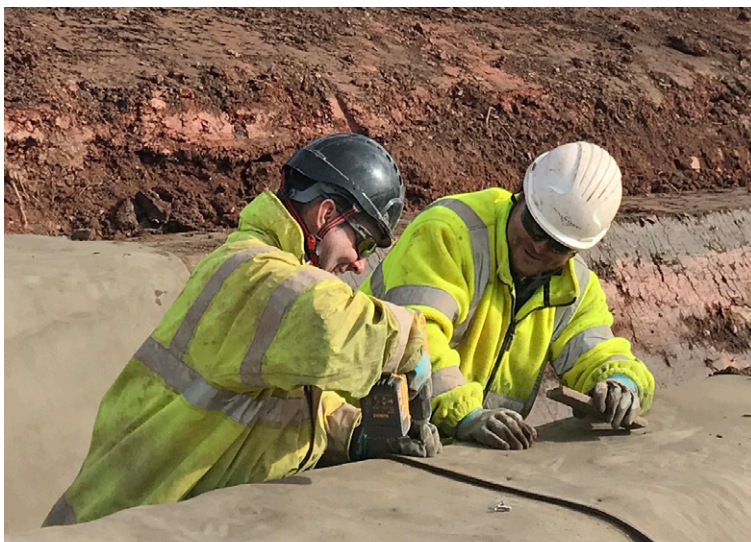
Joining overlaps using stainless steel screws

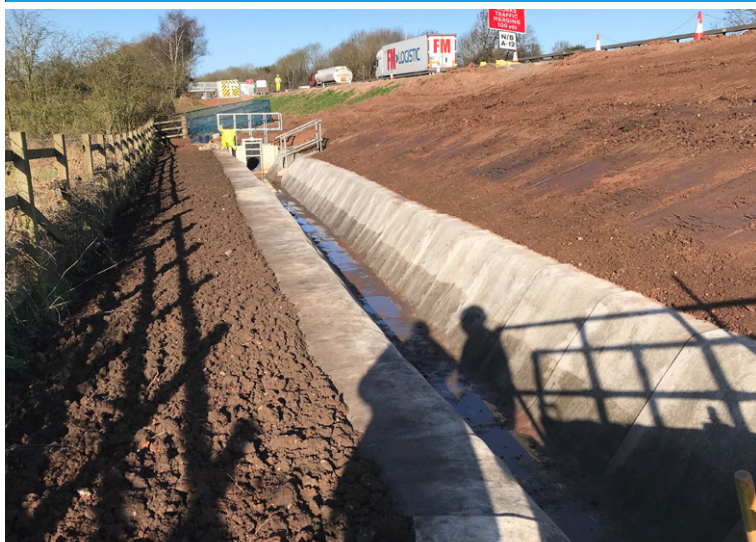
Completed ASC following backfilling of anchor trenches

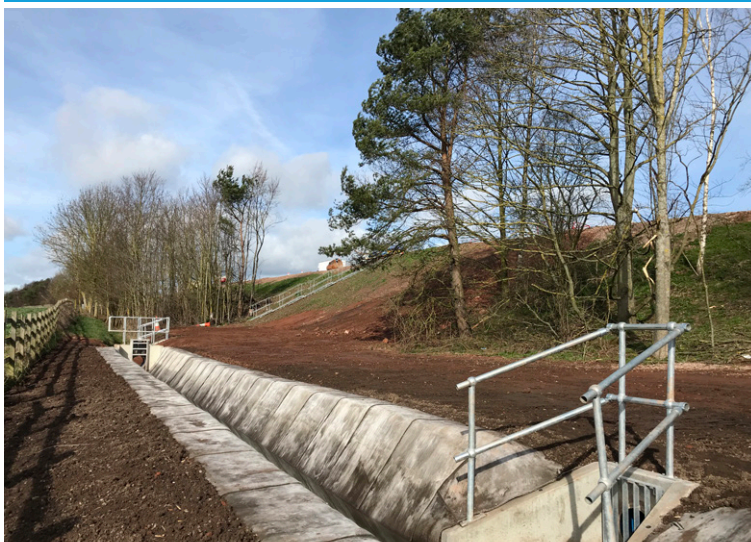
Completed ASC

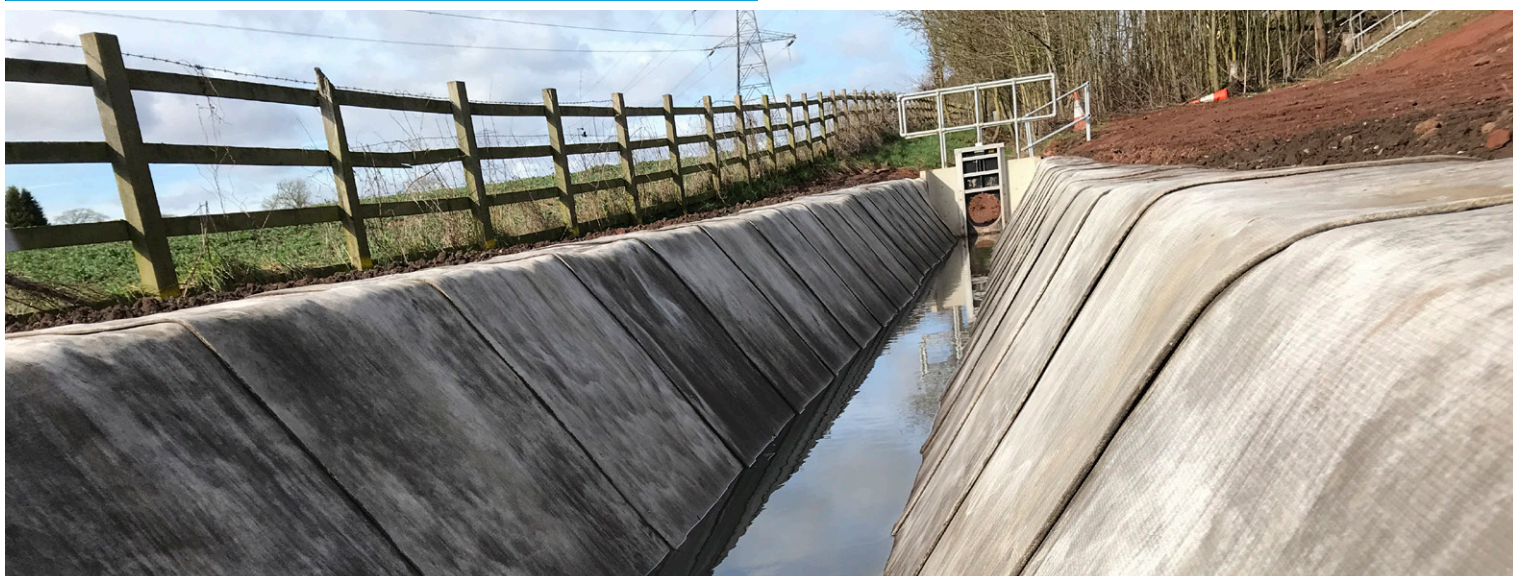
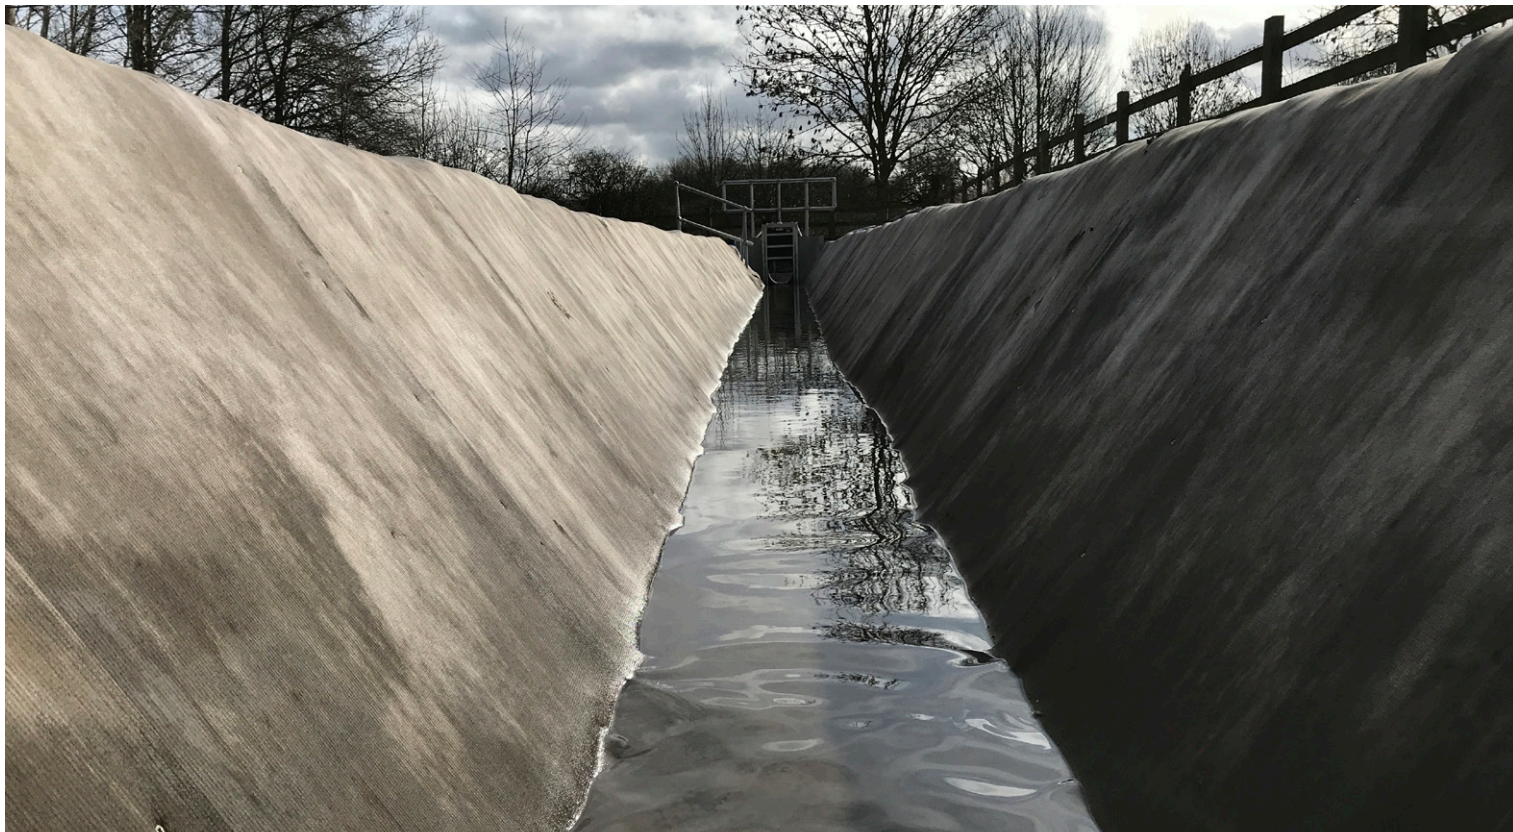
*Profile of completed ASC*
