CC13™ Bulk Rolls

Machen, South Wales,  
UK

CC13™ was used to  
provide a temporary  
erosion protection layer  
to a channel at a former  
paint factory site in  
Machen, South Wales

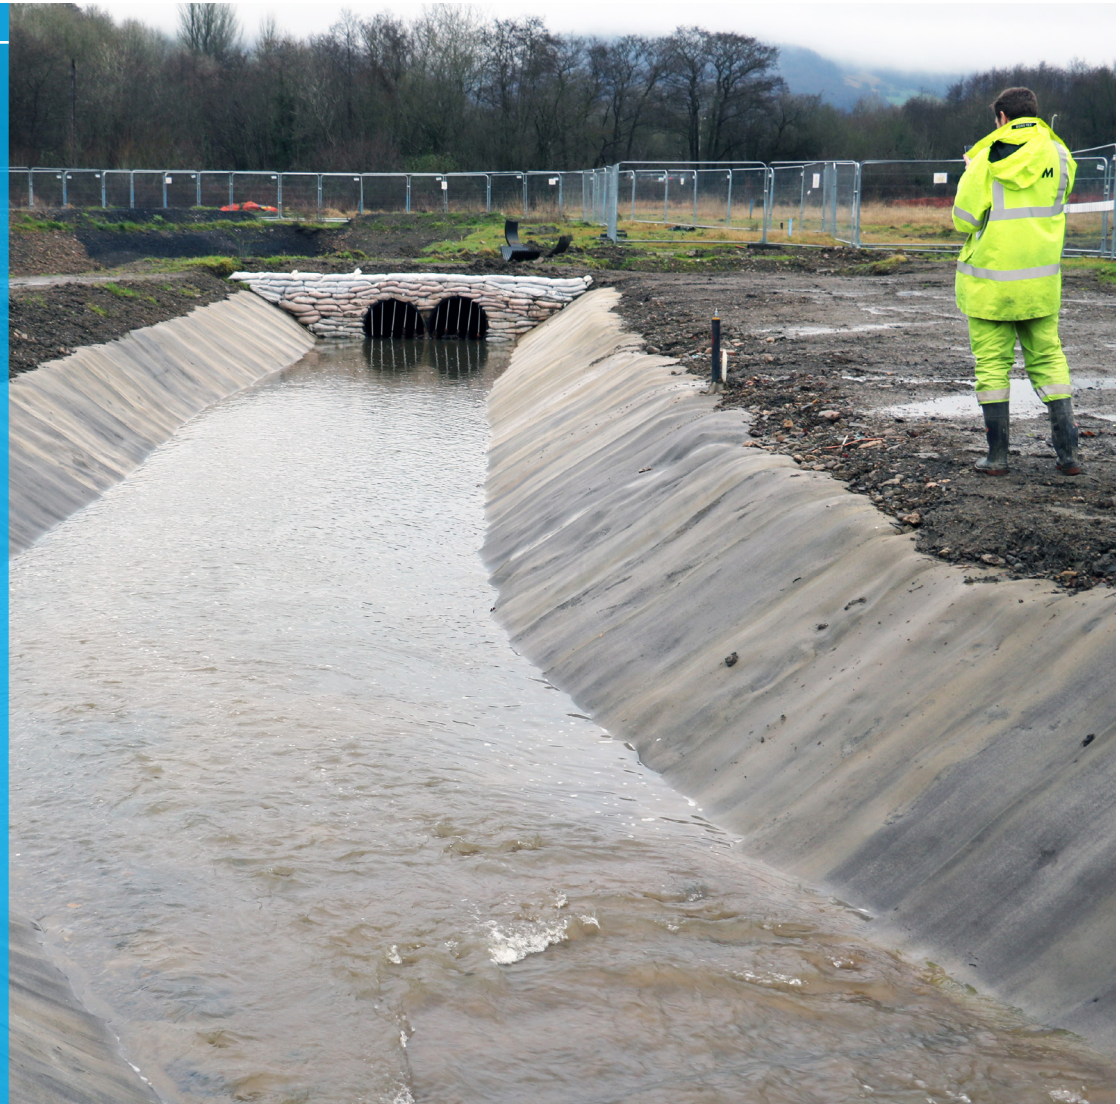
Completed section of channel at paint factory site in Machen

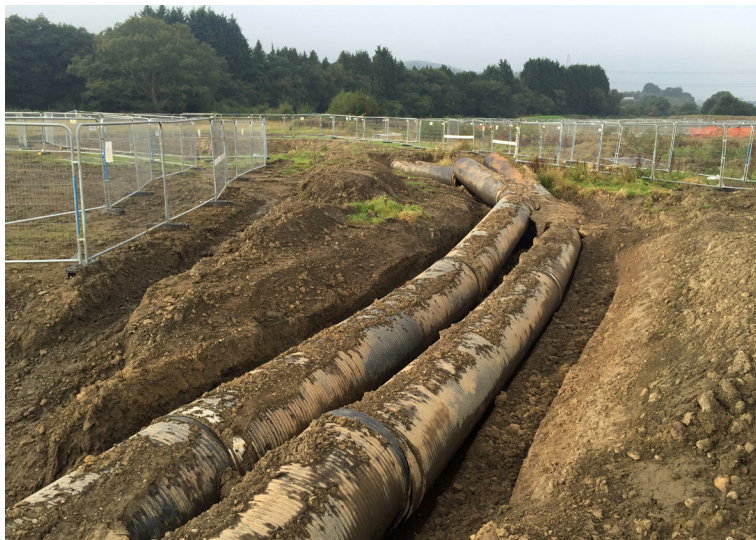
It is believed that the pipework had ruptured due to insufficient top cover and/or negative buoyancy to resist a rising water table and flood-logged ground conditions. The proposed solution was to remove the ruptured pipework section and re-profile the subgrade to an equal hydraulic capacity open channel. The replacement section of channel was approximately 60 linear metres in length with an approximate overall profile width of 7m.

*Existing ruptured pipework*

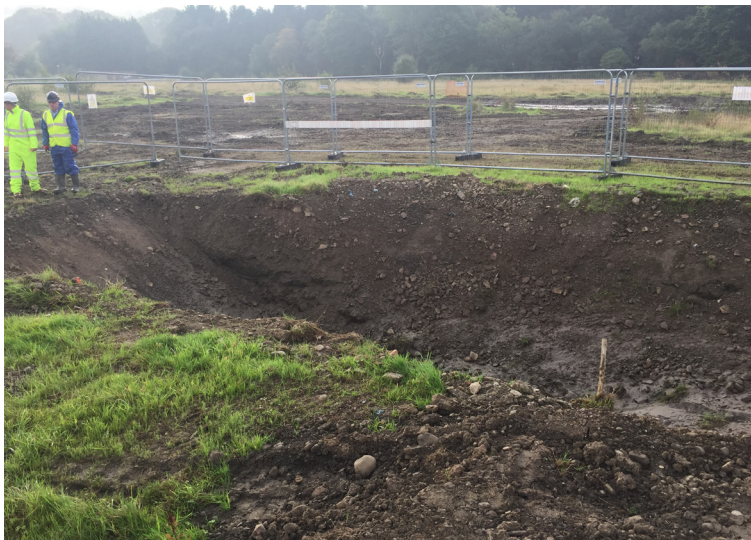
*Early stages of excavation work for channel*

The overflow channel was excavated and graded prior to installation to ensure the CC material had a flat, even surface on which to be laid. Vegetation and debris, including sharp stones and rocks, were also removed in order to avoid voids below the CC membrane.

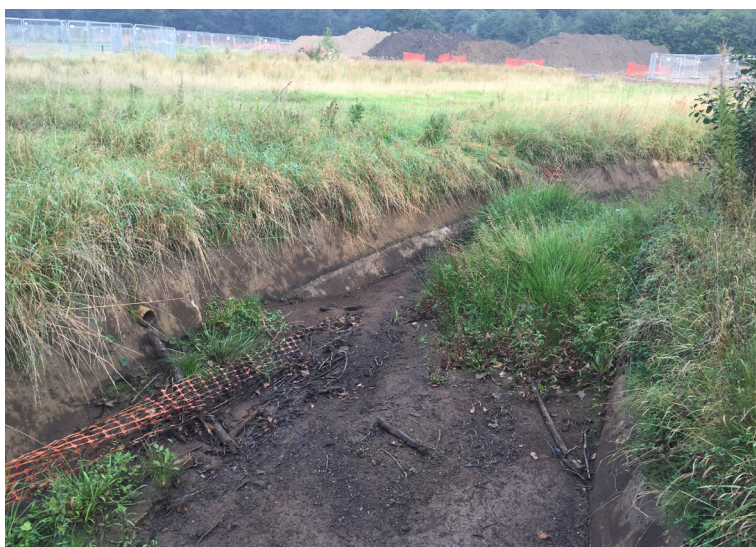
*Overgrown existing channel section*

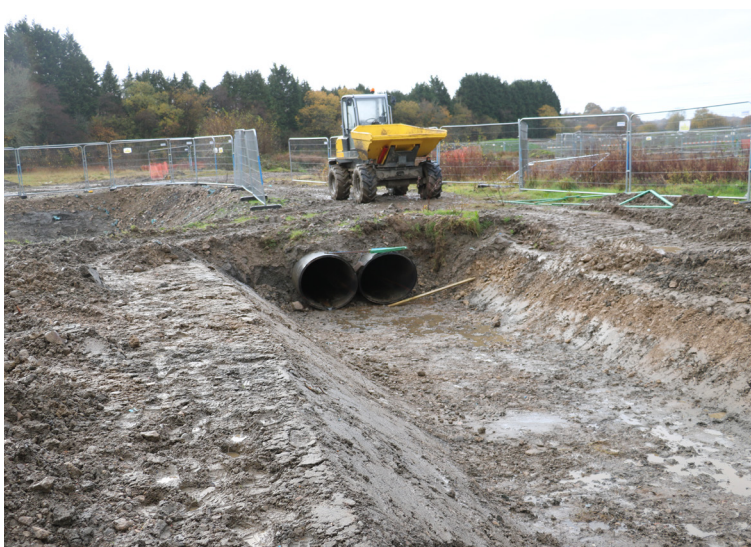
*Pipework outflow leading into the new channel*

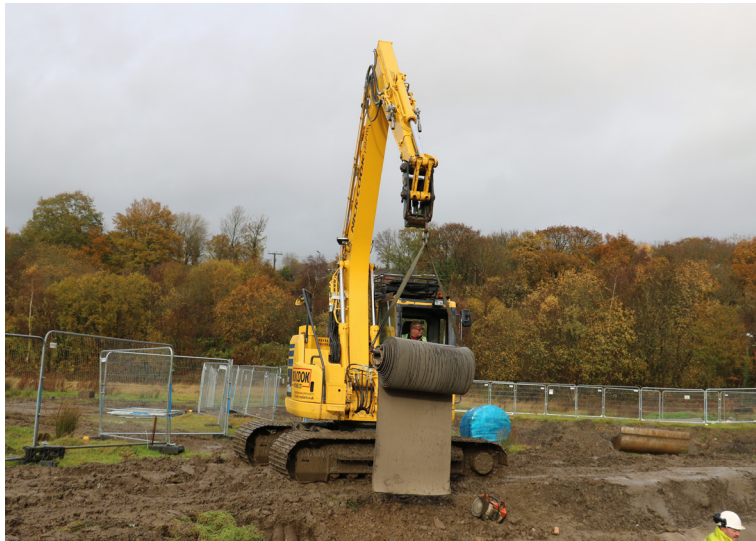
*CC bulk rolls mounted to a spreader beam for easy deployment*

Once ground preparations had been completed the CC was delivered to site in bulk rolls of CC13. The CC was mounted onto a spreader beam and excavator, and laid transversely across the width of the channel to account for any variation in the profile width. The material was then cut to length using a disc cutter and the edges of the CC were secured in the anchor trenches using ground pegs. Additional layers of the material were laid with edges overlapping by 100mm and secured in the same way. Overlaps were then jointed using screws and an auto-fed screwdriver at intervals of approx. 200mm.

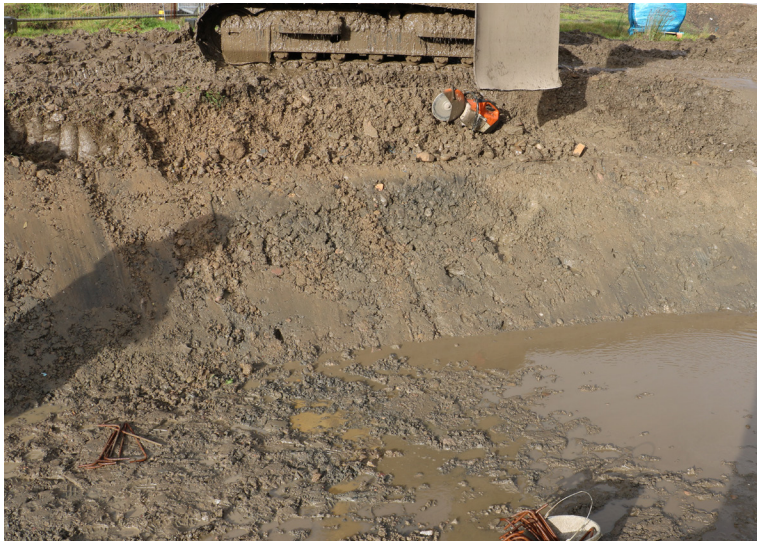
*The graded channel*

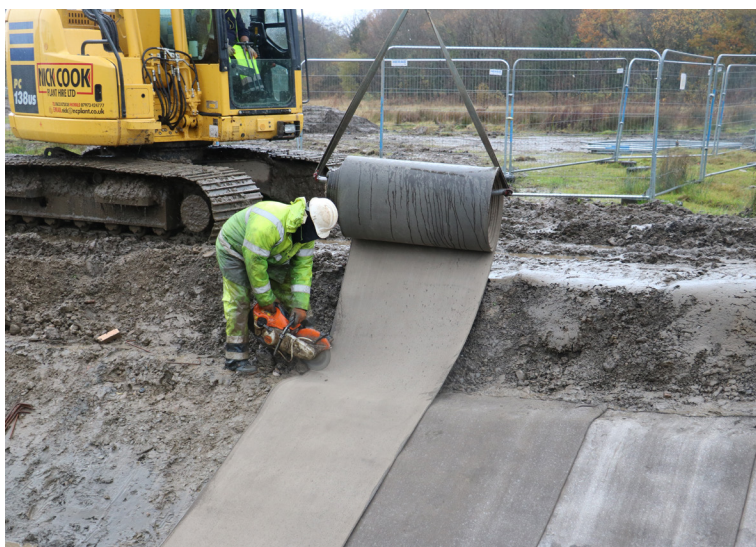
*CC laid transversely and cut with a disc cutter*

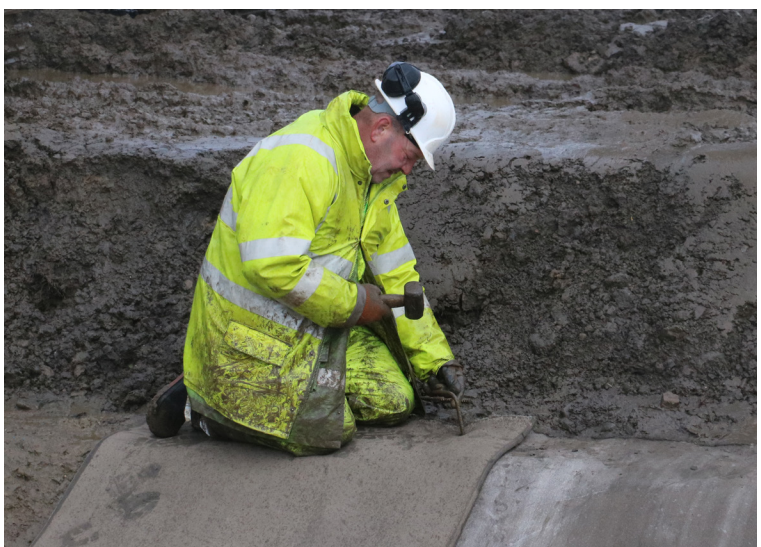
*Material edges fixed within anchor trenches using ground pegs*

This was repeated along the full length of the newly excavated channel. The terminating edges of the material at either end of the channel were fixed in the anchor trenches and buried, while the original pipelines at one end were protected using plastic grids and sandbags which created a headwall, also protecting the edges of the CC from ingress. Once the installation was complete, the CC was hydrated.

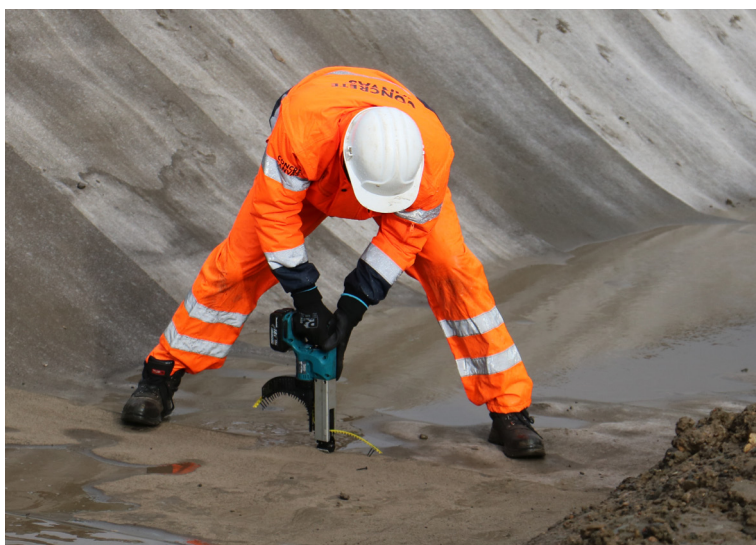
*Overlaps were jointed using screws and an auto-fed screwdriver*

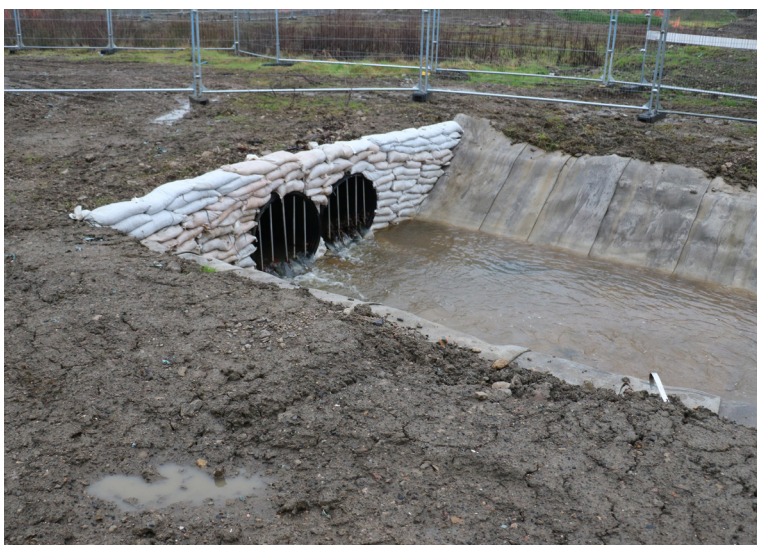
*Bagwork headwall termination*

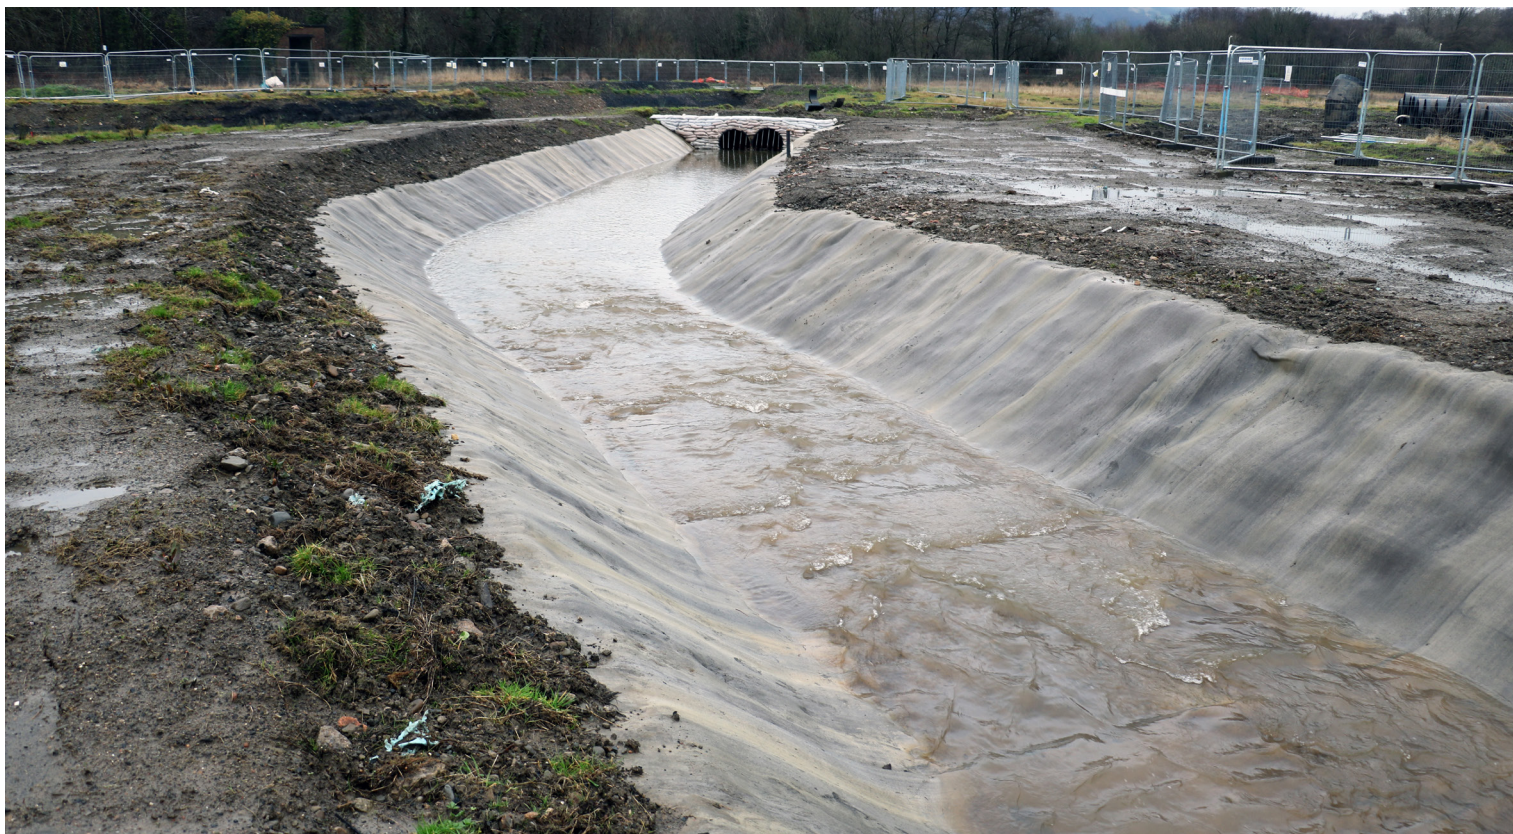
*Up-stream view of the completed channel in use*

A total of 320m<sup>2</sup> of CC13™ were installed in 10 days in inclemental weather conditions, offering commercial and logistical advantages over the alternative options.
