CC8™ Bulk Rolls

Mariana, Minas Gerais,  
Brazil

Samarco/ Skava Minas

CC8™ used to line  
a newly constructed  
channel for mine and  
rain water management

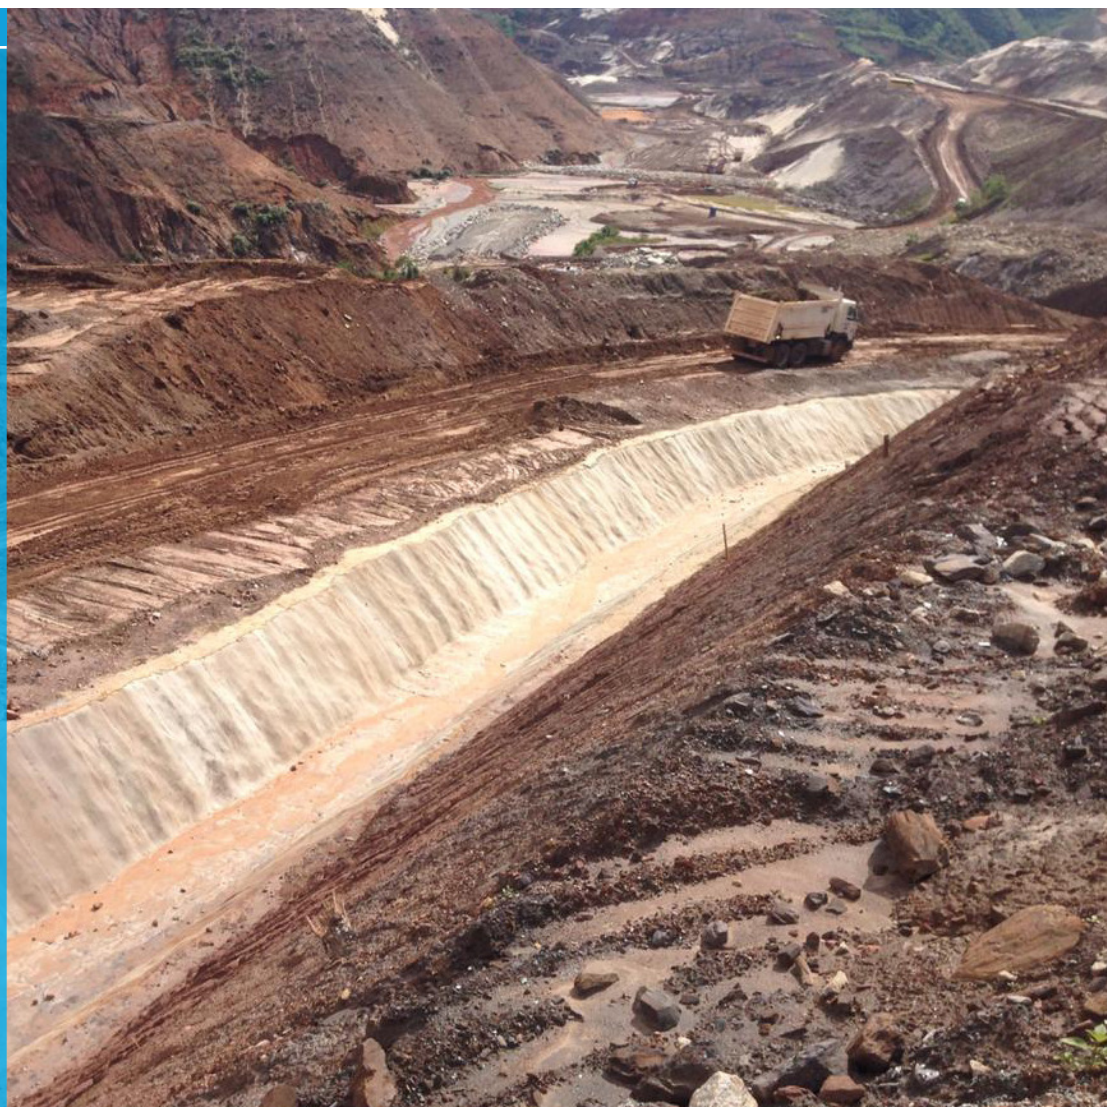
Completed channel section at a mine site in Mariana, Brazil

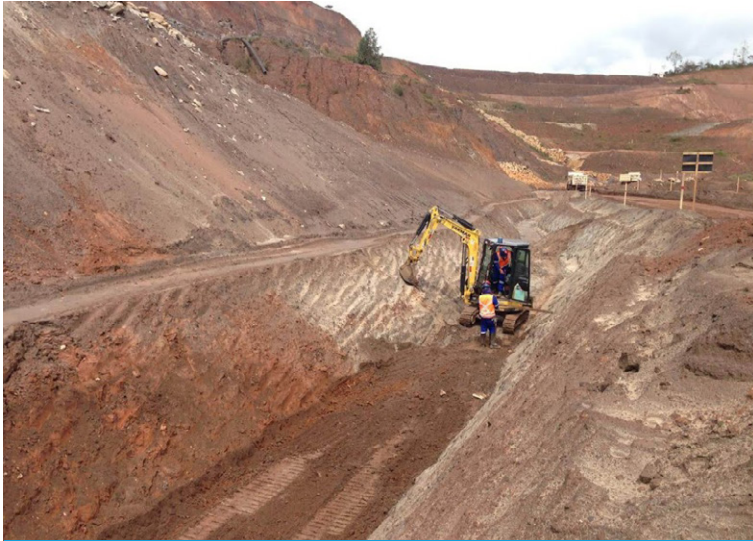
*Excavation of 3m deep channel*

Prior to installation, the 3m deep channel was excavated from tailings material which had been compacted over 10 years. The 3m slopes on either side were then profiled and compacted for a smooth finish, allowing the CC to be installed without risk of voids forming below the material. Anchor trenches were then dug on either shoulder of the channel, measuring 20 x 20 cm.

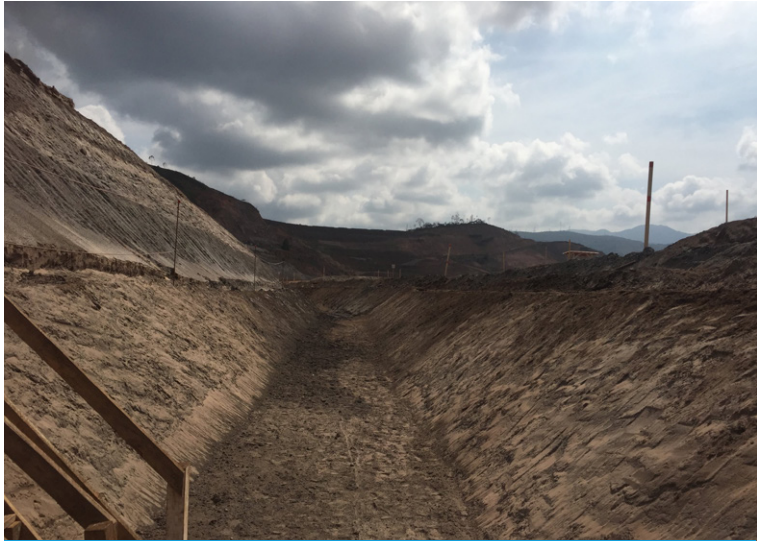
*Channel following ground works*

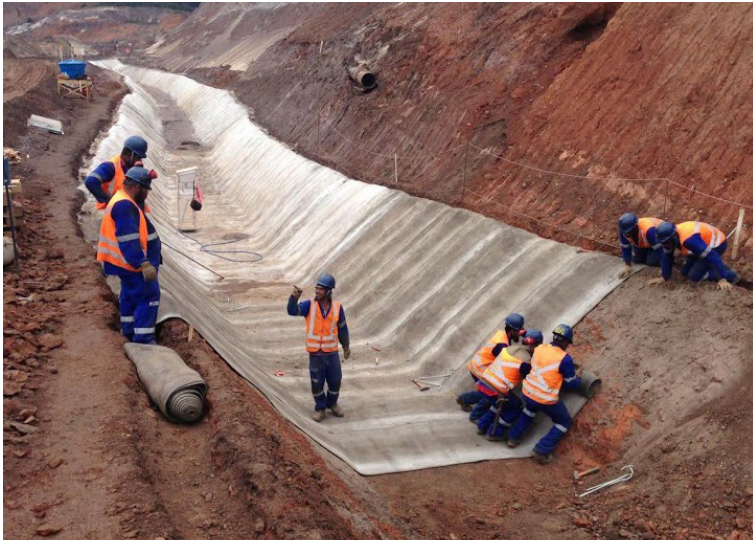
*CC deployed transversely*

The specified CC8™ material was delivered to the site in bulk rolls, transported by truck from a warehouse 15 minutes from the site. The CC was then cut to required lengths of 9.5m on average and manually transported to and deployed transversely across the channel. The edges of the CC material were captured within the anchor trench and fixed using steel ground pegs at approximately 1.5m intervals. Subsequent layers of CC were overlapped by 100mm and double-jointed using 35mm screws set at 200mm intervals following hydration of the lower layer below the overlap. This method was repeated along the full length of the channel before hydration was carried out via a 5000m<sup>3</sup> bowser. Initial hydration was carried out for 15 minutes and repeated an hour later. The anchor trenches were then backfilled using poured concrete. In four sections of the channel, where flow rates were above 10m/s, a concrete column measuring 20 x 20 x 400cm was installed on the base of the channel to dissipate water energy.

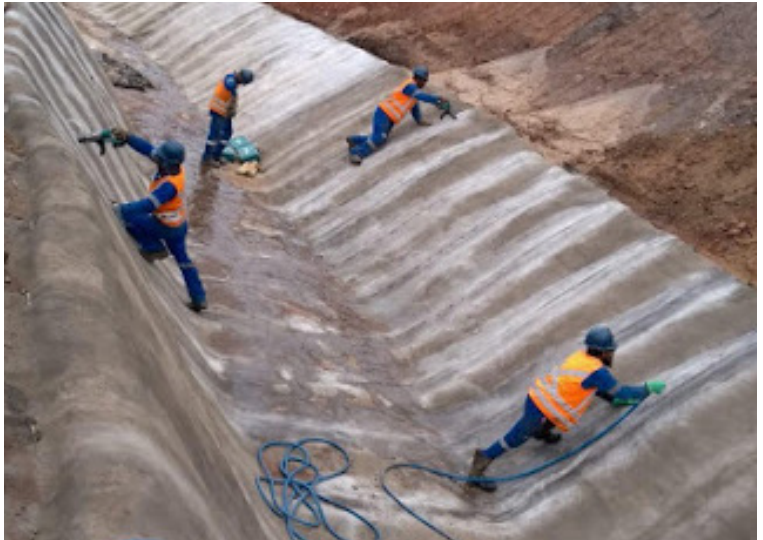
*Jointing of the overlaps*

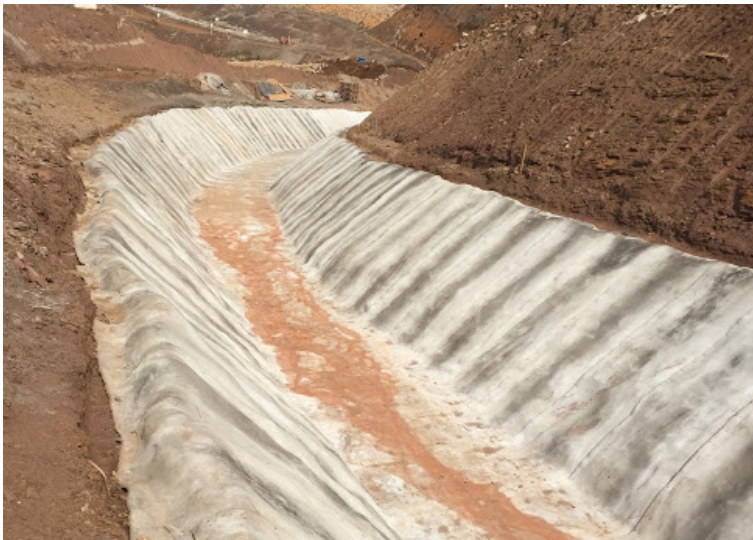
*Setting CC channel*

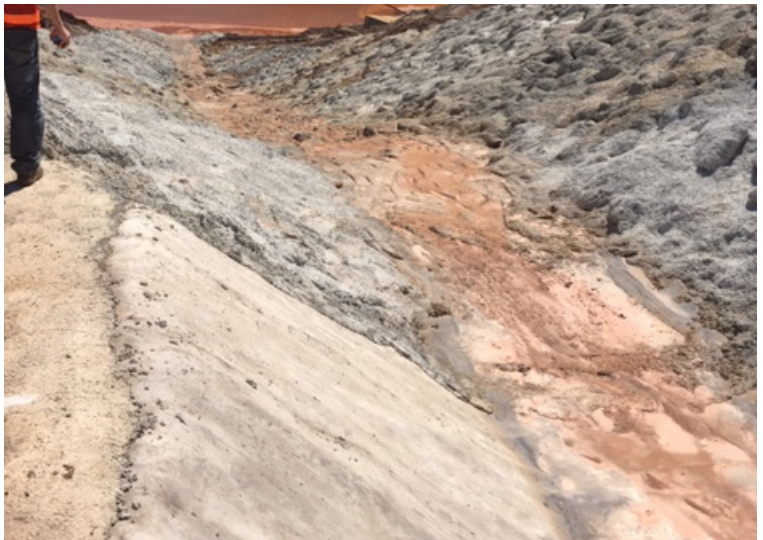
*CC termination at rocky section of channel*

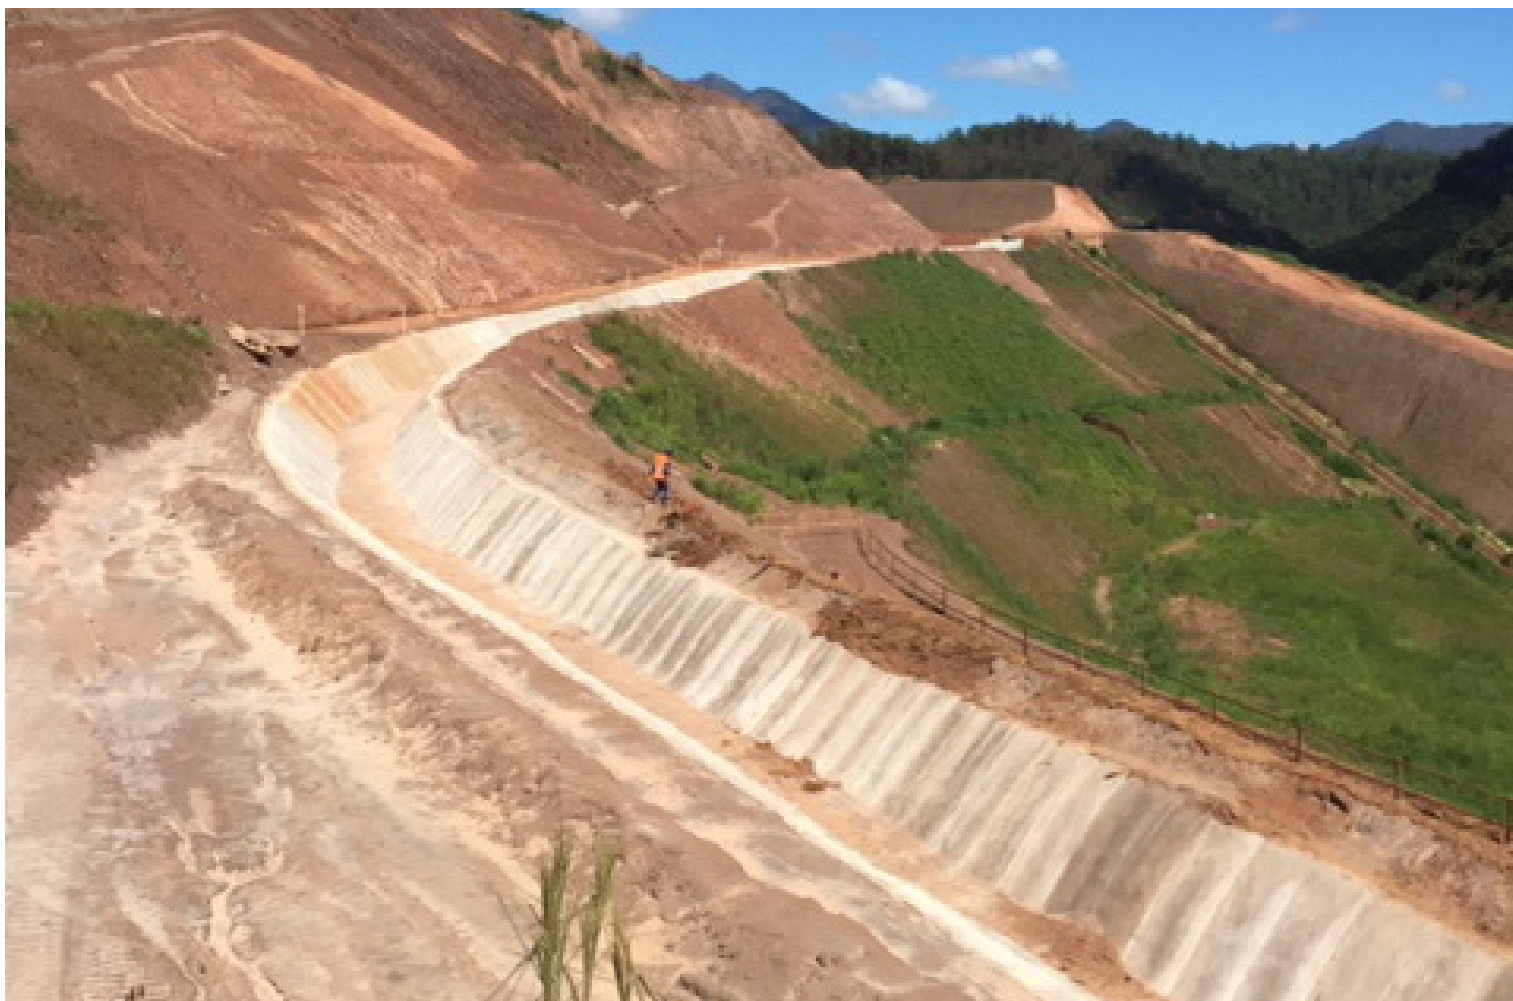
*Completed channel and backfilling of anchor trenches using mortar*
