CC8™ Bulk Rolls

Mutanda Mine, Kolwezi,
Democratic Republic of
Congo

CC8™ used to line a
newly constructed storm
water drain designed to
carry water away from a
mining area

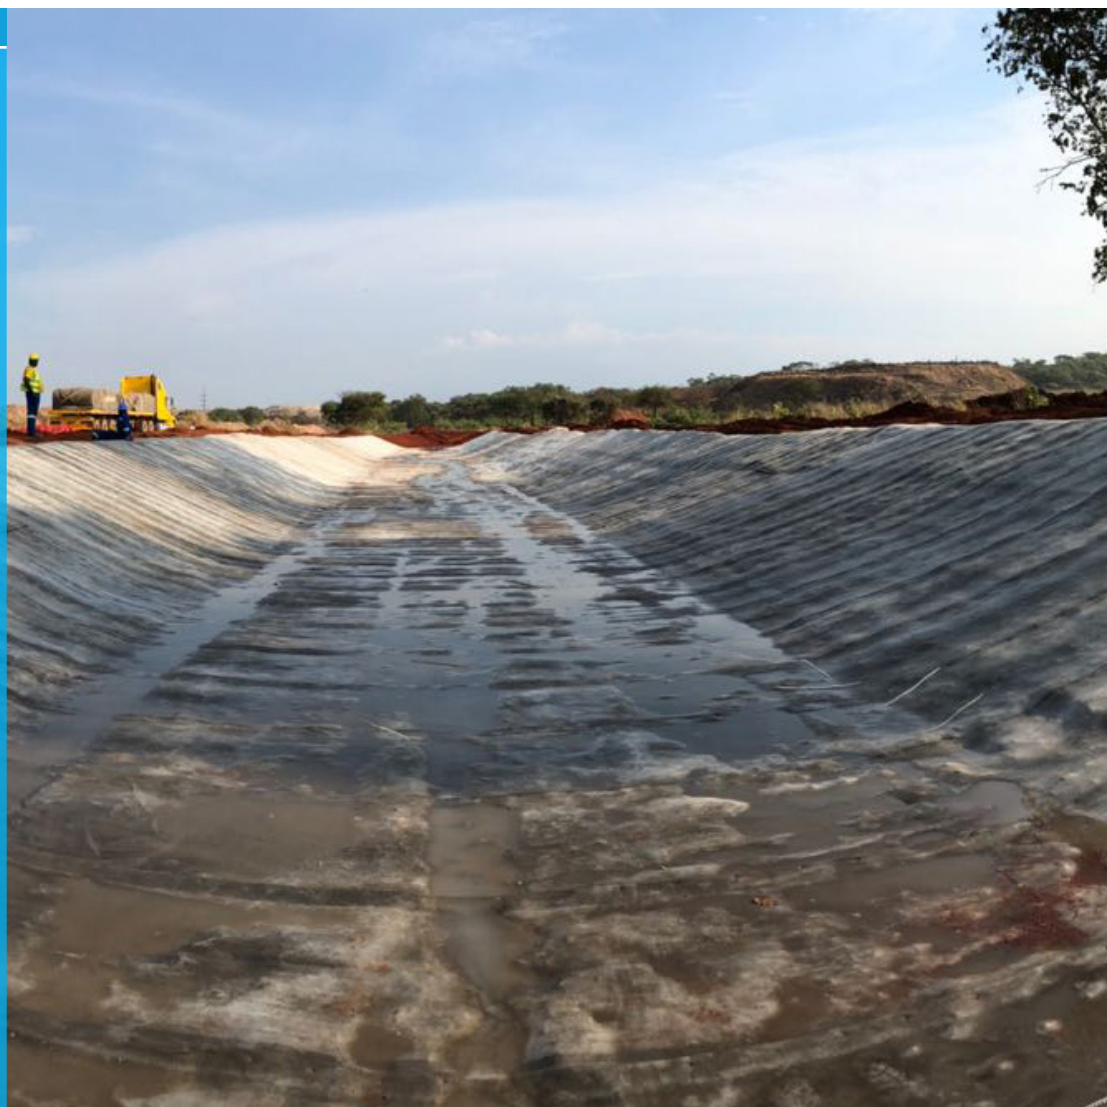
Completed channel installation

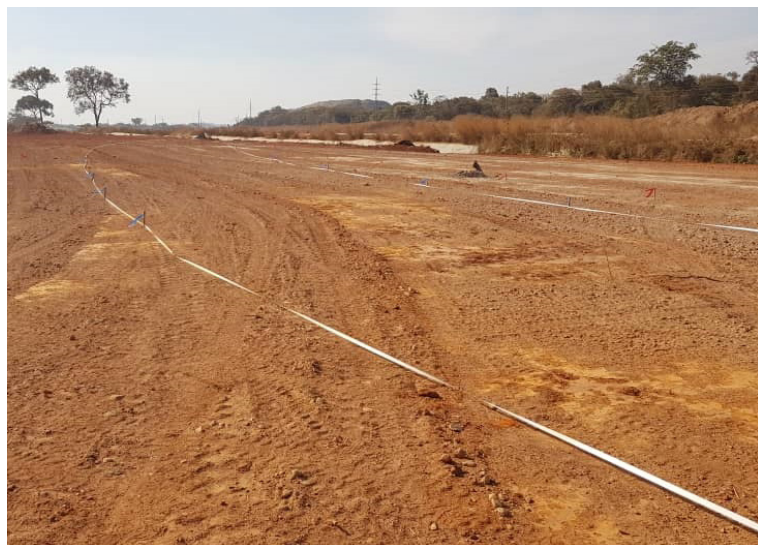
Channel marked out prior to ground works

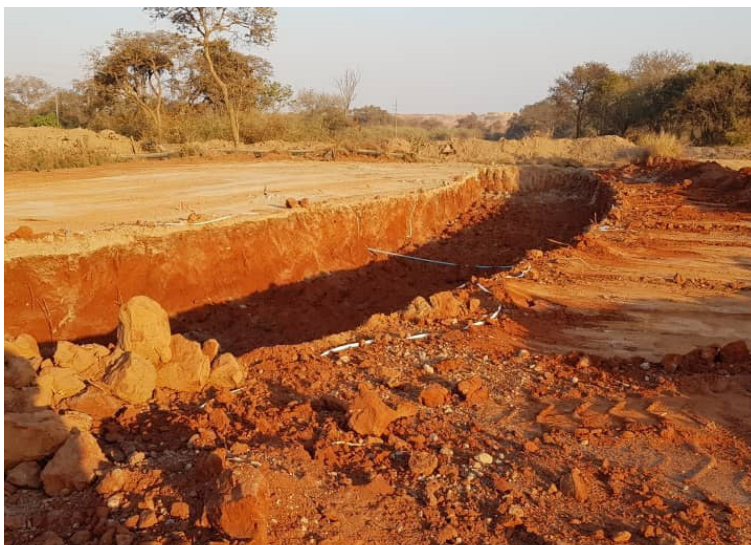
Channel excavated

Prior to installation, any vegetation growth was removed from the drainage channel before it was excavated and graded to establish the required slope angles and cut shape. A compactor was used on the base of the drain and the soil hydrated if it hadn't been raining to moisten it before installation.

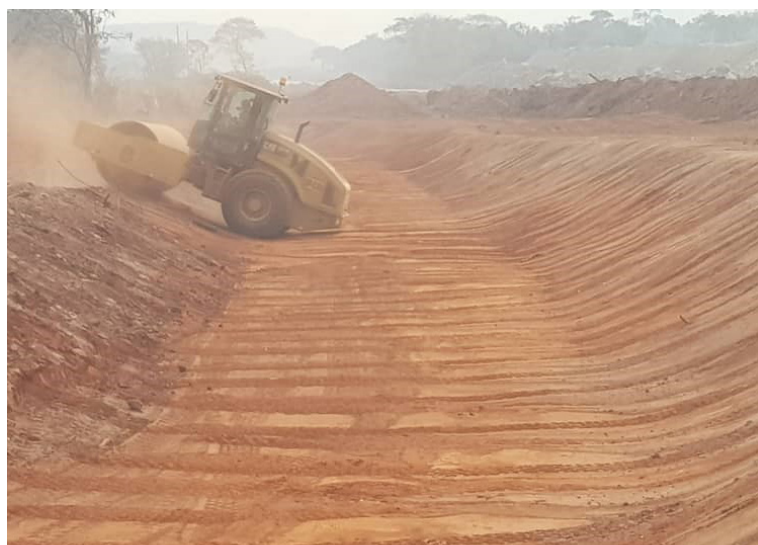
Compacting substrate following excavation of side slopes

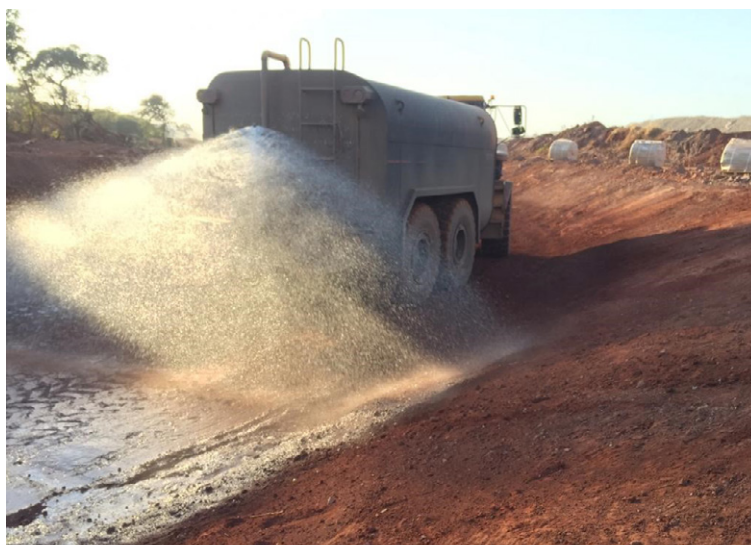
Moistening substrate prior to installation

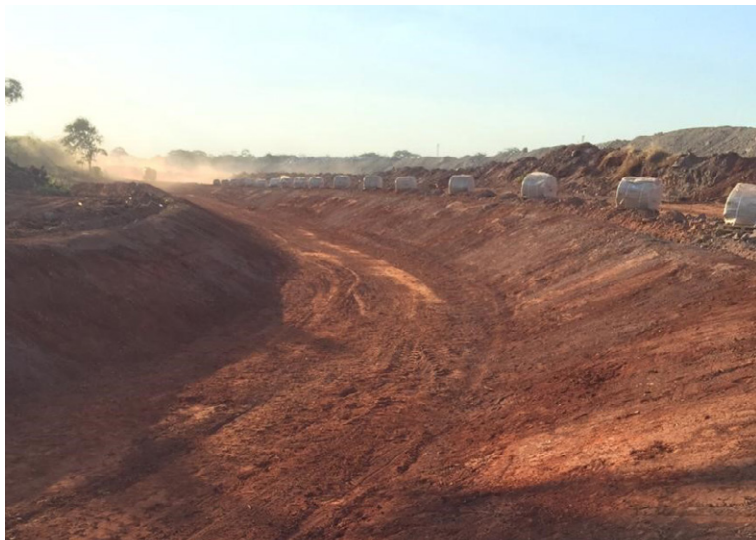
Bulk rolls stationed along channel shoulder

The CC was deployed from bulk rolls and laid transversely across the drain with layers overlapping in the direction of water flow to prevent ingress. Galvanised pegs were used to anchor each layer to the last through the overlap. Pegs were secured at the base of the channel along the toe of the side slopes to resist any potential movement resulting from drying conditions. Once the material was hydrated and hardened, pegs were also installed in the anchor trench which was then backfilled. 25mm stainless steel screws were installed at 200mm intervals along each overlap.

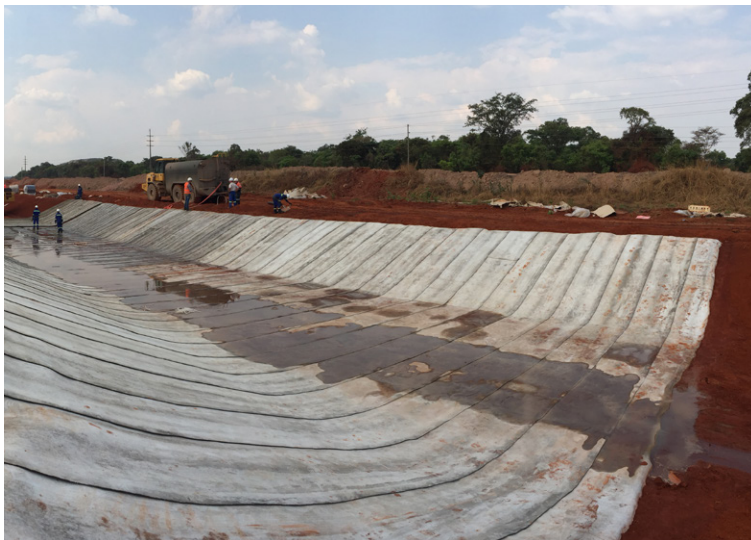
CC was laid transversely, using an excavator and spreader beam

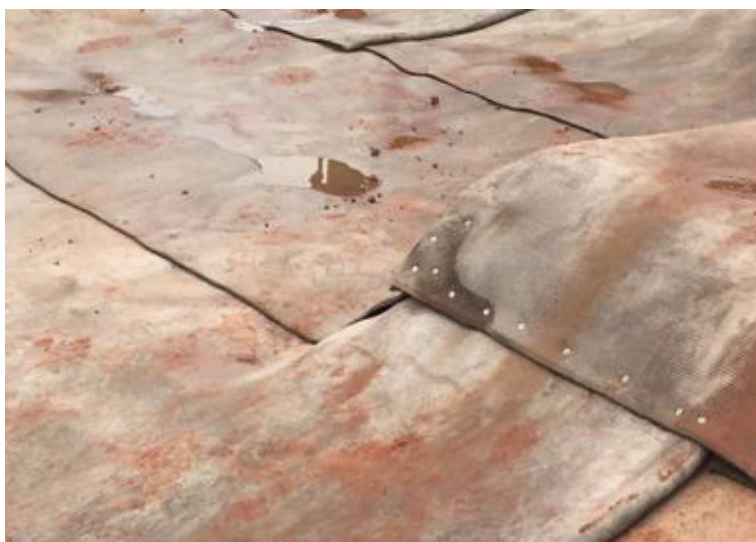
CC layers jointed using screws at corner section

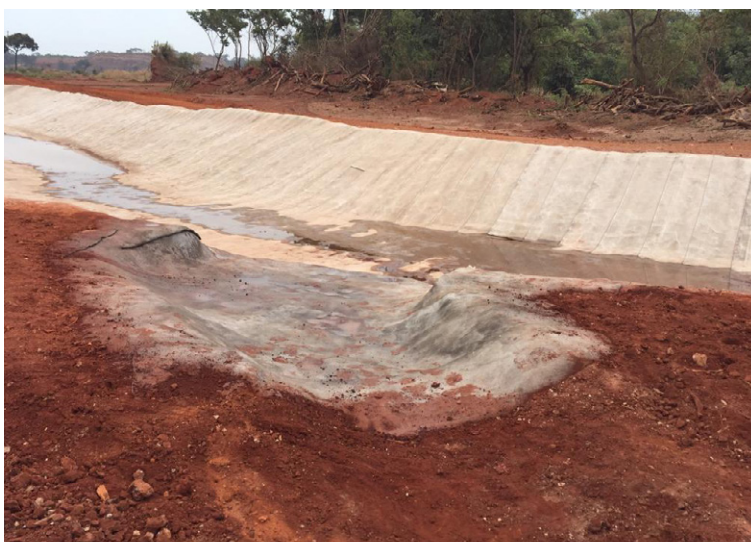
Inlet section of channel

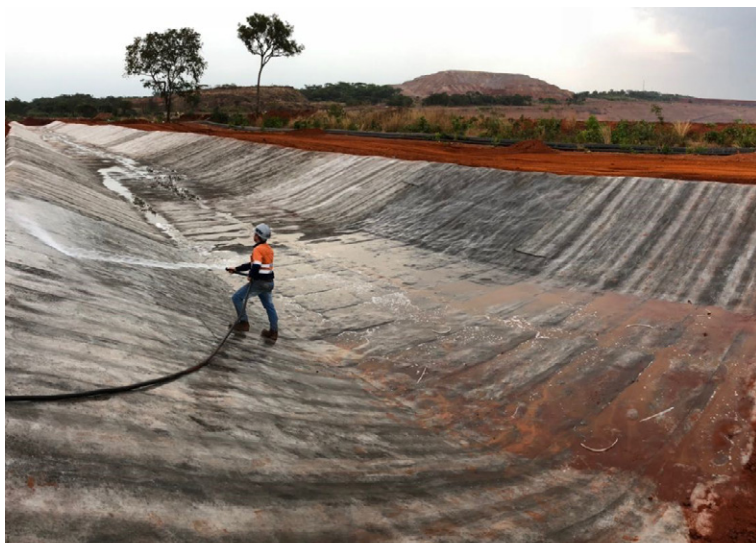
Hydration of material at end of work day

Due to the high temperatures, the CC was hydrated first before the joints were screwed, and a second hydration given 10-15 minutes later following jointing. A third hydration was then given until the material was saturated, and repeated at the end of each day. To ensure sufficient hydration and counteract any drying that may have occurred overnight, the material was hydrated again the following morning before further installation.

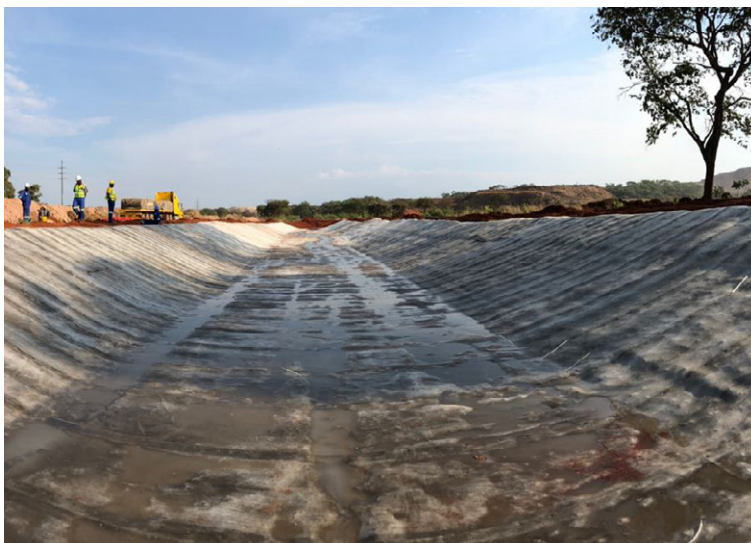
Completed channel section following hydration

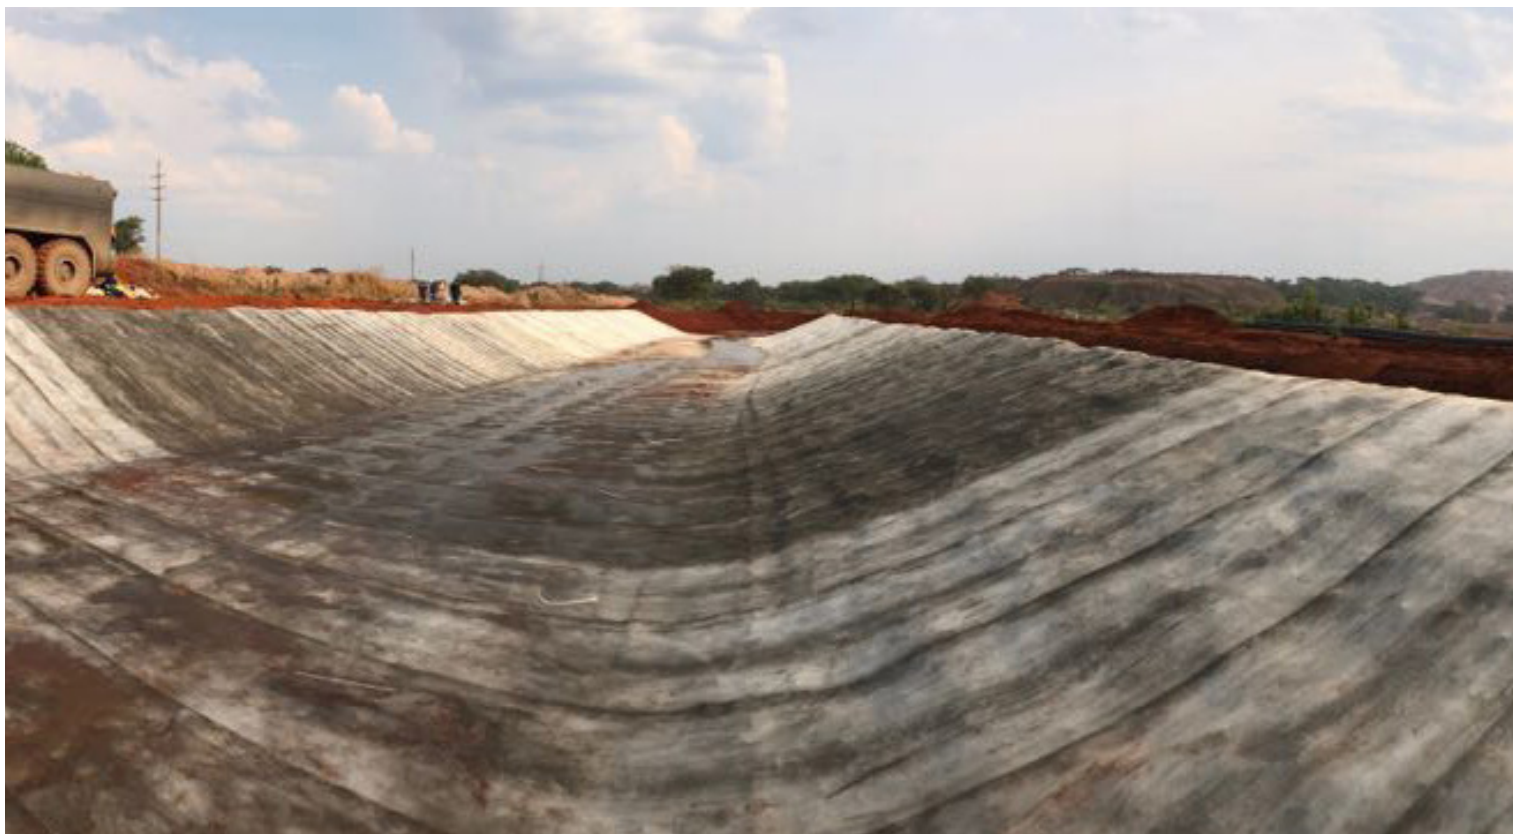
Wide angle view of completed channel section

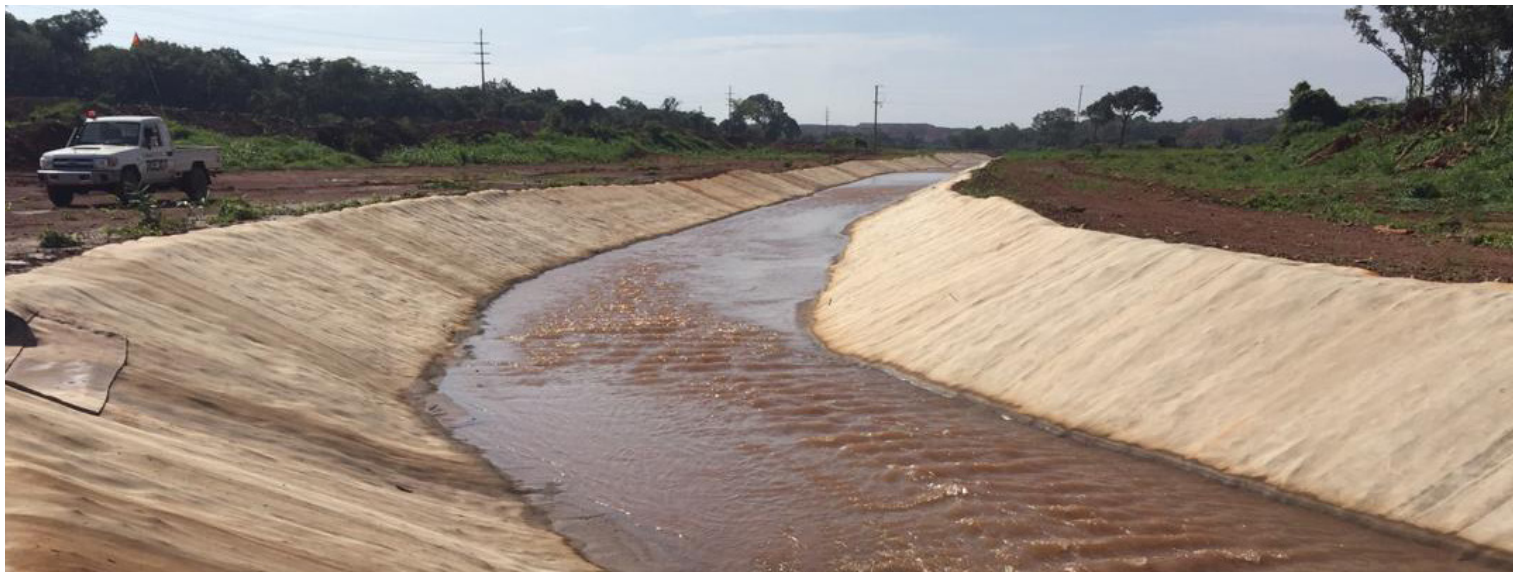
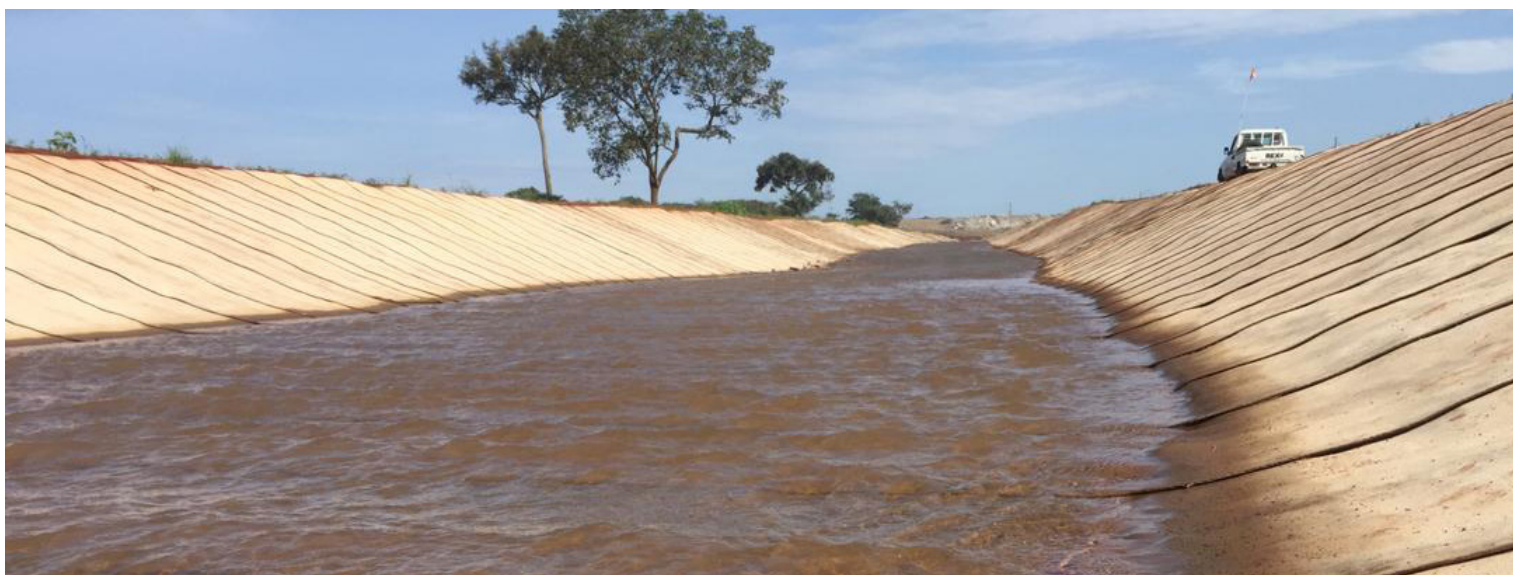
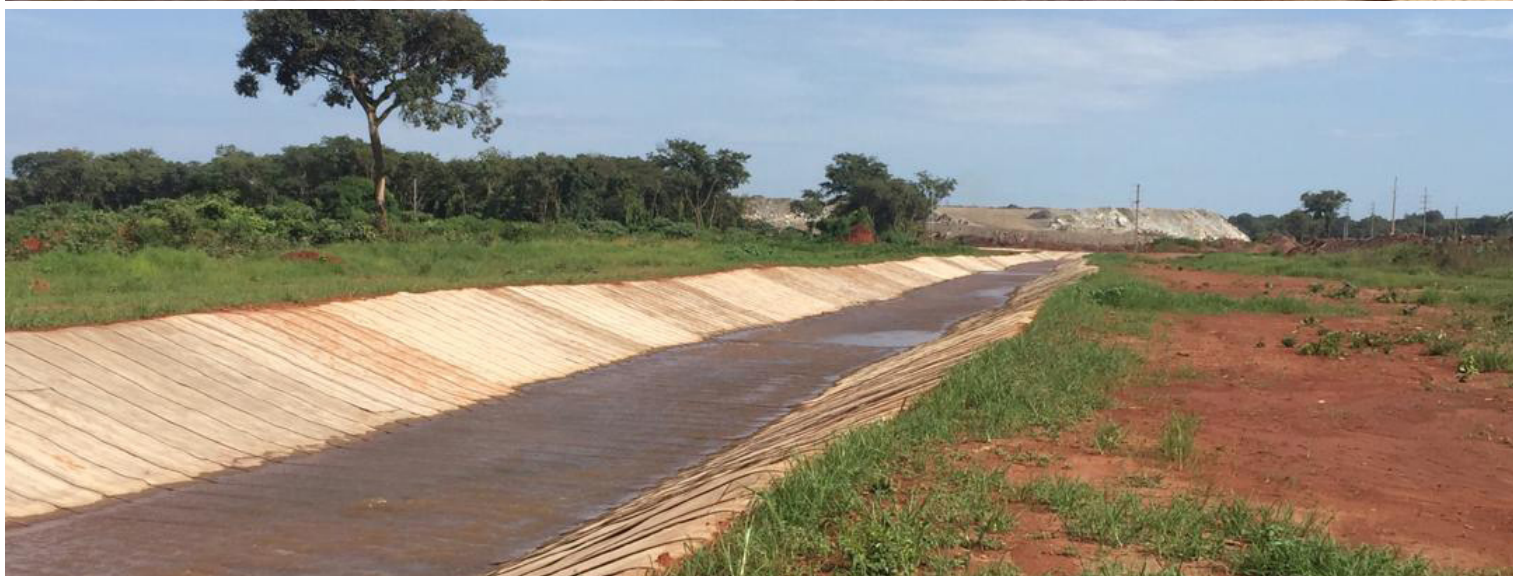
Channel re-visited 3 months after installation
